RAILROAD ACCIDENT REPORT

**HEAD-ON COLLISION BETWEEN
AMTRAK TRAIN NO. 82 AND
SEABOARD COAST LINE EXTRA 2771 SOUTH
LAKEVIEW, NORTH CAROLINA
APRIL 2, 1980**

NTSB-RAR-80-8

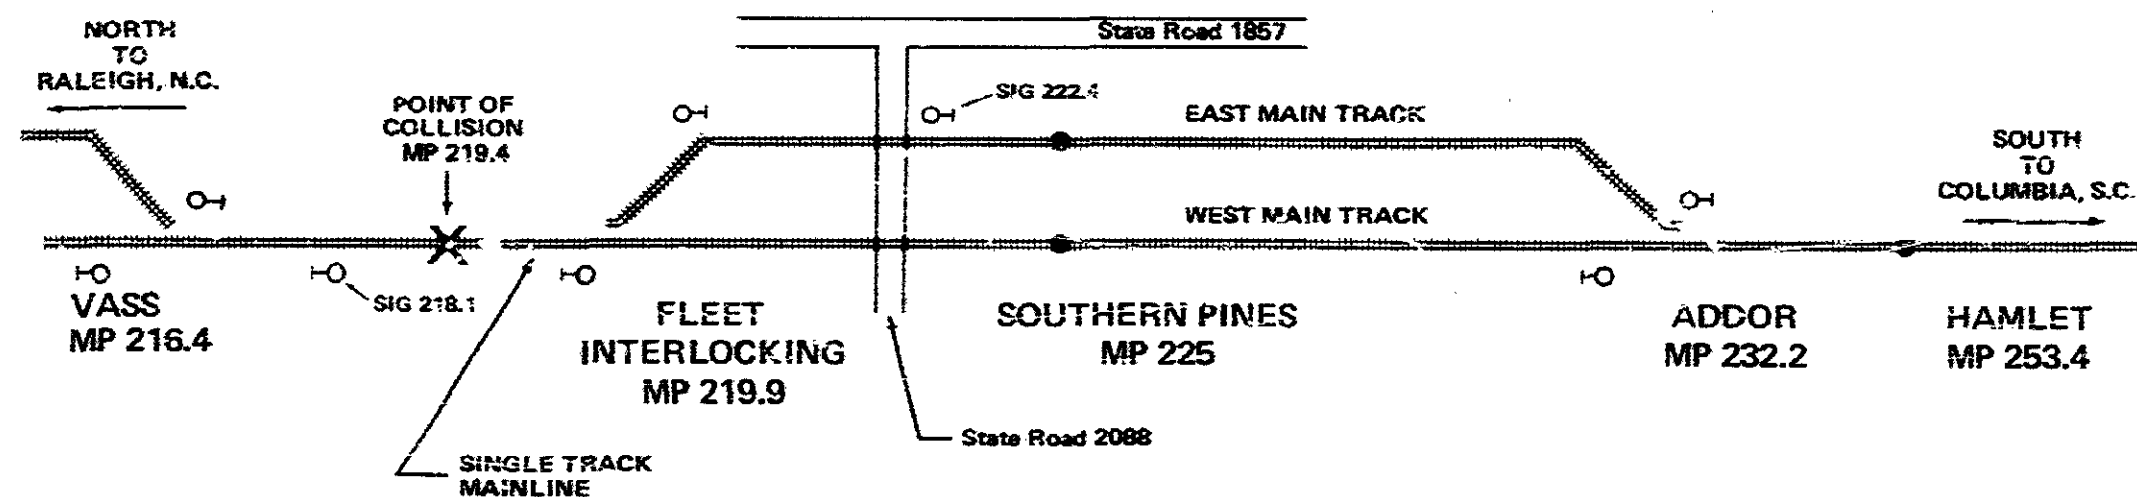
Figure 1.--Plan view of the Seaboard Coast Line Railroad between Hamlet, North Carolina, and Vass, North Carolina. (Not to scale.)
