RAILROAD ACCIDENT REPORT

**HEAD-END COLLISION OF
AMTRAK PASSENGER TRAIN NO. 74
AND CONRAIL TRAIN OPSE-7
DOBBS FERRY, NEW YORK
NOVEMBER 7, 1980**

NTSB-RAR-81-4

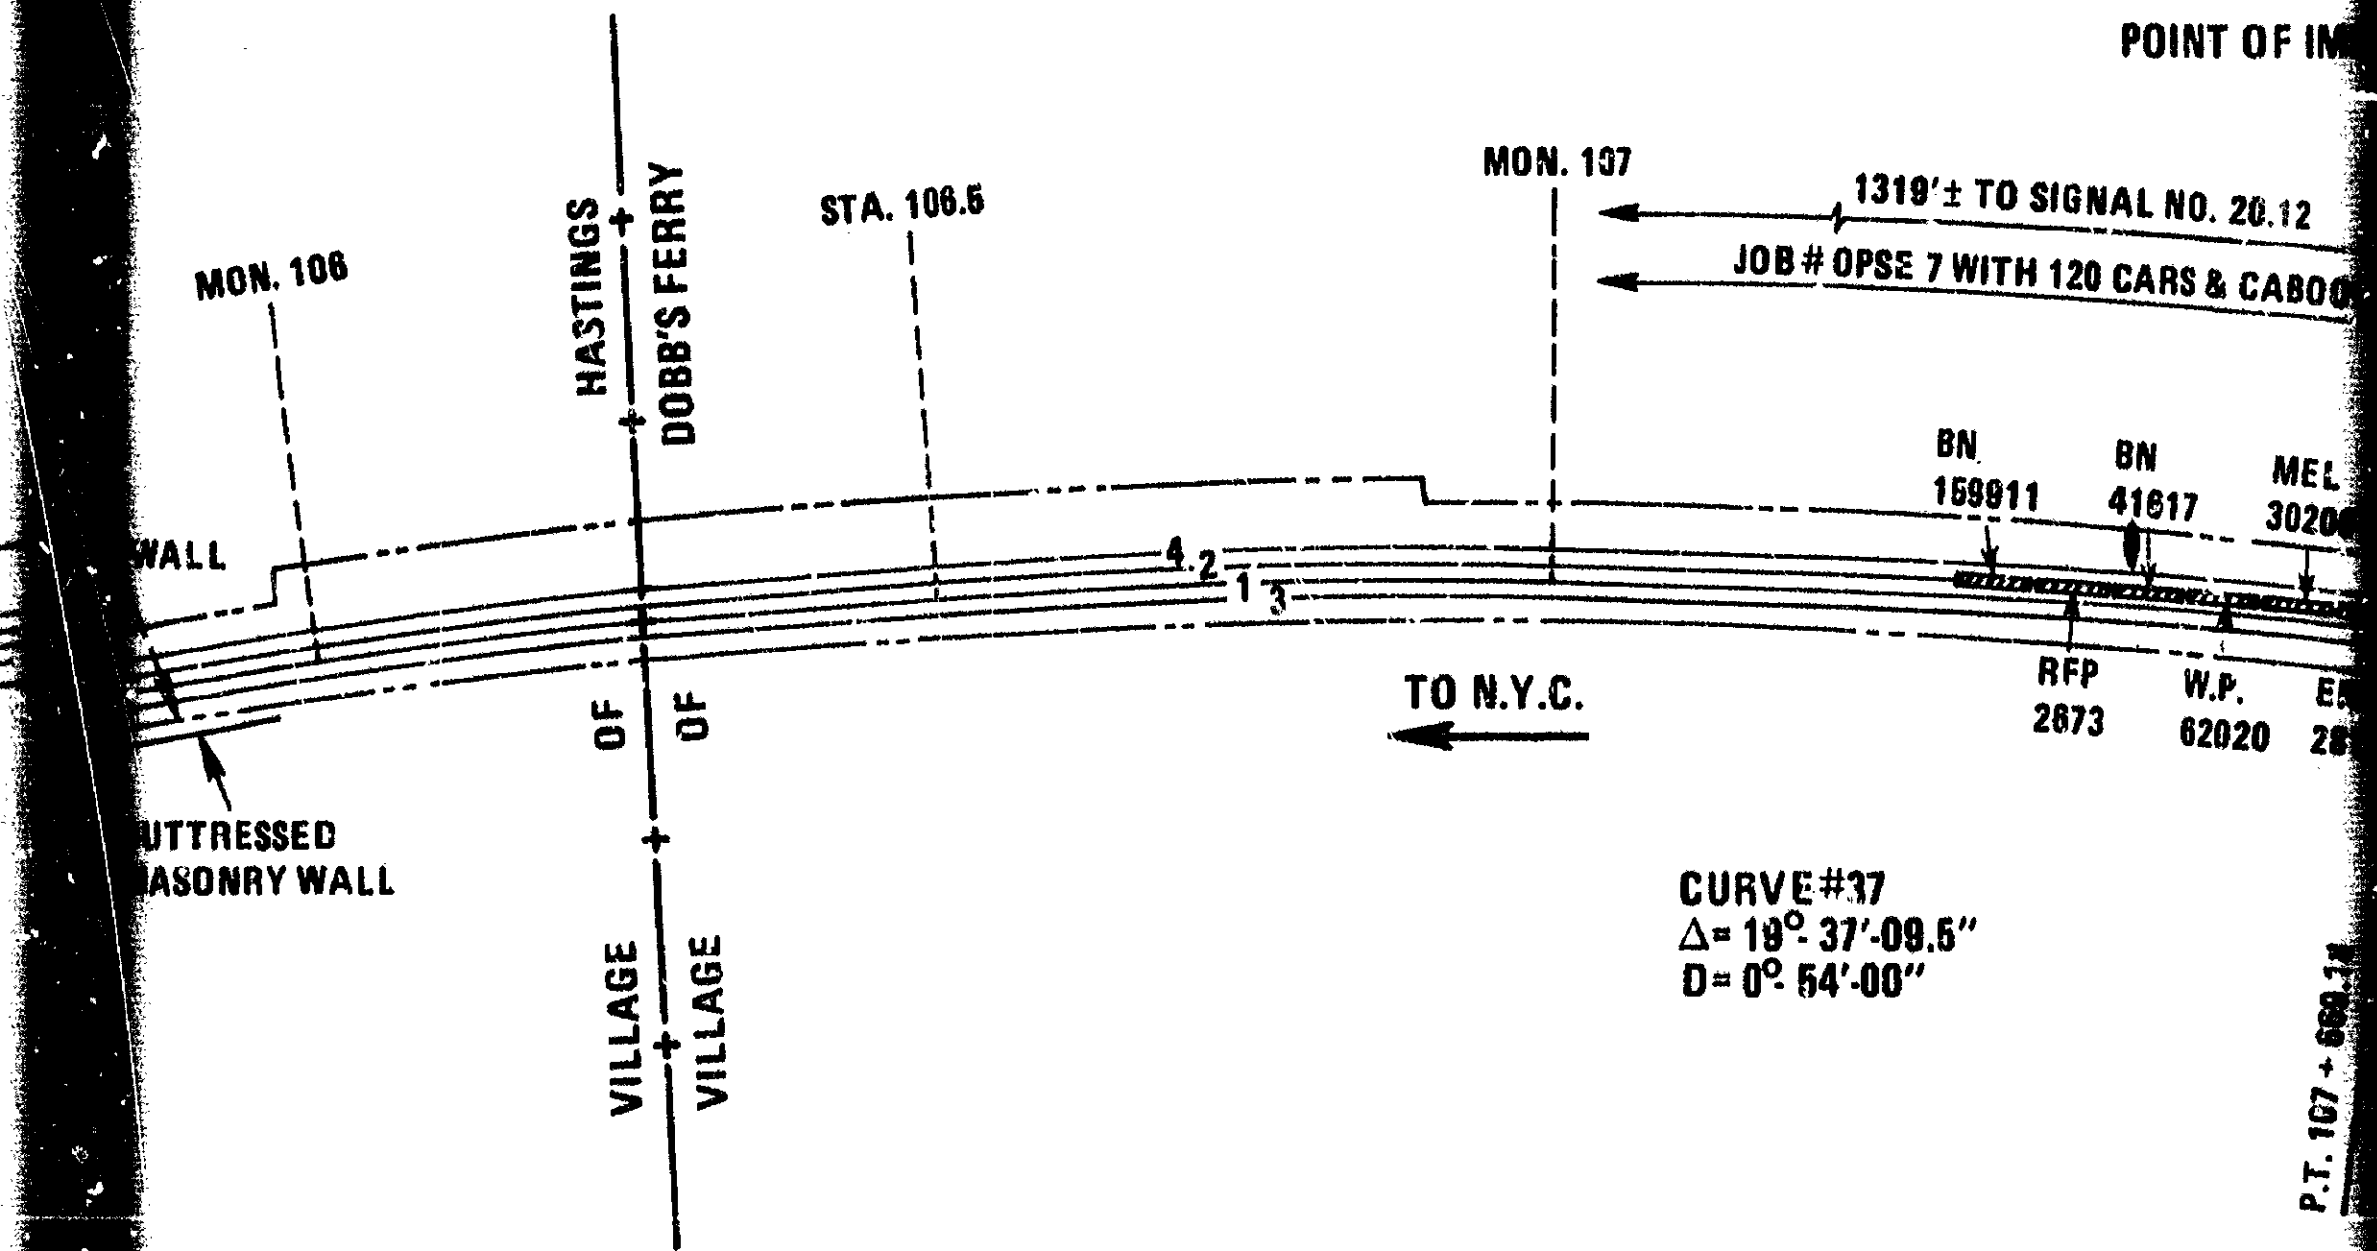
Figure 3.-- DOBBS FERRY AC

Moments later, OPSE-7 collided with standing train No. 74 at about 10 mph. The impact derailed the lead unit of OPSE-7 and pushed train No. 74 rearward about 112 feet, derailling the lead power car (see figure 2) and the following three passenger cars. (See figure 3.) Electrical power to the four tracks was shut off after a crewmember boarded the cab of the rear power car and used the radio to request that the power be shut off because of the collision and because passengers were getting onto the tracks. An employee of a restaurant adjacent to the accident site immediately called the Dobbs Ferry Police Department. Within 3 minutes after the accident, emergency forces began to arrive at the accident site.

Track damage was confined to the area of the collision and the 112 feet No. 74 was pushed rearward. The third rail equipment ^{4/} was also damaged when the second car of train No. 74 derailed and came to rest against it.

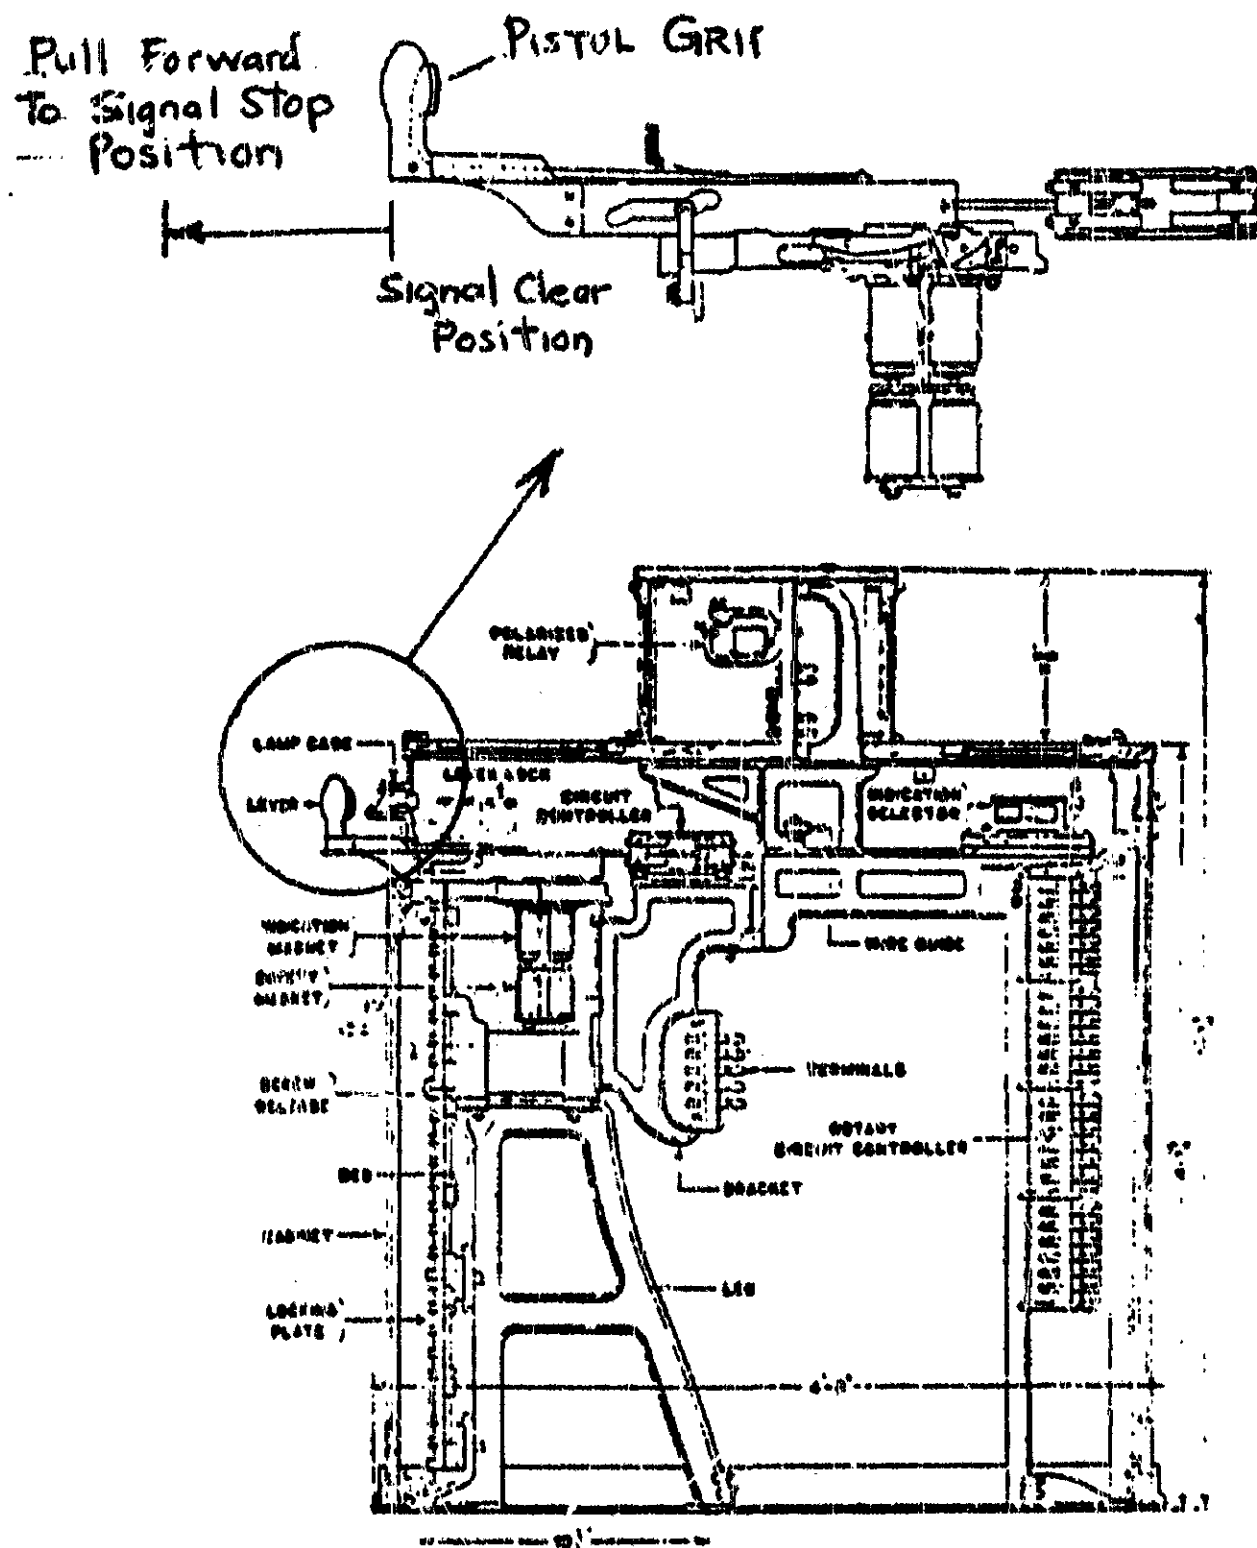
Figure 6.-- Unit lever-type machine.

The OW interlocking tower has a unit lever-type machine. (See figure 6.) The machine is equipped with 56 hand-operated levers: 33 levers control 34 signals, 19 levers control 20 switches, 3 levers control 4 electric locks, and there is 1 spare lever. The levers are a pistol grip-type which can only be moved by depressing the trigger in the handle. (See figure 6.) The blocking devices are metal boxes with opened ends.
