NATIONAL TRANSPORTATION SAFETY BOARD

RAILROAD ACCIDENT REPORT

**DERAILMENT OF
AMTRAK PASSENGER TRAIN NO. 21
ON THE ILLINOIS CENTRAL GULF RAILROAD
SPRINGFIELD, ILLINOIS
OCTOBER 30, 1980**

NTSB-PAR-81-5

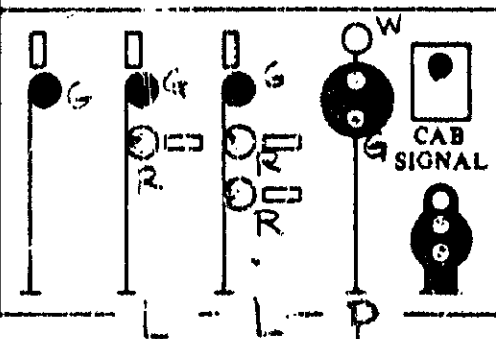
| RULE | Block and Interlocking Aspects | NAME | INDICATION |
|---|--|---|--|
| 281 | | Clear | Proceed. |

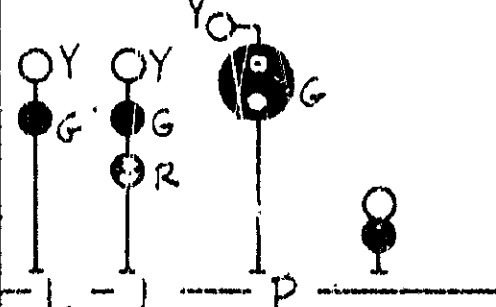
| RULE | Block and Interlocking Aspects | NAME | INDICATION |
|---|--|---|--|
| 283 | | Approach Limited | Proceed; approaching next signal prepared to enter turn out at prescribed speed, but not exceeding 40 MPH. |

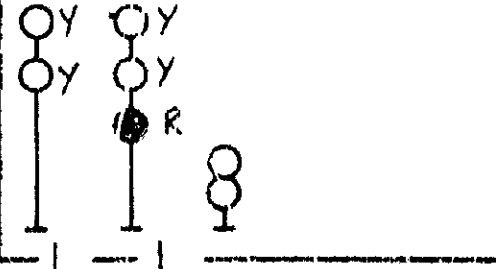
| RULE | Block and Interlocking Aspects | NAME | INDICATION |
|---|--|---|--|
| 284 | | Medium Approach | Proceed; approaching next signal prepared to enter turn out at prescribed speed, but not exceeding 30 MPH. |

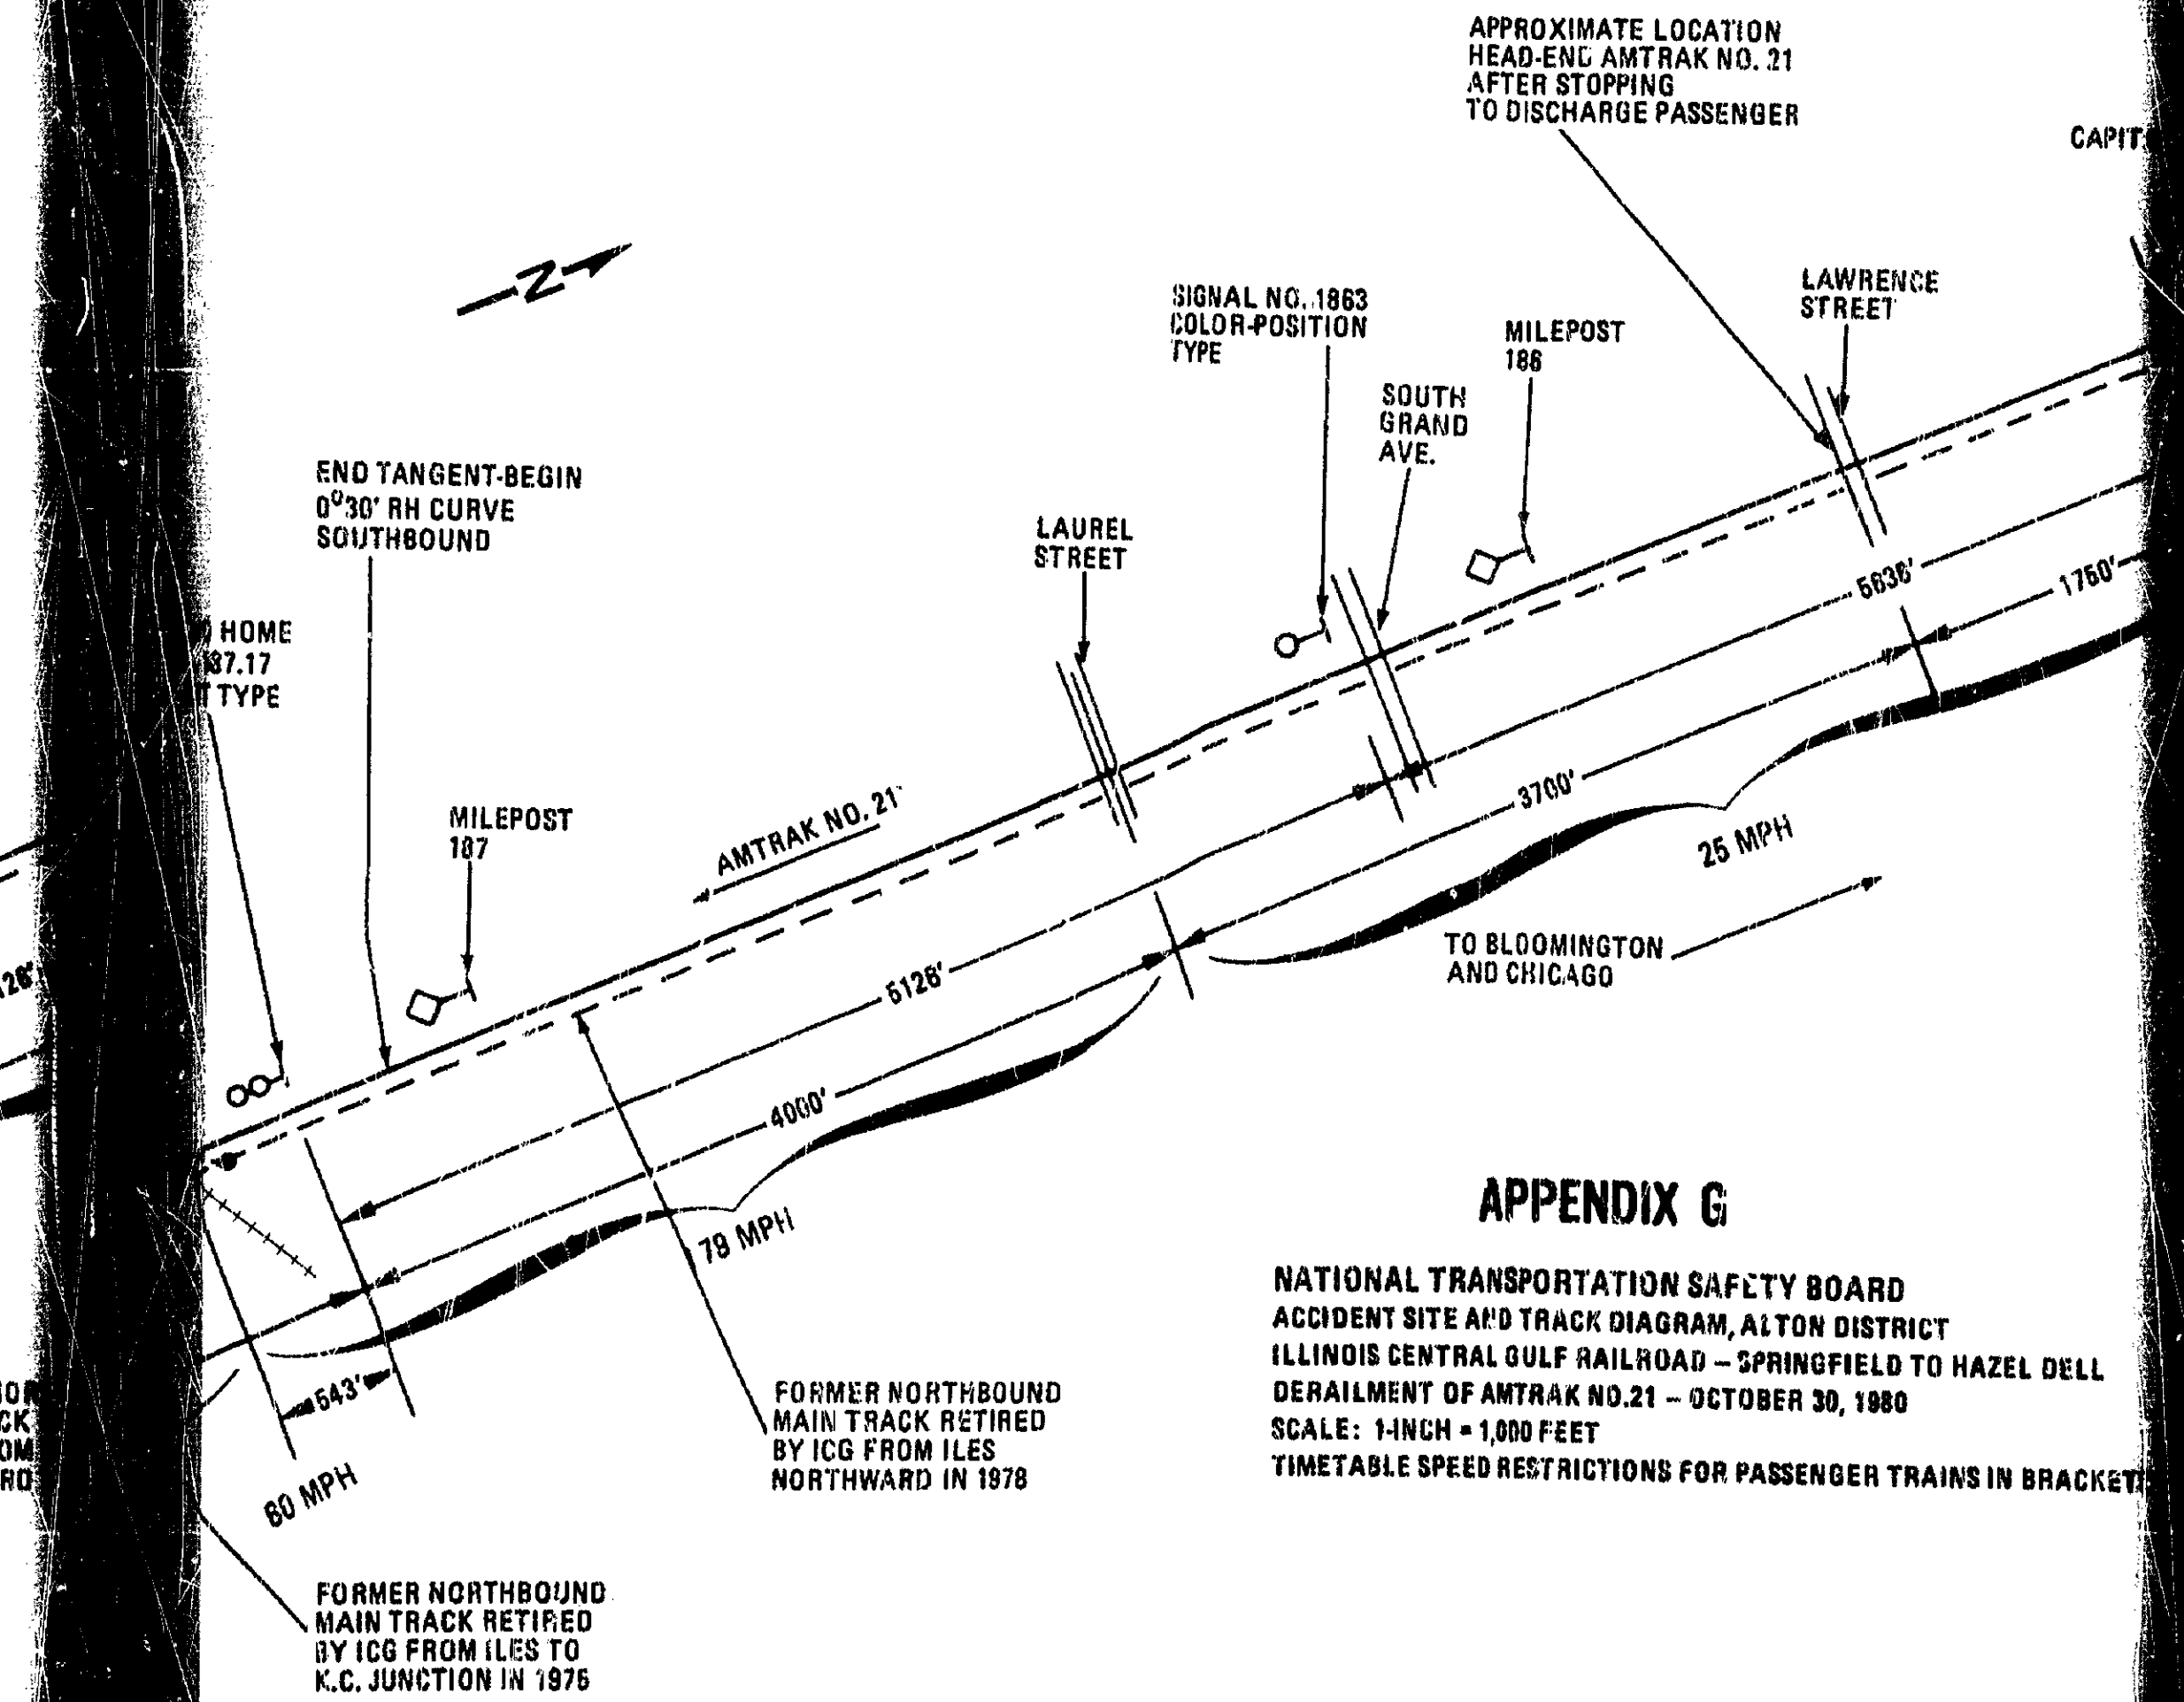
APPENDIX G

NATIONAL TRANSPORTATION SAFETY BOARD
ACCIDENT SITE AND TRACK DIAGRAM, ALTON DISTRICT
ILLINOIS CENTRAL GULF RAILROAD - SPRINGFIELD TO HAZEL DELL
DERAILMENT OF AMTRAK NO. 21 - OCTOBER 30, 1980
SCALE: 1-INCH = 1,000 FEET
TIMETABLE SPEED RESTRICTIONS FOR PASSENGER TRAINS IN BRACKET
