# **NATIONAL TRANSPORTATION SAFETY BOARD**

## **RAILROAD ACCIDENT REPORT**

**DERAILMENT OF ILLINOIS CENTRAL GULF RAILROAD  
FREIGHT TRAIN EXTRA 9629 EAST (GS-2-28)  
AND RELEASE OF HAZARDOUS MATERIALS  
AT LIVINGSTON, LOUISIANA  
SEPTEMBER 28, 1982**

NTSB/RAR-83/05

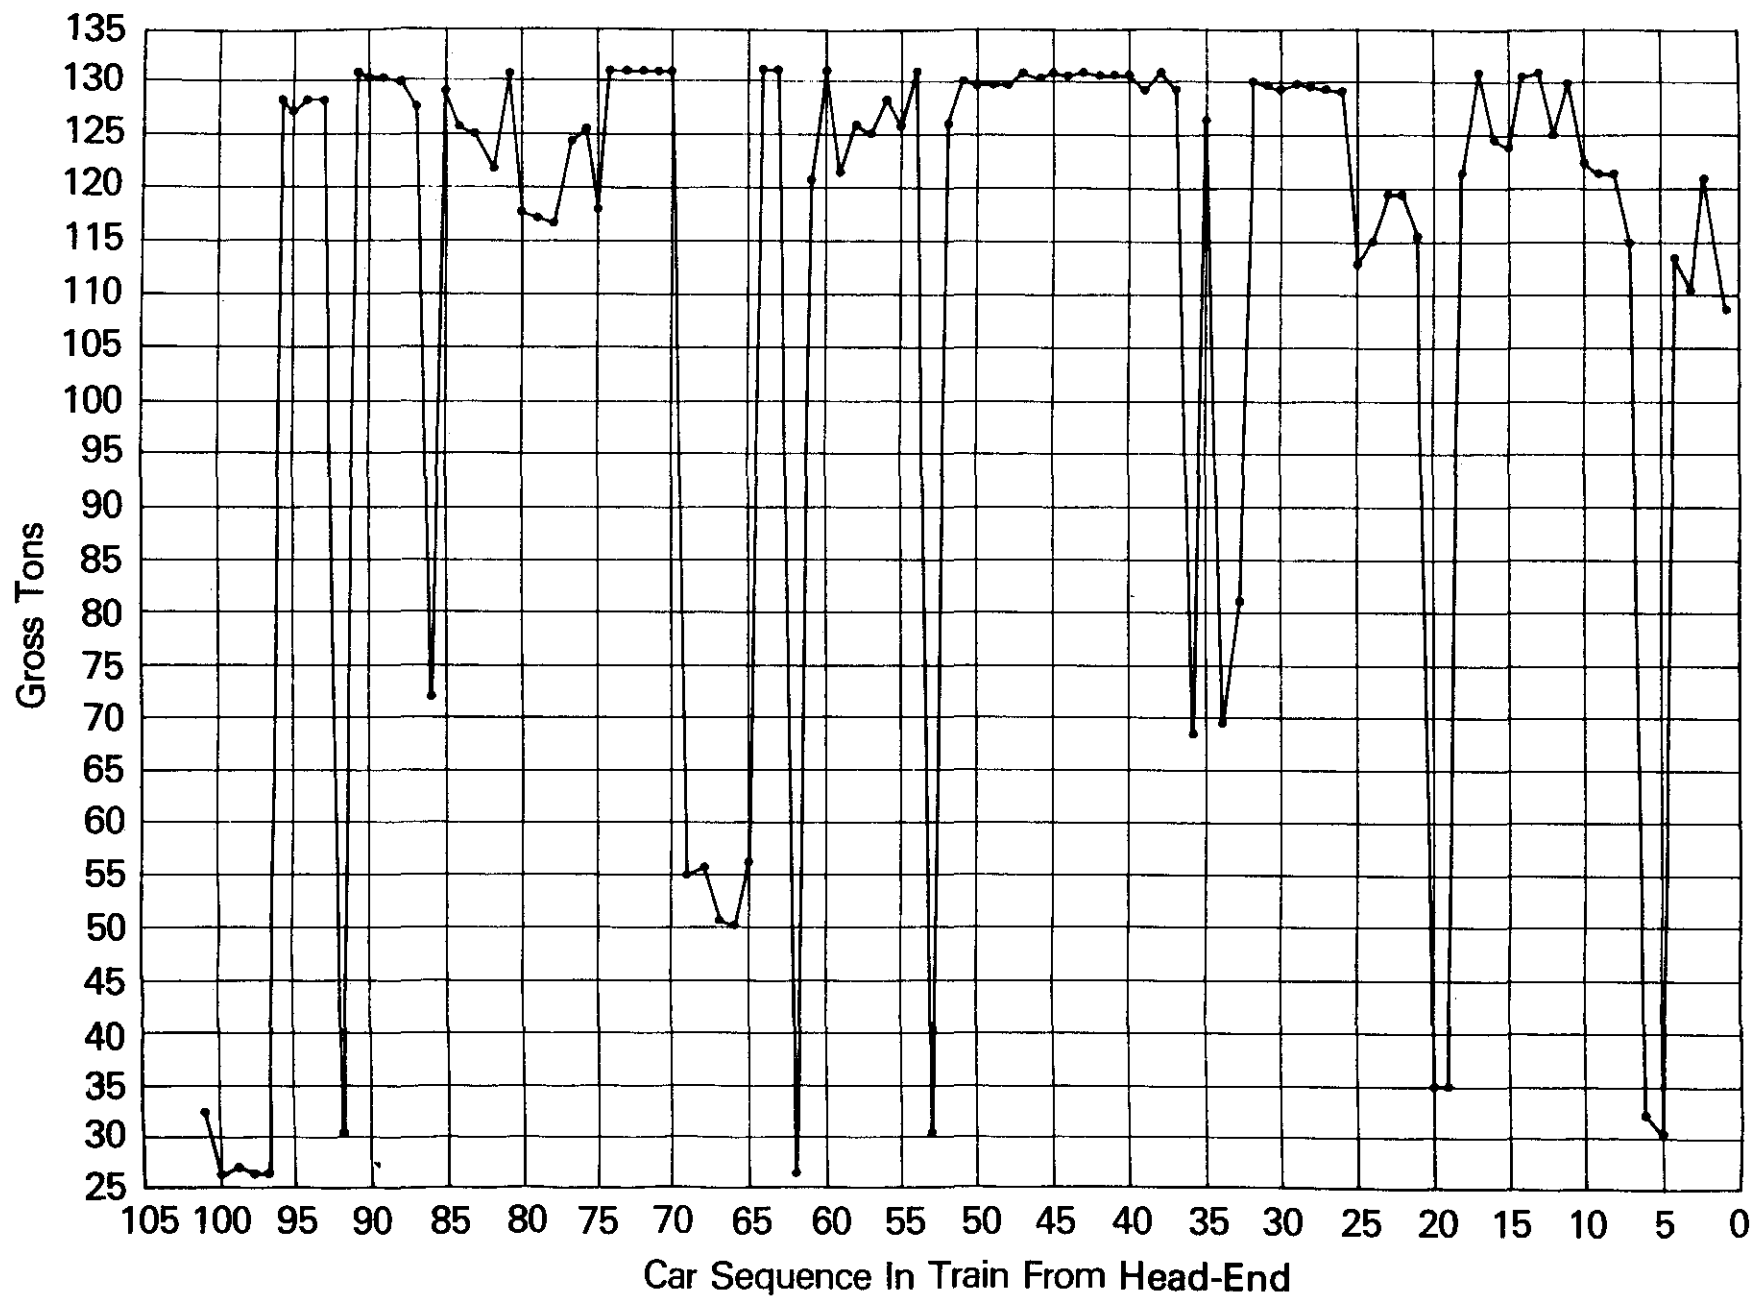
Most of the 16 empty cars in Extra 9629 East were scattered throughout the rear half of the train with 4 of them just ahead of the caboose. (See figure 2.) The 5th, 6th, 19th, and 20th cars were the only empty cars in the forward half of the train. These weighed 30 to 35 tons each whereas the 12 loaded cars between the two pairs of empty cars varied in weight from 115 to 131 tons each. Most of the 33 loaded cars behind the 19th and 20th head cars weighed 130 tons or more.

Figure 2.--Tonnage profile for Extra 9629 East.
