# NATIONAL TRANSPORTATION SAFETY BOARD

## RAILROAD ACCIDENT REPORT *2110.*

HEAD-ON COLLISION OF CHICAGO,  
SHORE AND SOUTH BEND RAILROAD  
TRAINS NOS. 123 AND 218  
GARY, INDIANA  
JANUARY 21, 1985

NTSB/RAR-85/13   (PB85-916313)

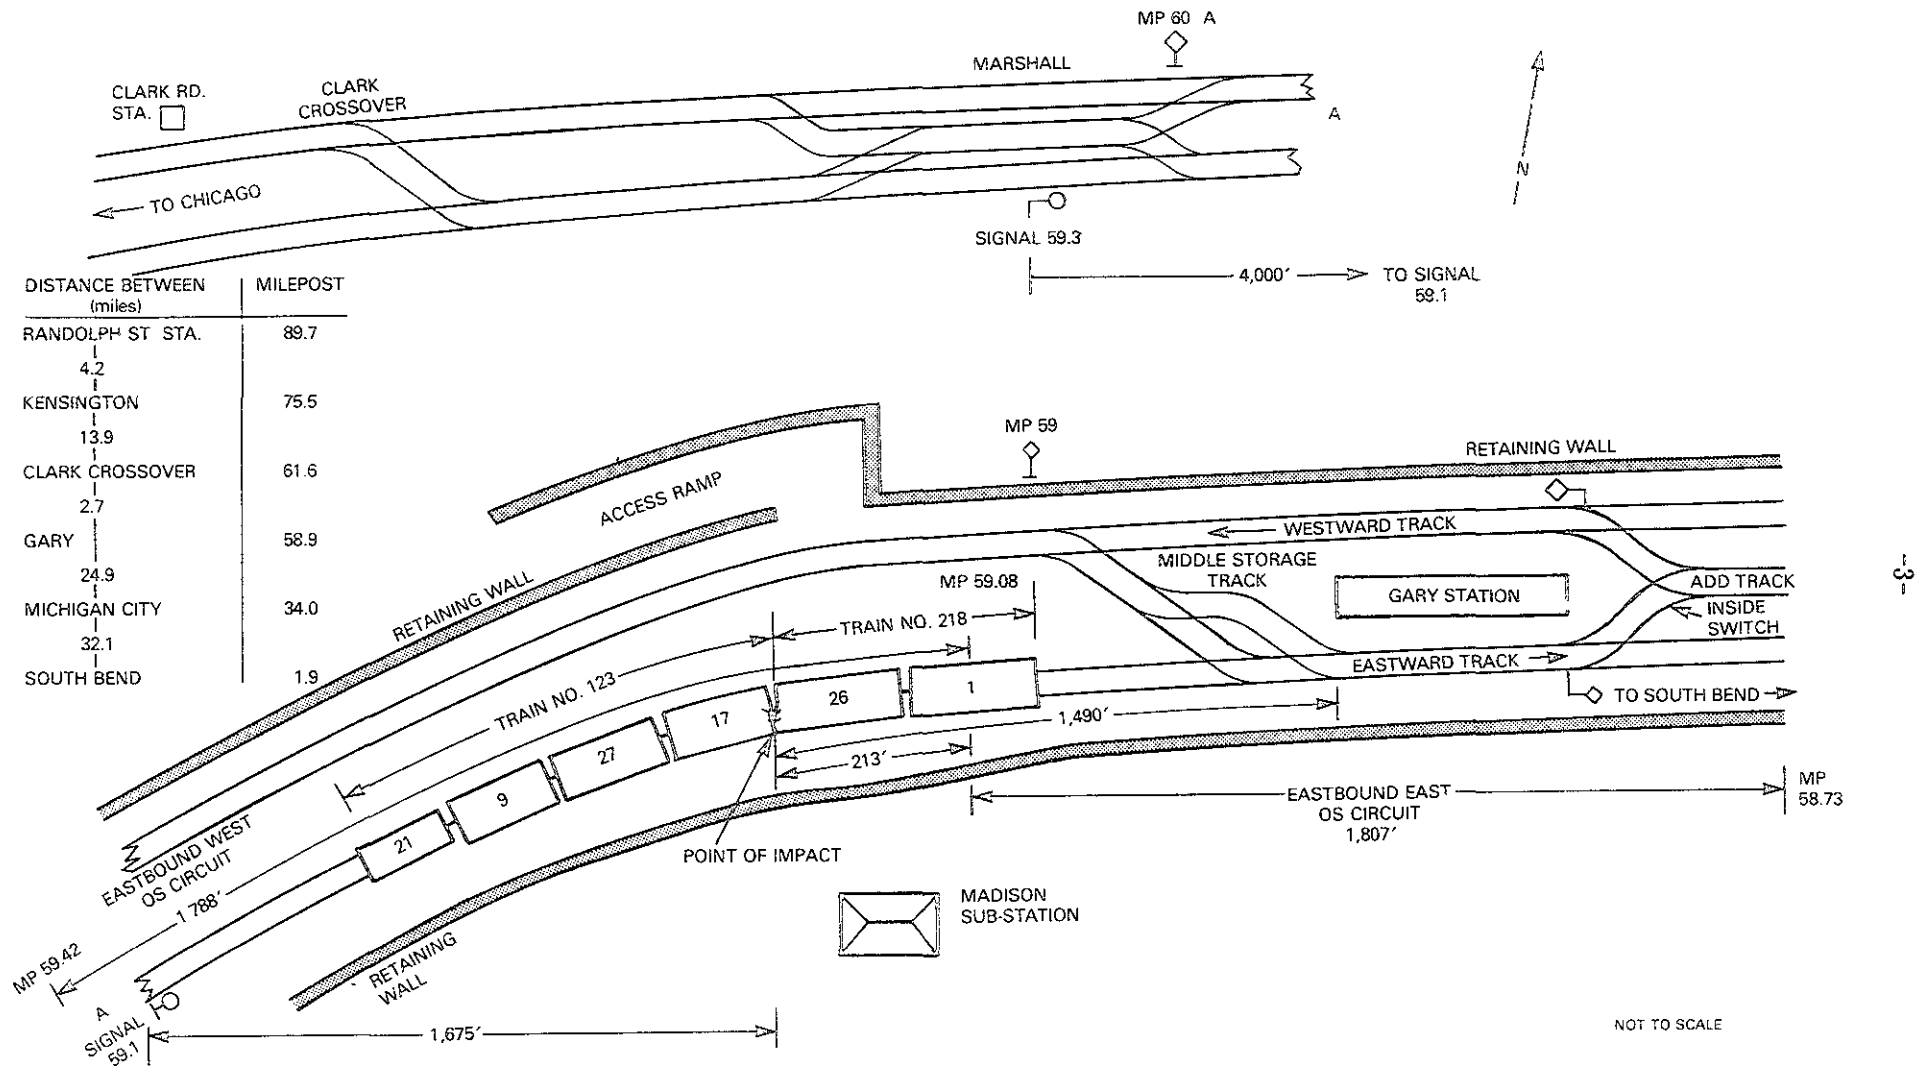
Figure 1.--Plan view of accident site.

The notice eliminated the requirement for the train dispatcher to issue a train order to move each train between the track limits specified in the notice. All the area covered by the notice was within Gary yard limits. (See figure 1.) The notice was posted about 10:15 a.m. on January 21, 1985, at the reporting point for traincrews and enginecrews in Michigan City. About the same time, copies of the notice were forwarded by a train messenger to be posted at the Randolph Street Station in Chicago.

Under single-track operating rule No. S-71 (Timetable Special Instructions) on the South Shore, a westbound train is superior to an eastbound train, i.e., an eastbound train must clear the main track if it meets a westbound train of the same class. Opposing trains of the same class 14/ are allowed to meet on "flat time," which means that an eastbound inferior train complies with operating rule No. S-71 if it clears the main track at a designated point before a westbound superior train is scheduled to leave that same point. For trains of the same class, no clearance margin of time is required. South Shore operating officers said that train No. 123 should have cleared the track for train No. 218 at Clark Crossover (by remaining west of the crossover) or at Marshall, or at the west end of Gary Station before 6:50 p.m., the scheduled departure time of train No. 218. (See figure 1.)
