# **NATIONAL TRANSPORTATION SAFETY BOARD**

## **RAILROAD ACCIDENT REPORT**

**DERAILMENT OF AMTRAK PASSENGER TRAIN 8  
OPERATING ON THE SOO LINE RAILROAD,  
FALL RIVER, WISCONSIN  
OCTOBER 9, 1986**

NTSB/RAR-87/06

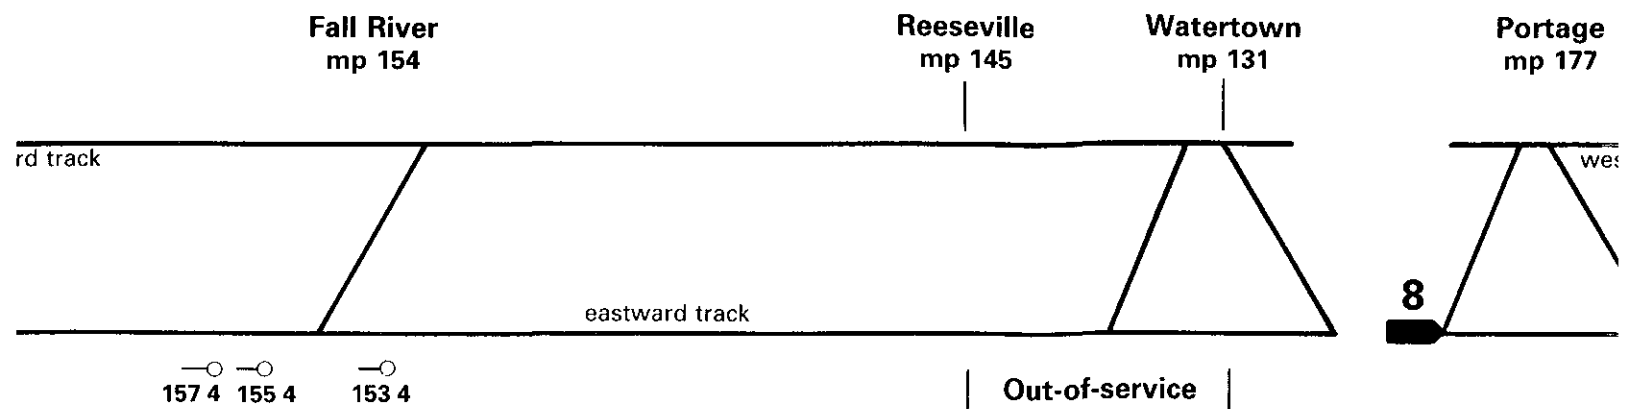
**(a) 9 a.m.**

At 9 a.m., eastbound freight train 200 arrived at Portage. (See figure 1a.) The engineer and conductor received train order no. 11 and another order that allowed them to operate on the westward track. Eastbound freight train 204 arrived at Portage at 9:10 a.m., and the engineer and conductor of that train also received a copy of train order no. 11. However, train 204 was held at Portage by the dispatcher to await the arrival of eastbound train 210. The train dispatcher stated that he wanted train 200 to depart Portage on the westward track and train 210 to depart Portage before train 204 on the eastward track. He further explained that train 210 would pass train 200 en route to Fall River, 24 miles east of Portage, and would cross over to the westward track before train 200 was allowed to proceed east of Fall River. Train 200 was a cabooseless train.

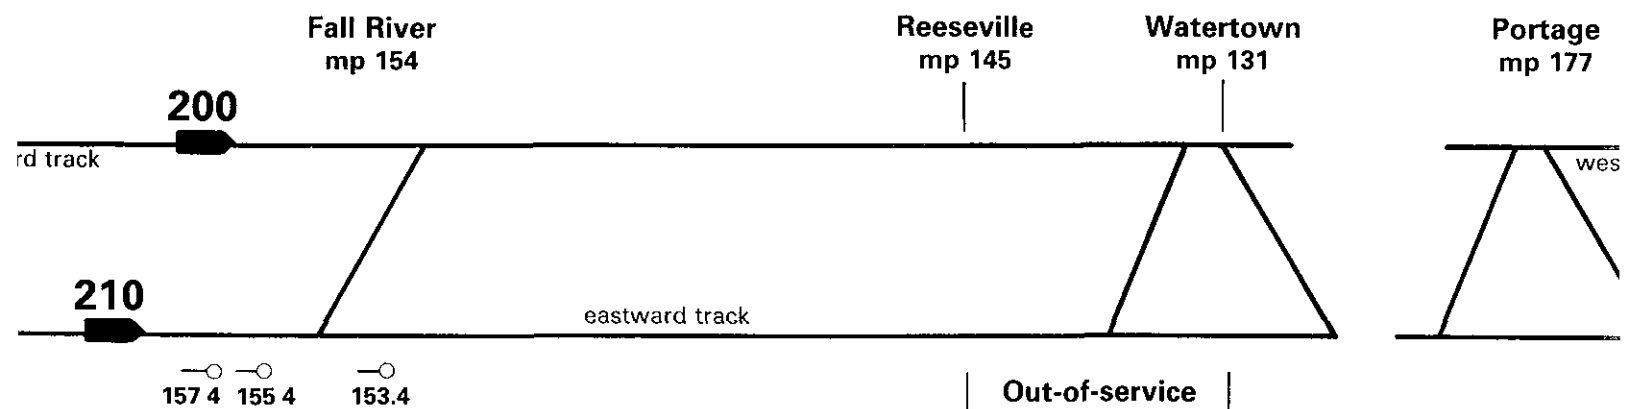
**(b) 9:55 a.m. - 10:15 a.m.**

At 9:55 a.m., train 200 departed Portage eastbound on the westward track and train 210 departed eastbound on the eastward track. A road foreman, the engineer's supervisor, took over the controls of the locomotive of train 210 at Portage. The crew of train 200 had received an order that allowed the train to proceed only to Fall River and wait there so that it would not interfere with the movement of train 210. At 10:15 a.m. the dispatcher advised the switchtender that train 210 would be the next train to arrive at Fall River (figure 1b). The switchtender suggested a crossover procedure that might expedite the movement of the train; he stated that the train dispatcher agreed with this suggestion. The crossover procedure consisted of delaying the positioning of the crossover switches until a train passed the last wayside signal, 2 miles west of the crossover at Fall River. According to the switchtender, this procedure would display continual green signals that would allow the engineer to operate at a higher speed until nearing Fall River. The engineer would then slow his train at his own discretion, rather than obey the speed restrictions imposed by the signals that would have been displayed had the switches been operated before the train passed the signal.

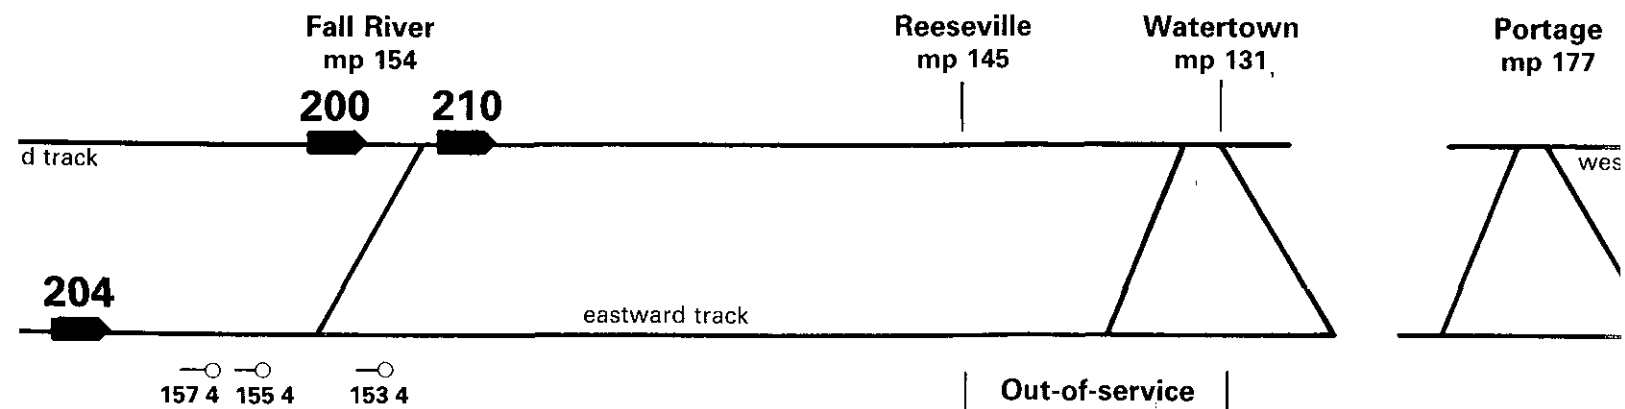
**(c) 10:59 a.m.**

After the locomotive of train 210 passed signal 155.4 (the last signal before Fall River), the road foreman radioed the switchtender at Fall River to reverse the switches of the crossover to allow his train to cross over to the westward track and to continue eastbound. Immediately after receiving that communication, the switchtender stated that he heard the locomotive horn sound a warning for a grade crossing east of signal 155.4 and that he reversed the switches as he had been instructed. Within minutes, train 210 arrived at Fall River, and at 10:59 a.m. it had completed the crossover move from the eastward to the westward track (figure 1c). Meanwhile, train 200 arrived and stopped at Fall River; the switchtender stated he overheard the engineer and conductor receive an order from the operator at Portage allowing train 200 to proceed eastbound on the westward track. By this time the switchtender had lined the switches to the crossover in the normal position, so that as soon as the order to proceed was complete, train 200 could depart.

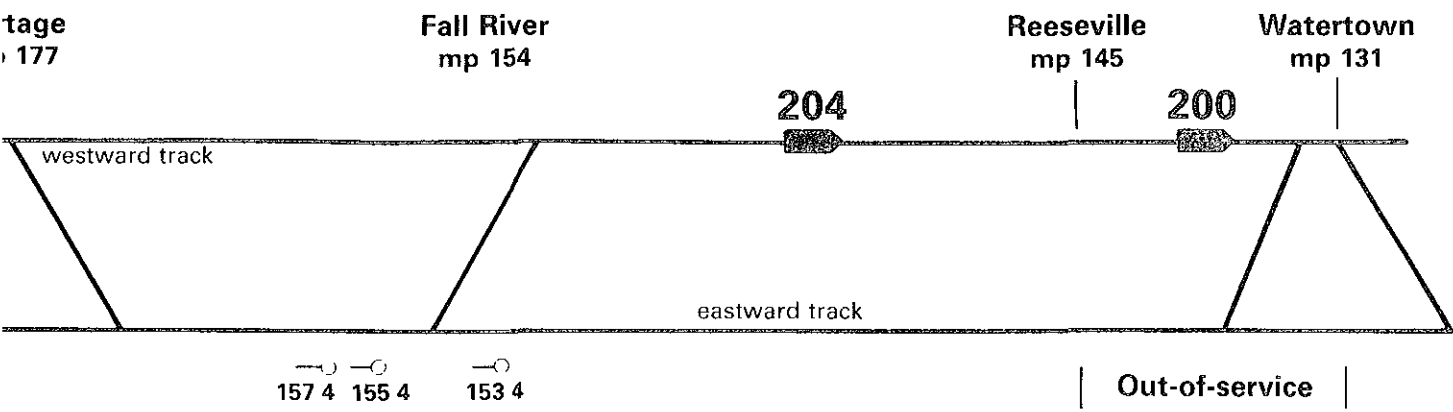
(d) 11:34 a.m. - 11:56 a.m.

Train 204 departed Portage at 10:40 a.m. on the eastward track and its engineer and conductor were instructed to stop at Fall River to receive a train order. Train 204 arrived at Fall River about 11:30 a.m. and stopped; the switchtender overheard on his portable radio that the engineer and conductor of train 204 had received an order that would allow the train to cross over to the westward track at Fall River. The switchtender then reversed the switches to allow train 204 to proceed. Train 204 completed the crossover to the westward track at 11:34 a.m. (figure 1d), and the switchtender then lined the switches to the normal position.

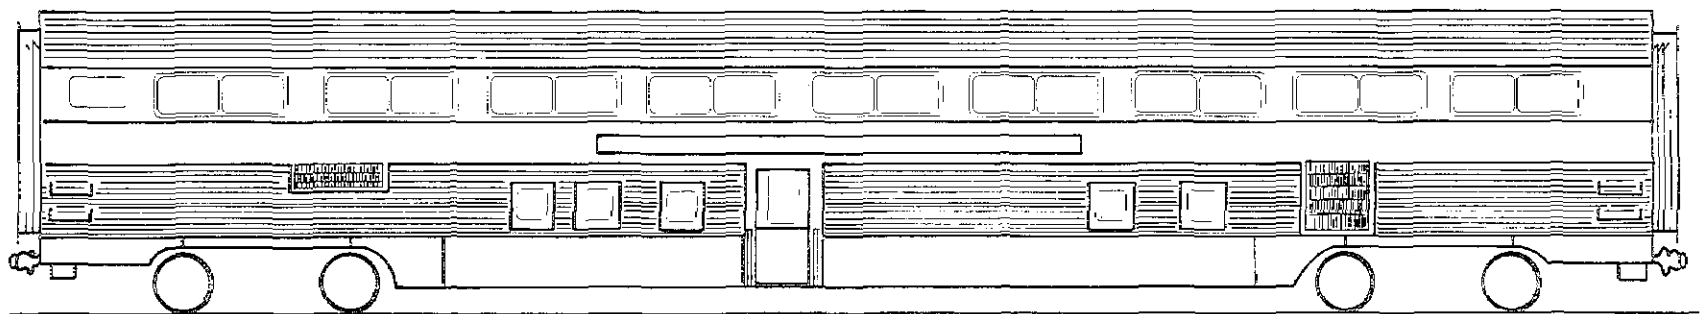
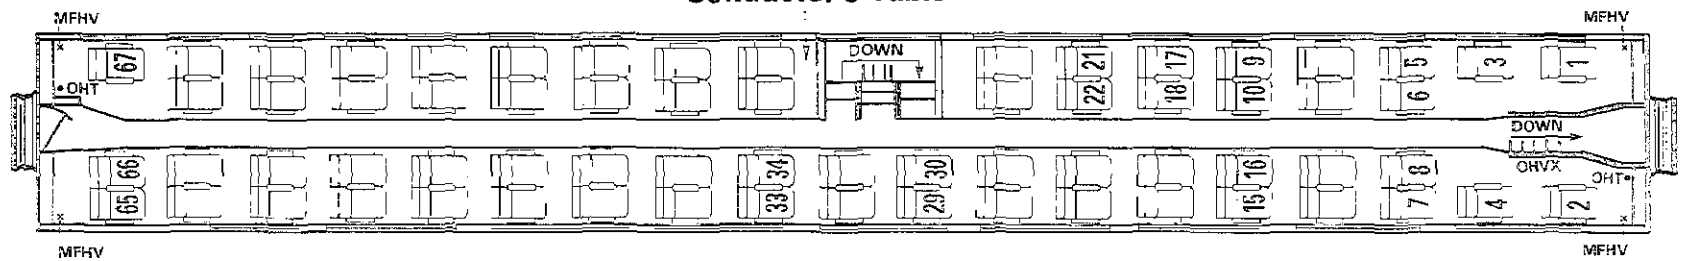
Figure 4.--Diagram of coach/dorm car.

The baggage car, next in line, also overturned. This car was extensively damaged; both ends of the car were crushed. The following car, a coach/dorm car, sustained extensive damage as a result of the collision with other cars during the derailment. This car did not overturn but jackknifed from the train, went over the embankment, and was leaning to one side. The roof of the car was crushed inward about 4 feet, and the side of the car at seat locations 1, 5, 9, and 13 was torn away; the windows were also torn away. At seats 13 and 14 the sidewall was crushed inward about 15 inches, crushing the window seat armrest (figure 4). The window frame was twisted with the outside glass missing, but the inside Lexan window remained in place (figures 5, 6, and 7).
