RAILROAD ACCIDENT REPORT

REAR-END COLLISION OF AMTRAK PASSENGER TRAIN 94, THE COLONIAL AND CONSOLIDATED RAIL CORPORATION FREIGHT TRAIN ENS-121, ON THE NORTHEAST CORRIDOR CHASE, MARYLAND JANUARY 4, 1987

NTSB/RAR-88/01

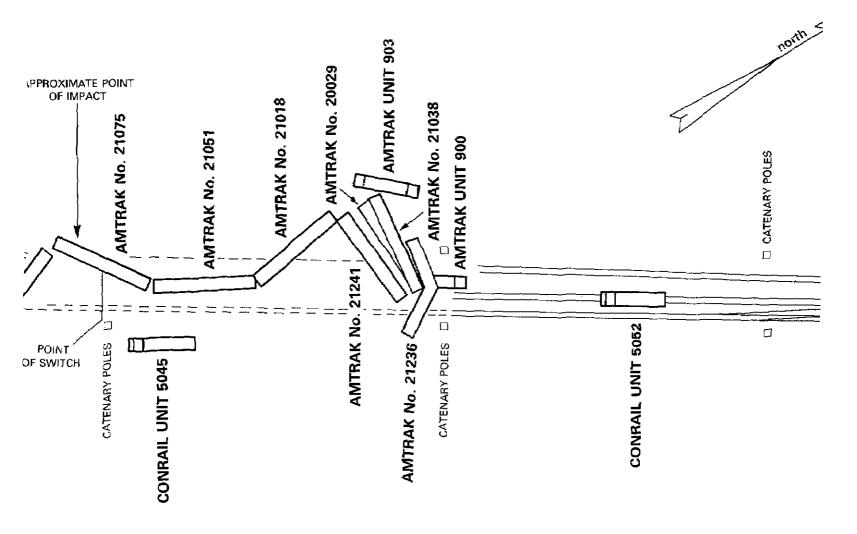
"GUNPOW" INTERLOCKING WRECKAGE DISTRIBUTION PLAN CHASE, MARYLAND

The rear Conrail unit was virtually disintegrated with parts scattered across the tracks and property east of the tracks. The largest piece of wreckage came to rest about 150 feet northeast of the collision point. The rear of the middle Conrail unit was crushed by the rear unit. Uncoupled from the lead unit, it was propelled forward on track 2 for about 700 feet. Only the rear truck of this unit derailed. The lead Conrail unit sustained relatively superficial damage, although driven forward about 900 feet, it was the only piece of equipment in the two trains that was not derailed.

The forward cab and superstructure of the lead Amtrak locomotive unit was crushed downward and inward to the underframe. Separated from the trucks, the remains of the car body came to rest west of the tracks about 400 feet north of the collision point. The trailing Amtrak unit remained in line with the track, although separated from its trucks, and came to rest leaning about 45° to the right at a point about 45° feet north of the collision point (see figure 3).

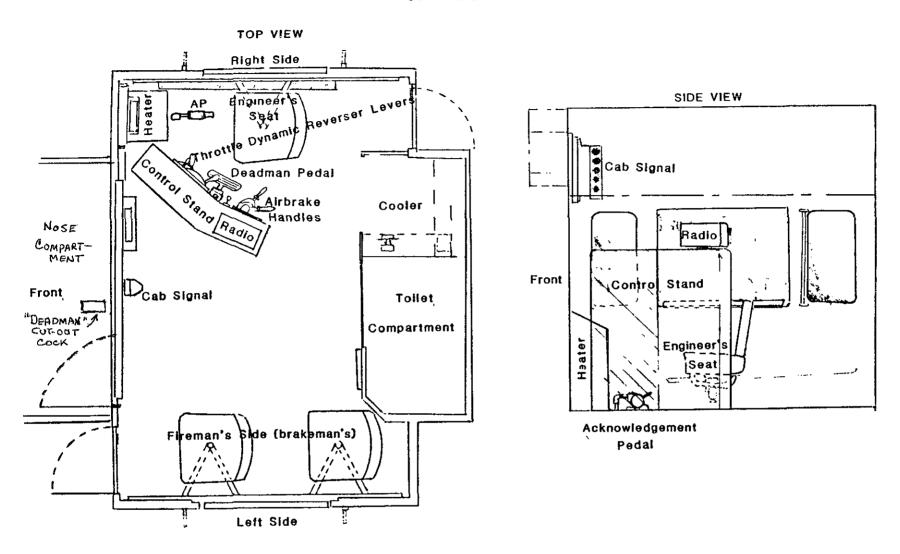
Figure 13. Cab signal of Conrail unit 5044 with the cover removed; the bulb for the "approach" aspect is missing.

The four-aspect cab signal of unit 5044 was of the same configuration as the Amtrak AEM-7 locomotives; it was mounted in the middle of the forward cab bulkhead at the top of the windshield. The hinged cover had two sets of aspect ports set at oblique angles so that one could be viewed from each side of the cab. The top port was the "clear" aspect, the next two below were the "approach medium" aspect, the next below was the "approach" aspect, and the bottom port was the "restricting" aspect. There were screw-in receptacles in the signal box for four small white bulbs--one for each aspect. An examination of the signal box after the accident revealed that the bulb for the "approach" aspect was missing (see figure 13). All the other aspects had operative bulbs that were properly inserted.
