NATIONAL TRANSPORTATION SAFETY BOARD

RAILROAD ACCIDENT REPORT

**COLLISION AND DERAILMENT
OF AMTRAK TRAIN 6
ON THE BURLINGTON NORTHERN RAILROAD
RUSSELL, IOWA
OCTOBER 12, 1987**

NISB/RAR-88/04

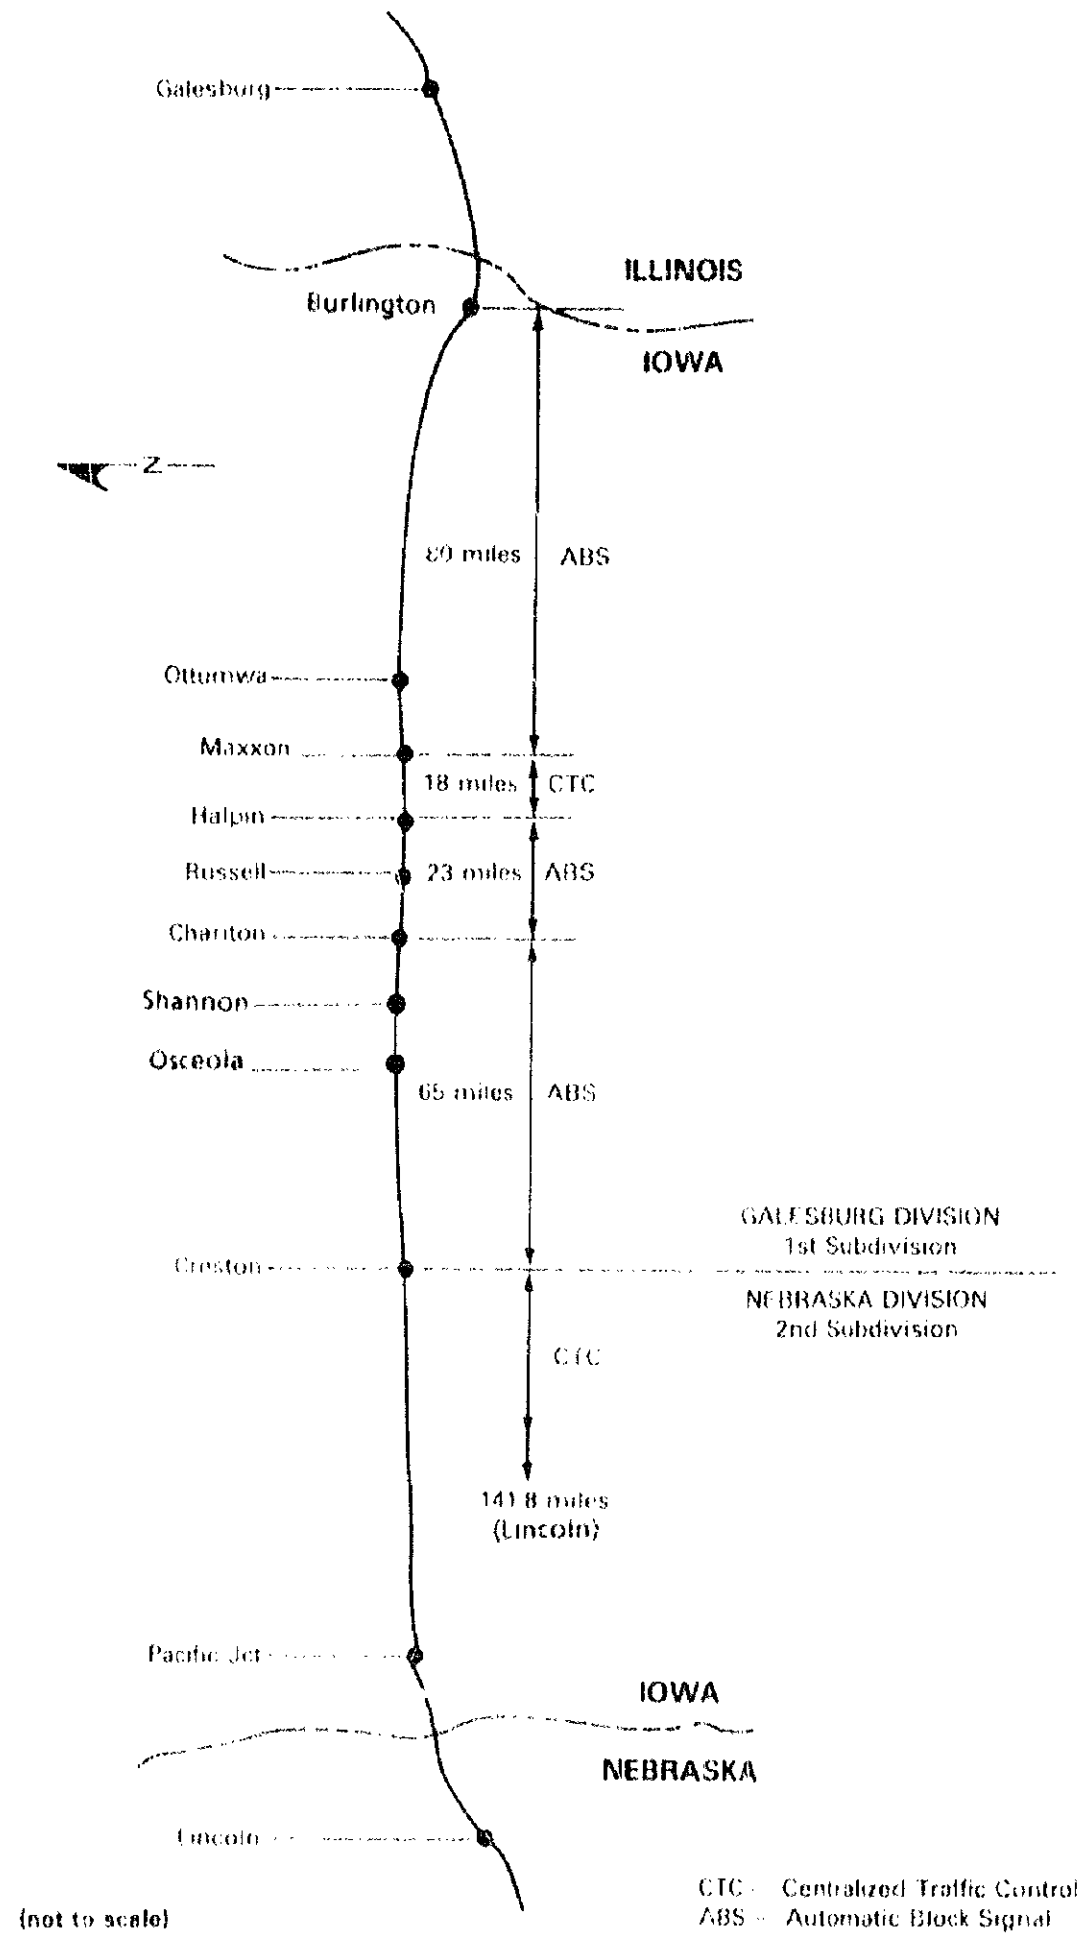
Figure 1.-Route of Amtrak train 6 from Lincoln, Nebraska, to Galesburg, Illinois

That morning, National Railroad Passenger Corporation (Amtrak) train 6, the California Zephyr, was operating eastbound. The train was being operated over BN tracks as Extra Amtrak 396 East. The train consisted of two diesel-electric passenger locomotives, three baggage cars, a coach/dorm car, five coaches, a lounge/cafe car, a dining car, and three sleeping cars. An Amtrak operating crew change was made at Lincoln, Nebraska, at 0610. Train 6 entered the First Subdivision of the Galesburg Division at Creston, Iowa, a crew-change point for BN crews. An exchange of BN pilots¹ was made at that time. (See figure 1.)

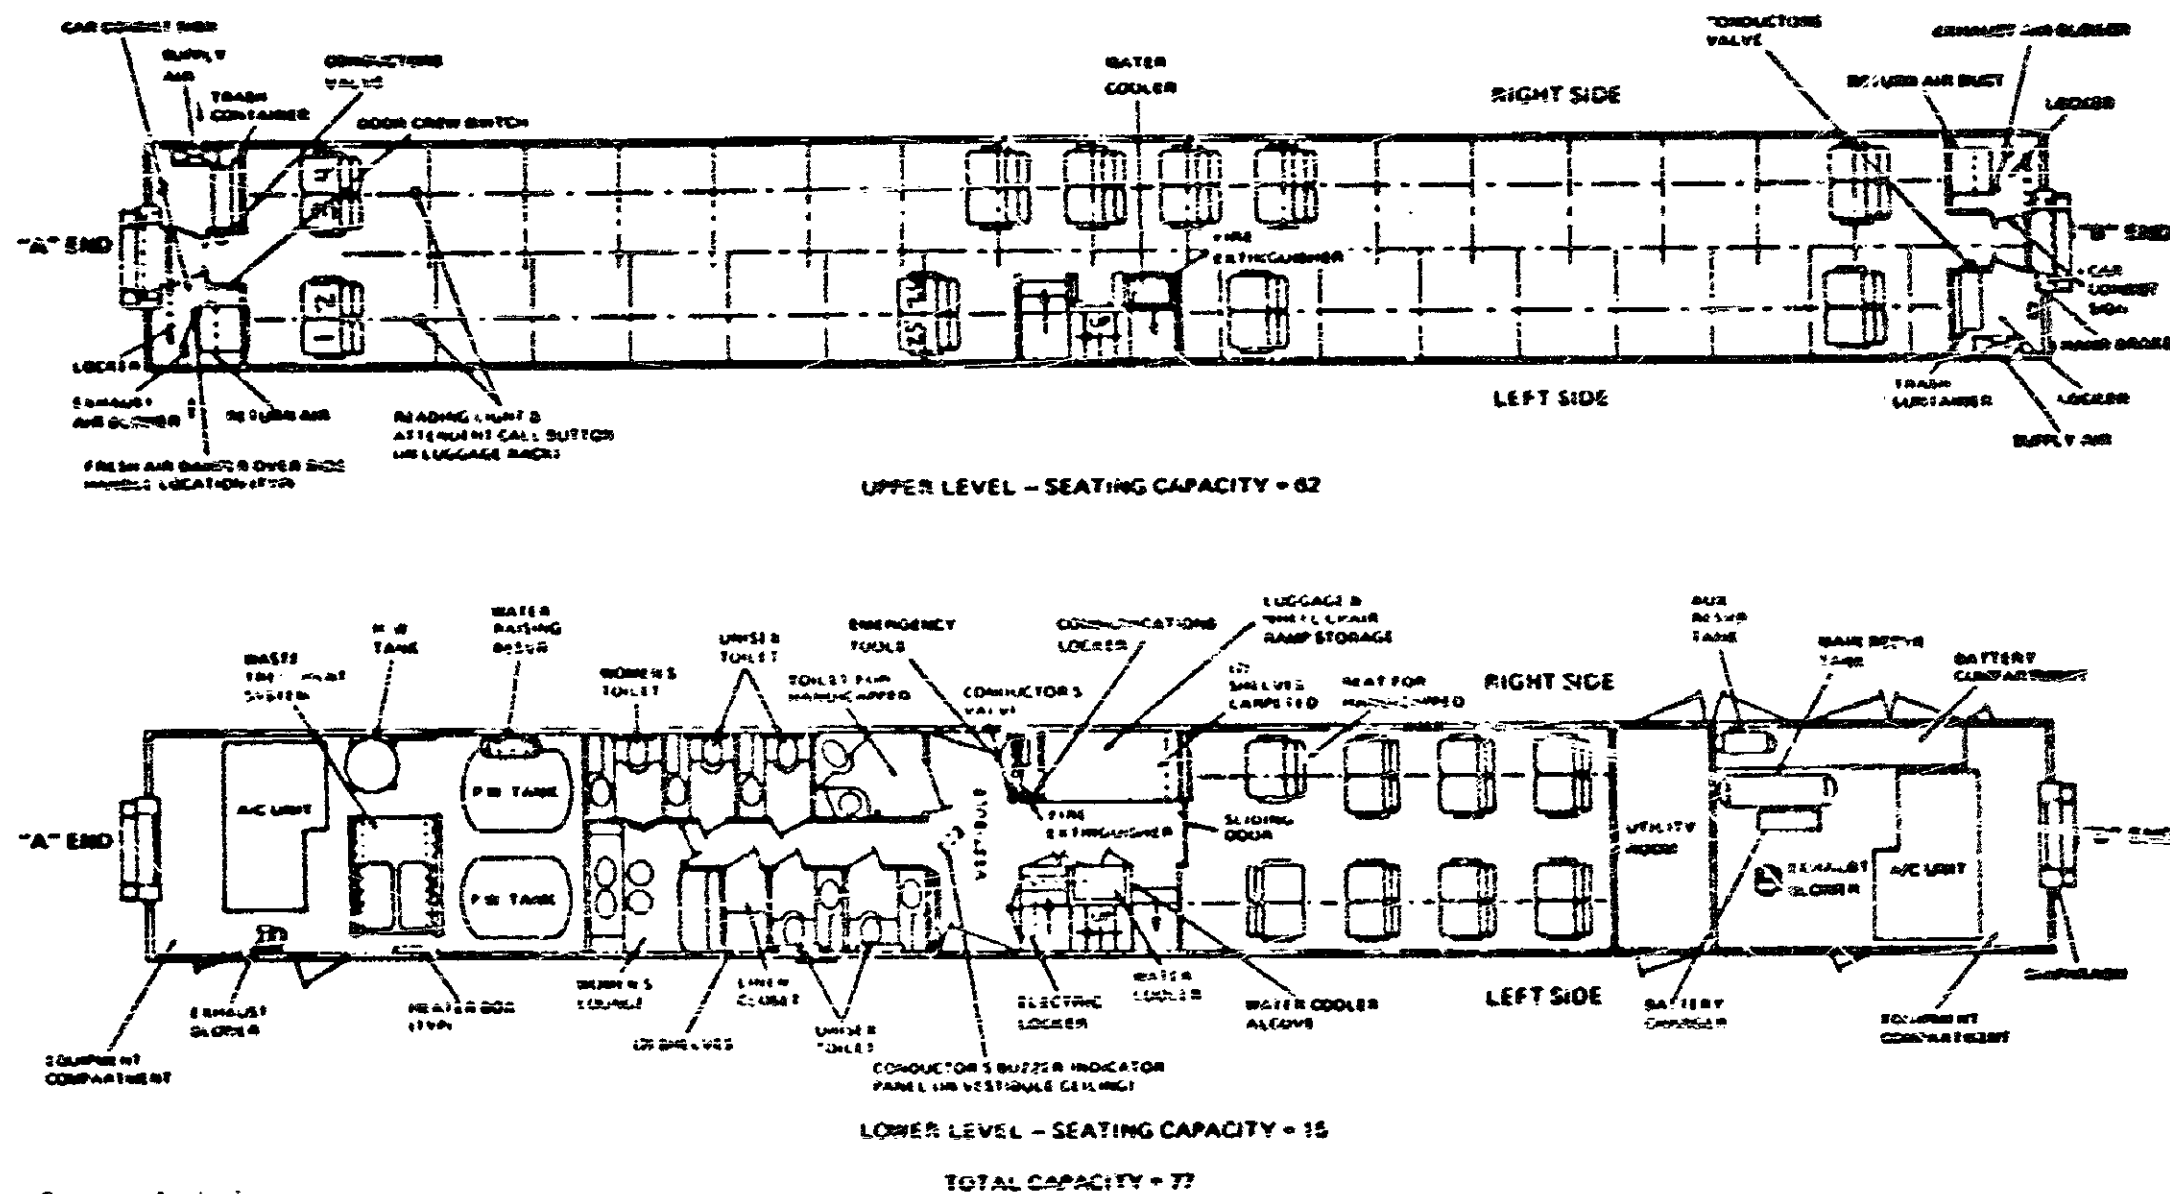
Figure 9.--Coach car, interior arrangement and floor plan.

The five coach cars were of the superliner type. Each car was about 85 feet long and constructed of stainless steel. The upper level had 62 coach seats with leg rests; the lower level had 15 coach seats. A stairway connecting the two levels was located near the center of the car. On each side of the car on the lower level was a center entrance door; on the upper level were end doors that permitted access to the other cars. (See figure 9.)

All seats in the five coach cars were double-width seats with one armrest on each end of the pair of seats. Each of these double-width seat units was mounted on a central pedestal. The units locked into position when facing either forward or rearward. They could be unlocked and allowed to rotate to the alternate position by depressing a pedal at the base of the pedestal. The seats then snapped into the locked position. Seatback cushions were designed to be removed by first pulling the bottom of the cushion away from the frame, separating the hook-and-loop type fastener, then lifting the headrest part of the cushion off the sheet metal strip at the top of the frame, which served as the headrest support. Overhead luggage racks, approximately 2 feet wide, were located along the sidewalls over the seating areas and contained no type of baggage securing devices.

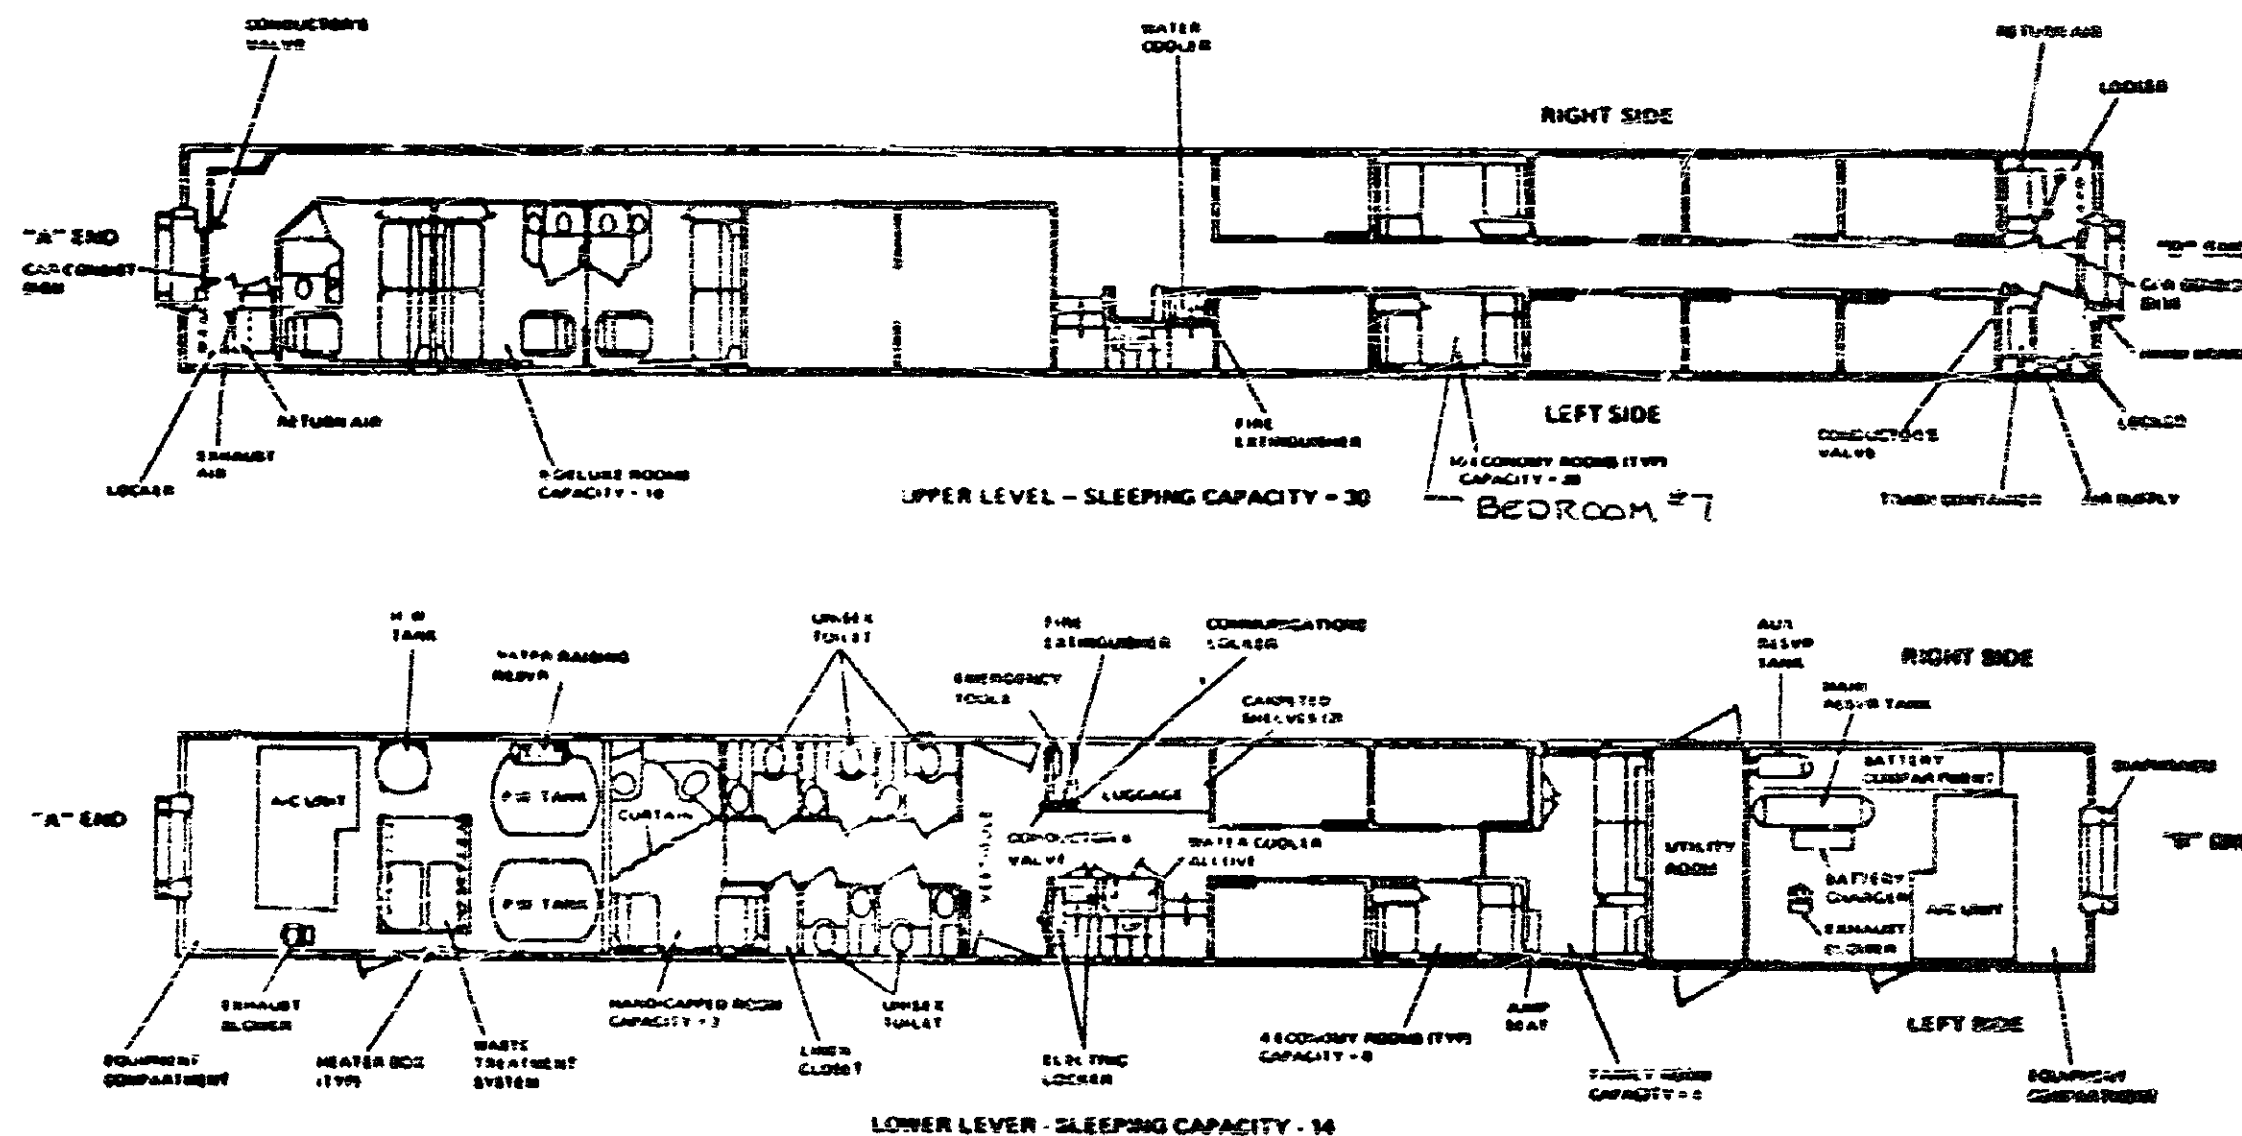
Figure 10.—Sleeping car, interior arrangement and floor plan.

The three sleeping cars were of the same construction and design as the superliner coach. Each had five deluxe rooms and 10 economy rooms on the upper level, for a sleeping capacity of 30. A stairway led to the lower level, where there were four economy rooms, one family room, and a handicapped room, for a sleeping capacity of 14. The lower level had five unisex restrooms and storage at the car ends. (See figure 10.)
