RAILROAD ACCIDENT REPORT

REAR-END COLLISION OF
AMTRAK/MASSACHUSETTS BAY
TRANSPORTATION AUTHORITY COMMUTER TRAINS,
BOSTON, MASSACHUSETTS,
NOVEMBER 12, 1987

NTSB/RAR-88/05

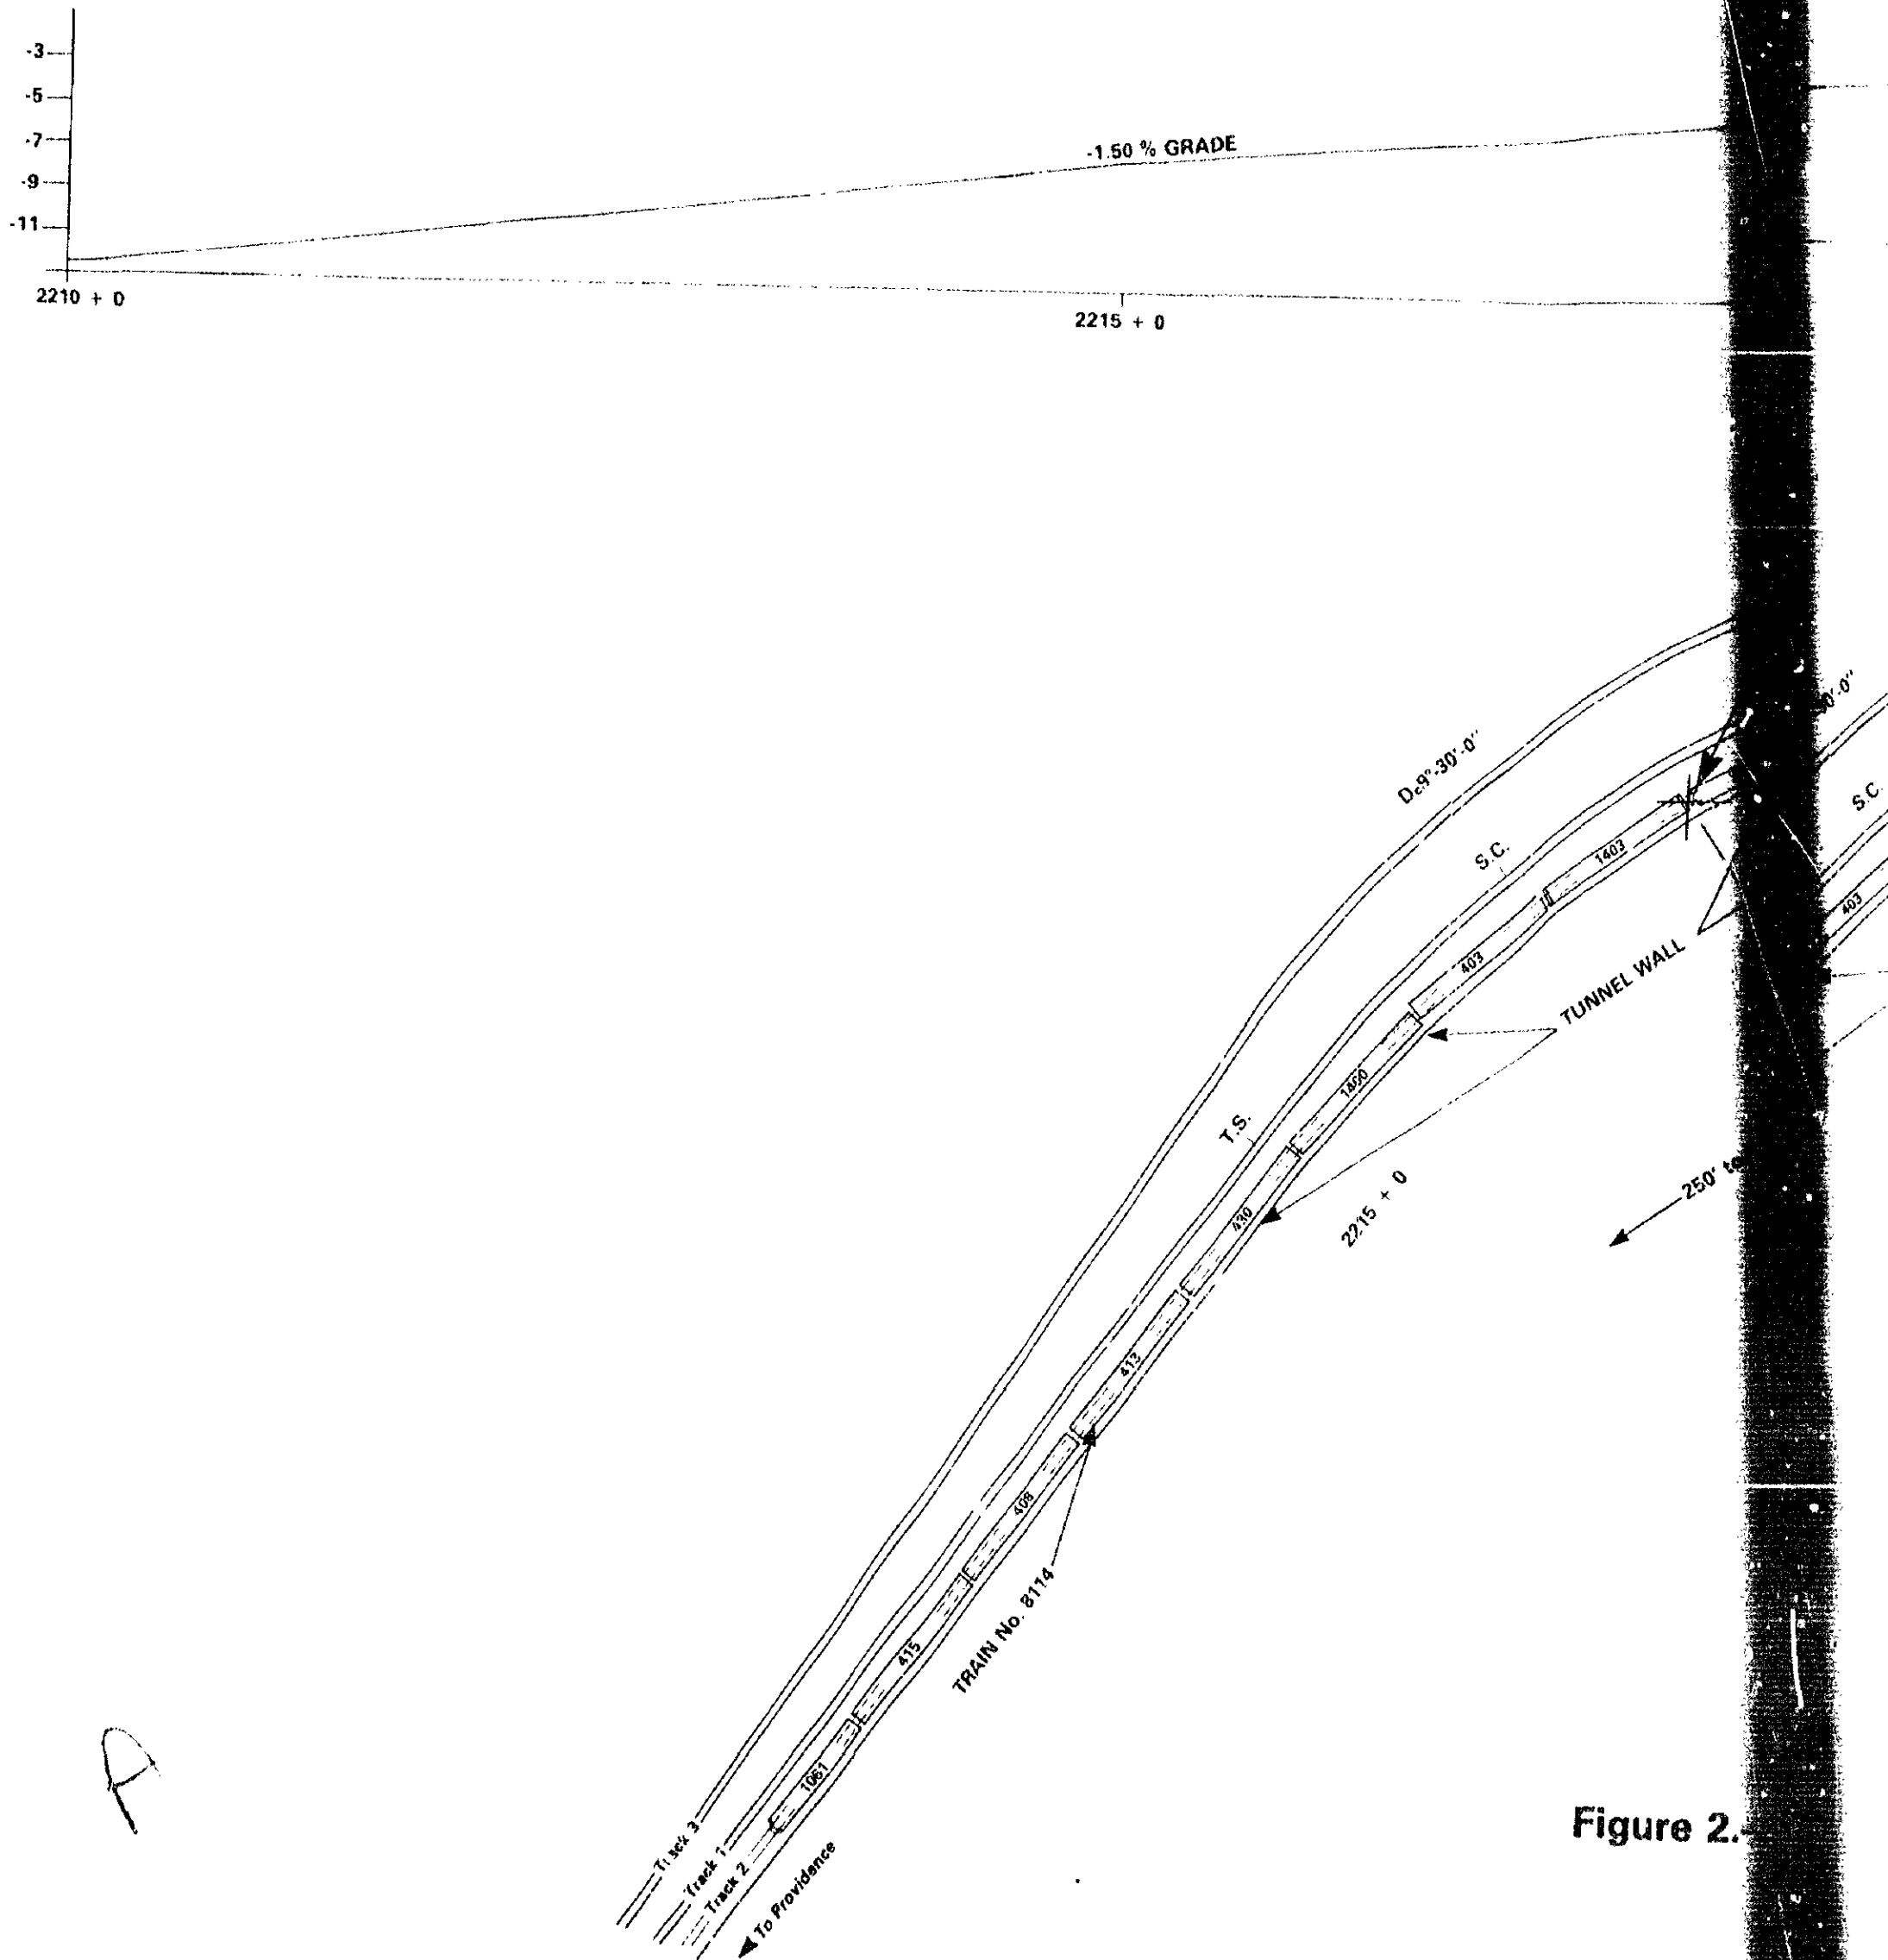
Figure 2.

The engineer said that as train 8110 rounded the curve approaching the Back Bay station platform, he observed train 8910 stopped at the platform. (See figure 2.) Because only about two car lengths of platform space remained behind train 8910, the engineer of train 8110 stopped his train short of the platform to prevent any passengers from detraining. Train 8110's engineer then radioed train 8910's engineer to request that train 8910 pull forward. After train 8910's engineer complied with that request, train 8110's engineer pulled his train forward so that the head 3 1/2 cars were stopped adjacent to the station platform.

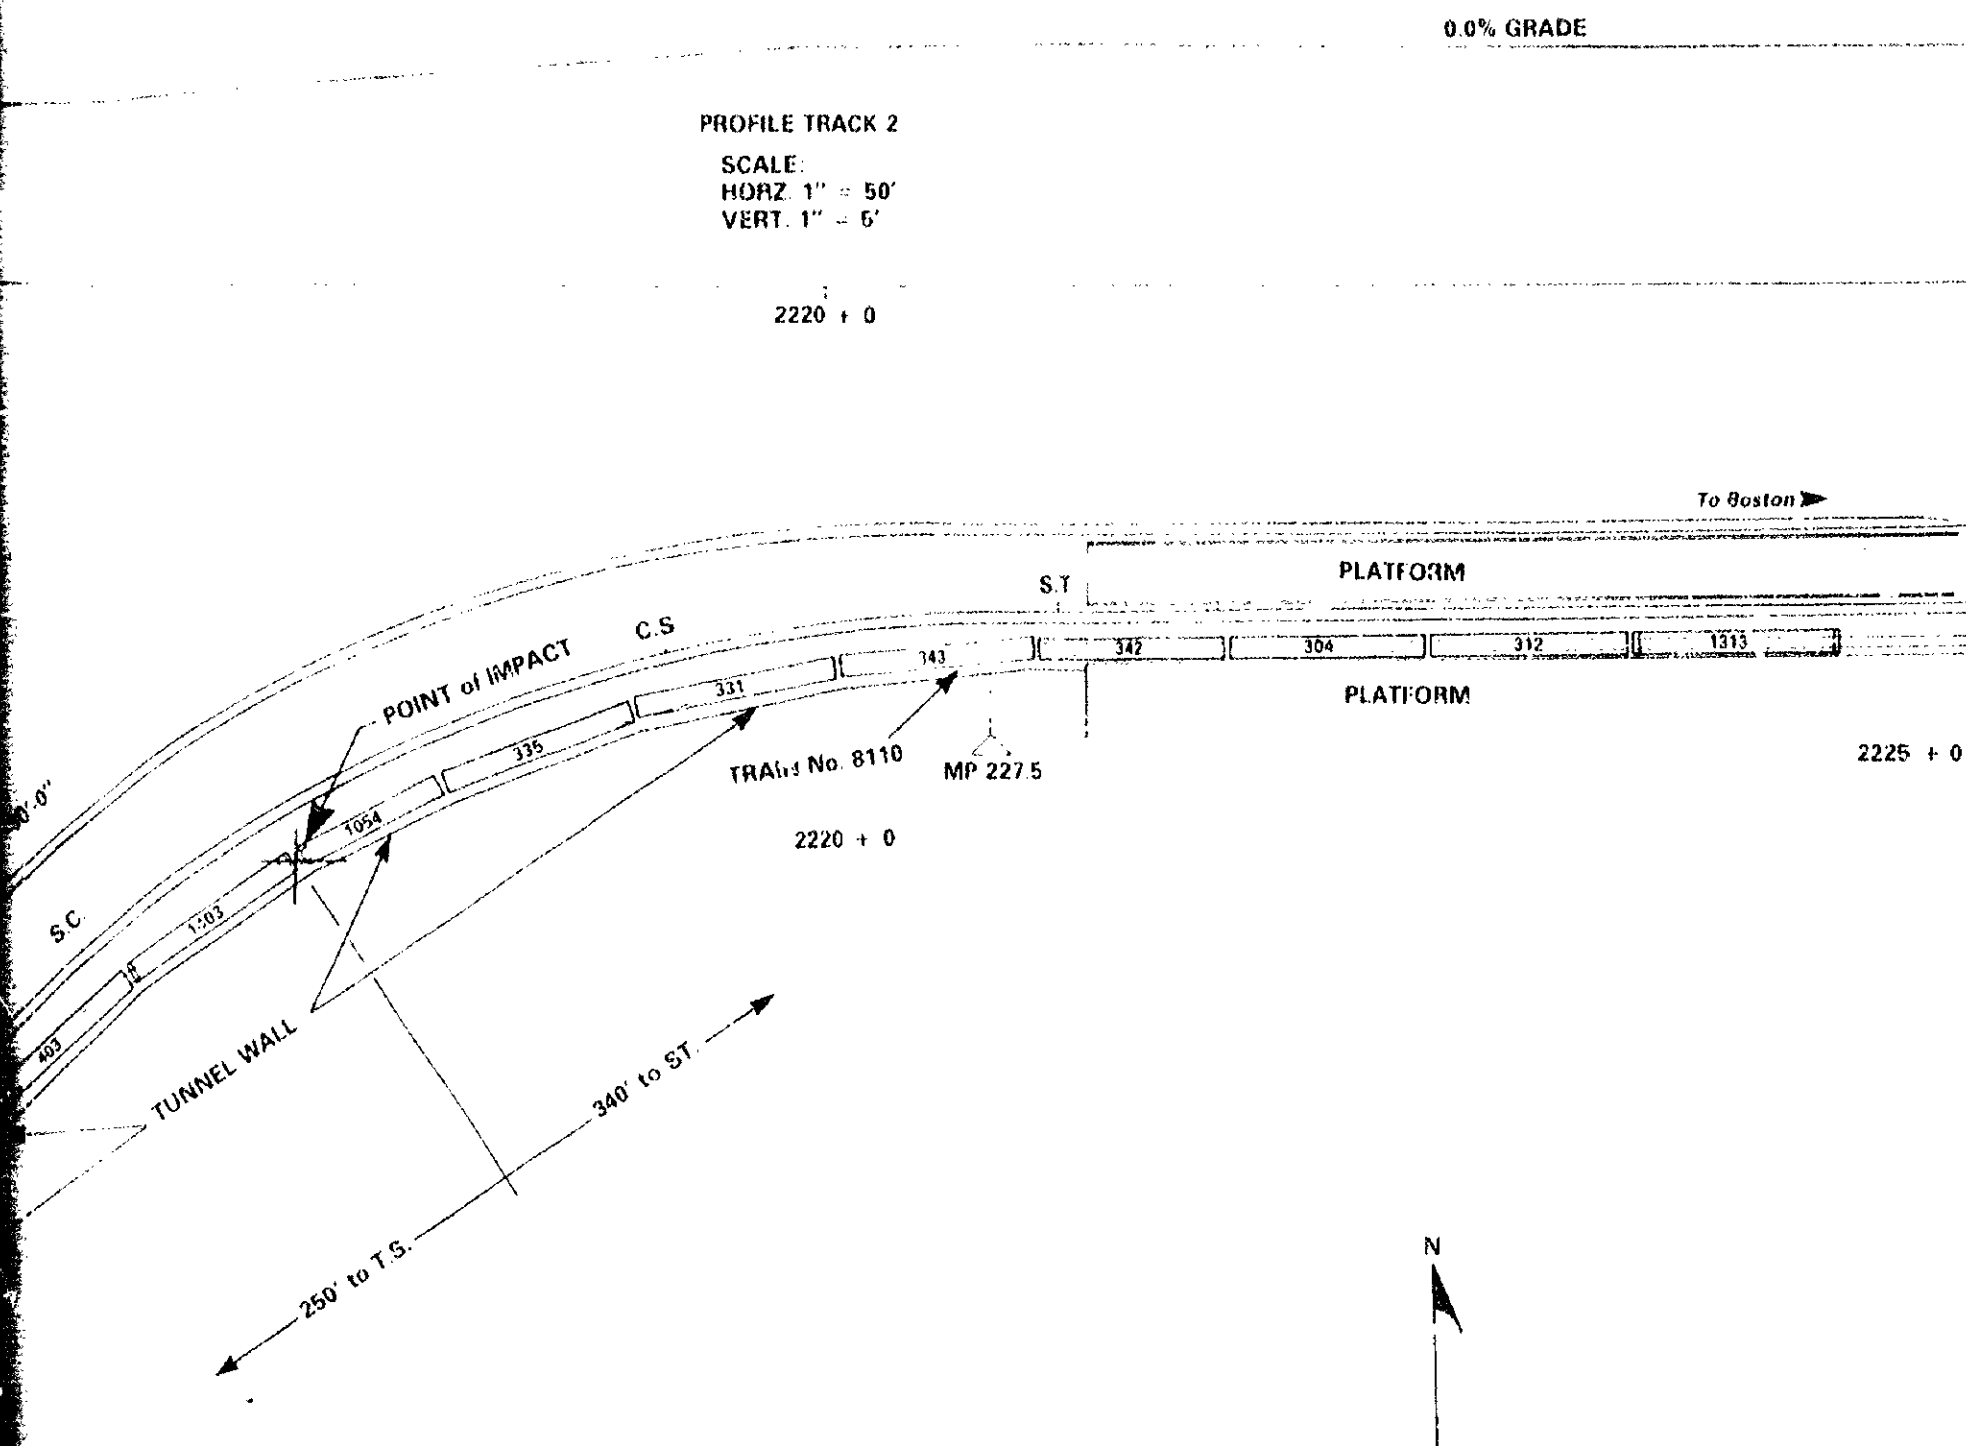
Figure 2.--Plan view of accident site.

At 8:05, train 8114 collided with the rear end of train 8110 340 feet west of the Back Bay station platform near the apex of a 9° 30' curve to the right. (See figure 3.)
