# NATIONAL TRANSPORTATION SAFETY BOARD

## RAILROAD ACCIDENT REPORT

COLLISION OF  
NORFOLK SOUTHERN CORPORATION TRAIN 255L5 WITH  
CONSOLIDATED RAIL CORPORATION TRAIN TV 220  
BUTLER, INDIANA  
MARCH 25, 1998

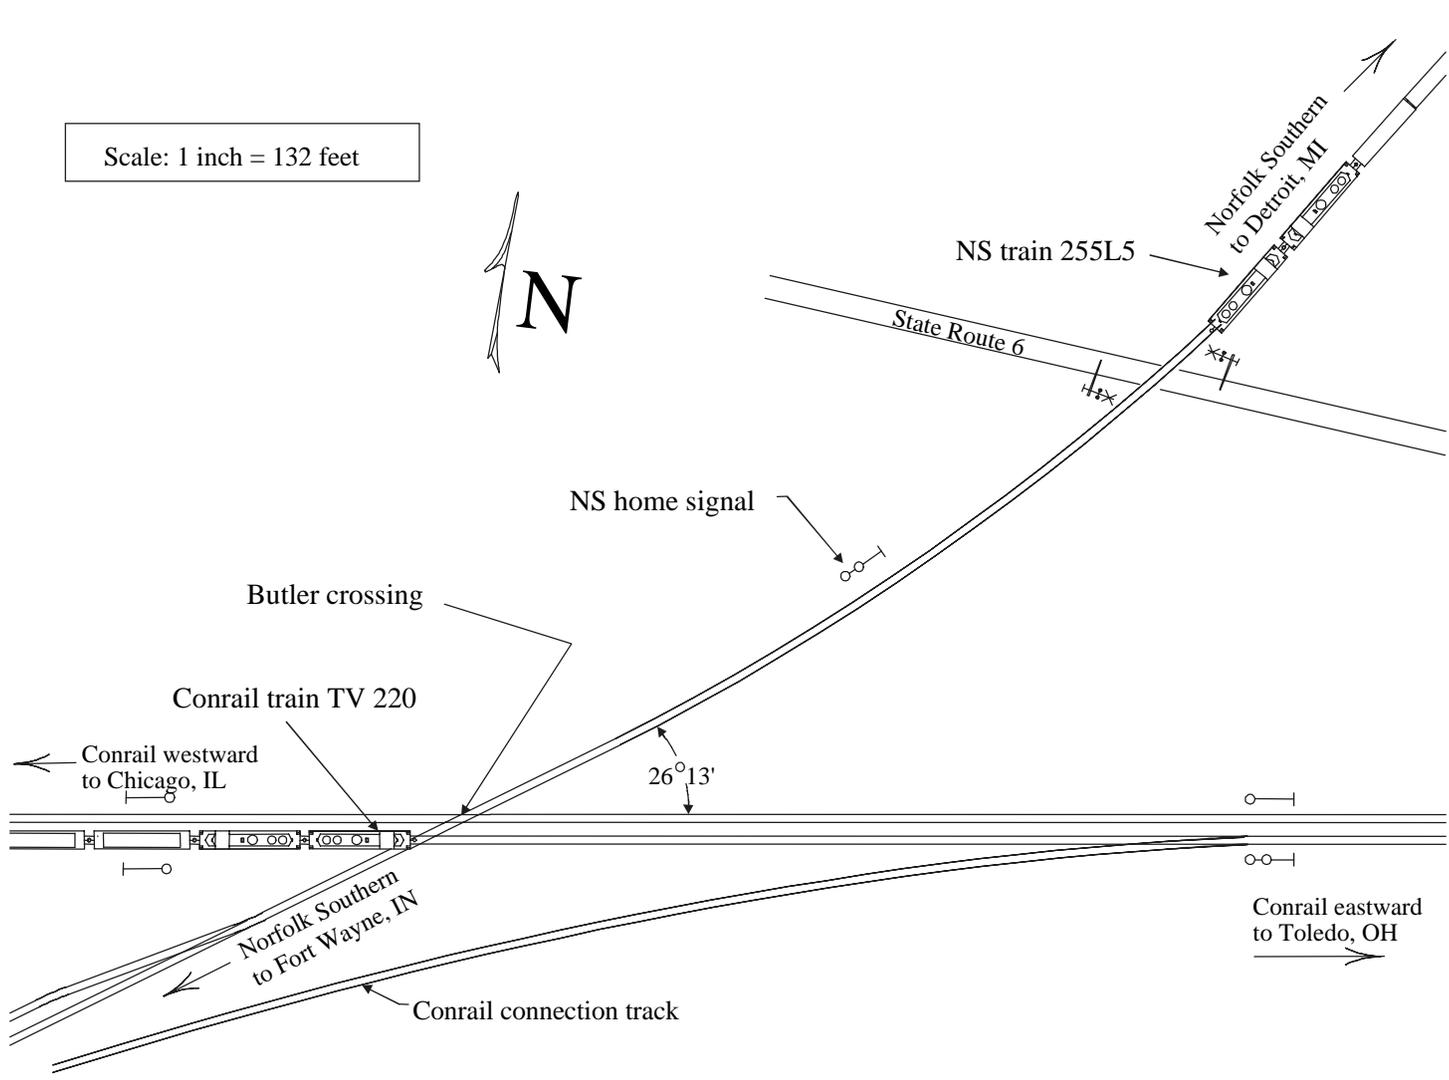
**Figure 2.** Southbound Norfolk Southern (NS) train approaching eastbound Conrail train at Butler crossing

Conrail refers to the crossing as “CP [control point] 358,” and locates it at MP 358.5 on its timetable. Norfolk Southern refers to the crossing as “Butler,” and locates it at MP 113.9 on its timetable. The Butler interlocking consists of two track crossings, or diamonds, at the points where the single-track Norfolk Southern main line crosses the Nos. 1 and 2 main lines of the double-track Conrail Chicago Line. (See figure 2.)

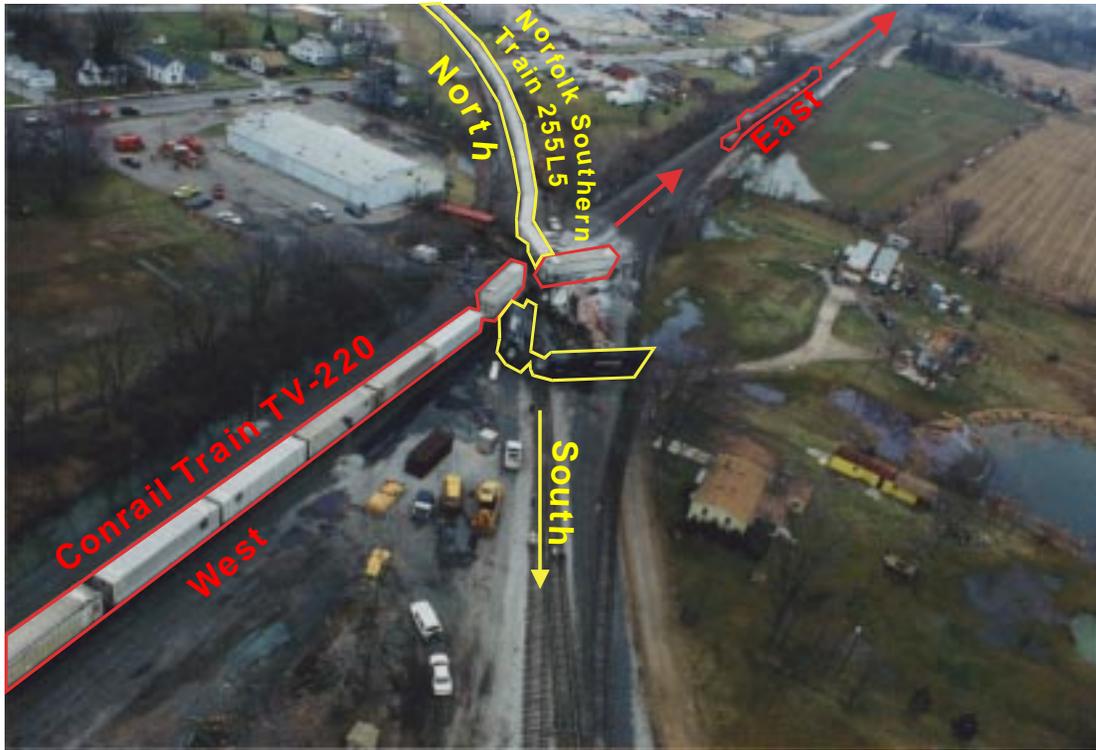
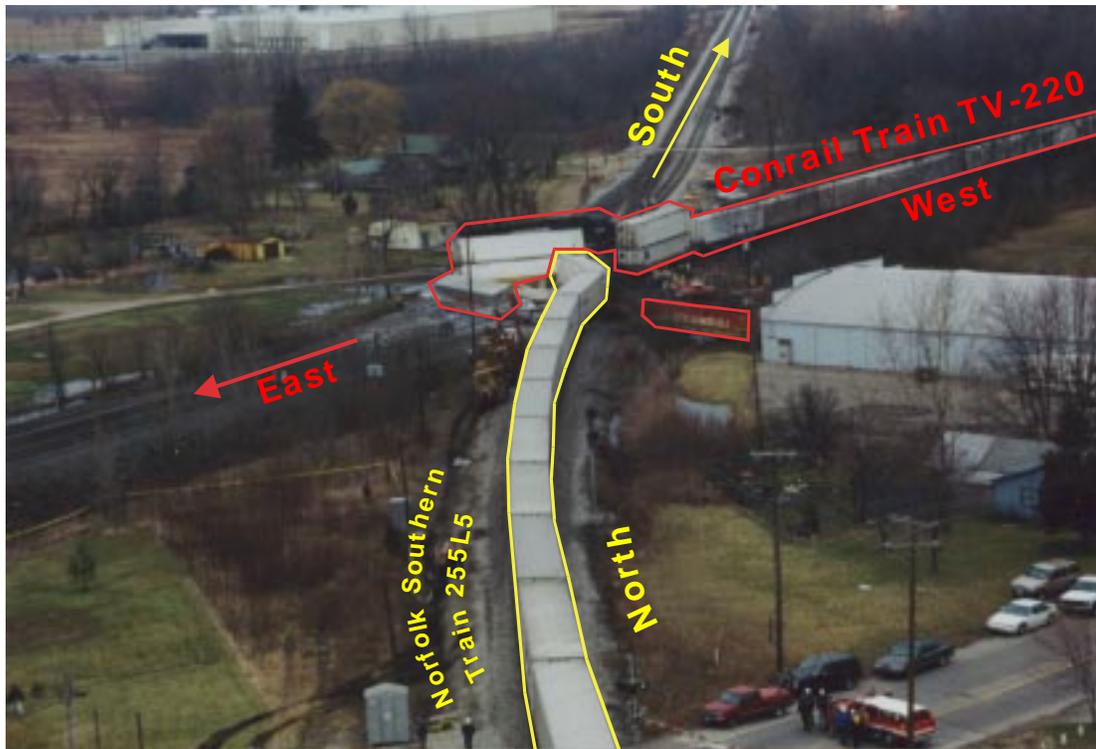
**Figure 3.** Conrail and Norfolk Southern (NS) trains viewed facing north (*top*) and south (*bottom*)
