**RAILROAD/HIGHWAY
ACCIDENT REPORT**

ILLINOIS CENTRAL RAILROAD COMPANY

Train No. 1 Collision With Gasoline Tank Truck At

Loda, Illinois, January 24, 1970.

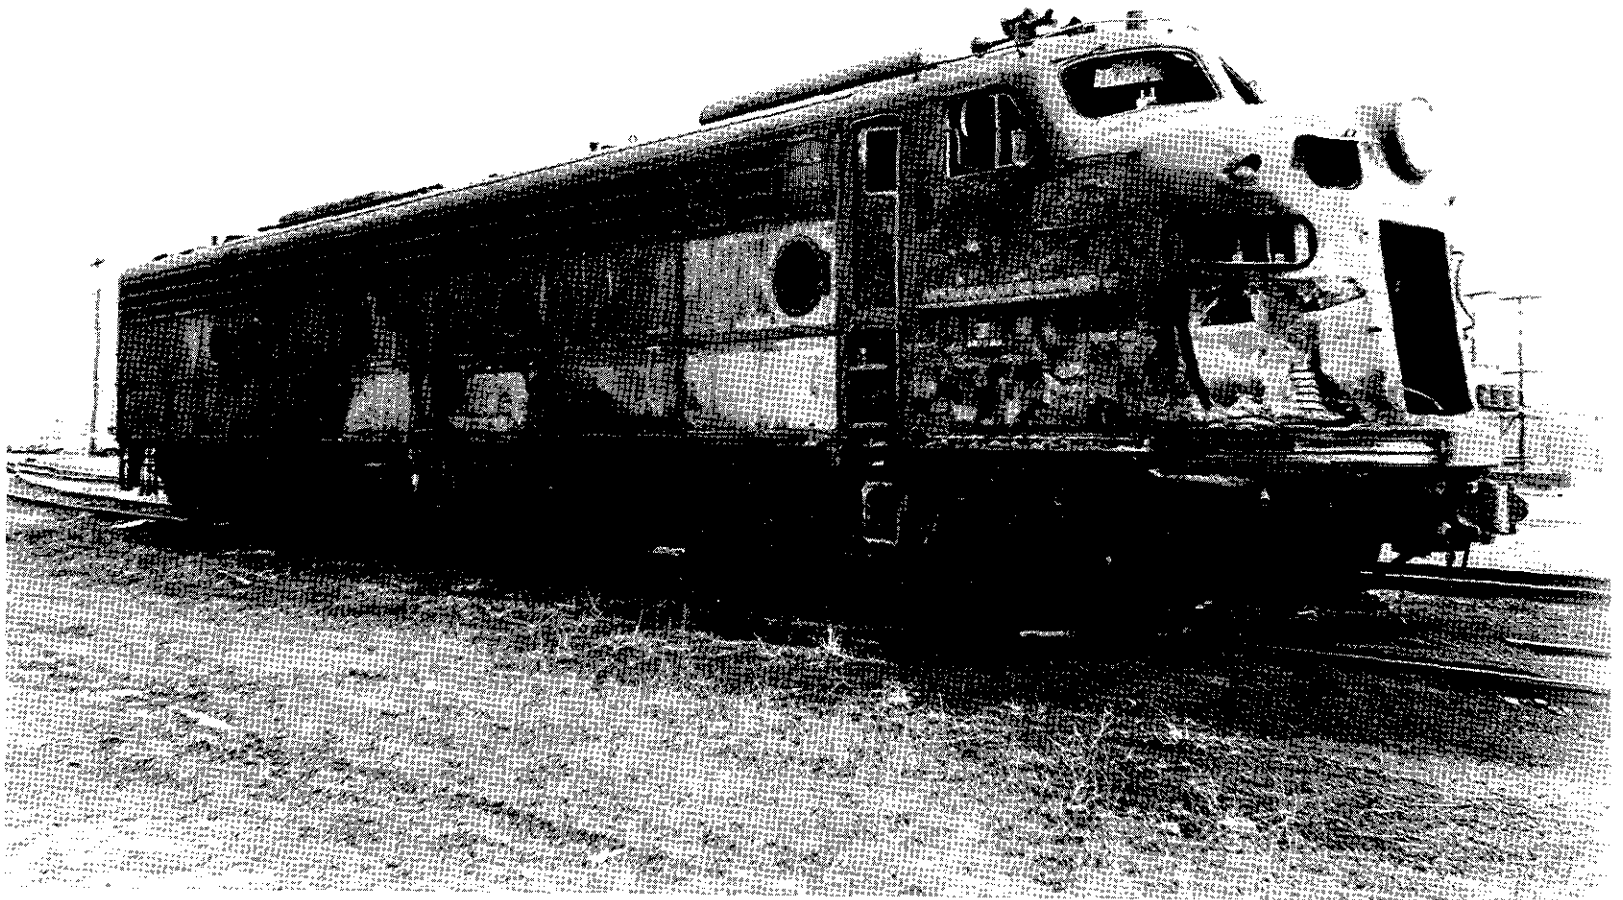
FIGURE 4

Diesel-electric unit No. 4019, the first unit of train No. 1 on the day of the accident, was a 2,250-horsepower, type E-8, passenger, A Unit, manufactured by the General Motors Corporation in 1950 (See Figure No. 4). It was provided with two six-wheeled trucks equipped with traction motors, two diesel engines—each driving electric generators which provided power to the traction motors, a steam generator, and the necessary electrical and mechanical controls for the operation of this and the other units of the locomotive. To aid in describing the unit, the superstructure can be divided into three areas: the nose, the control compartment, and the engineroom which housed the diesel engines, the electric generators, and other associated equipment.

A fire extinguishing system was not installed in these units. Portable fire extinguishers are provided, but they do not have the capacity to control a fire such as the one that developed in this accident. One Ansul dry powder extinguisher is located in the control compartment and two CO₂ extinguishers are located in the engineroom.

The locomotive unit has two headlights. One is a sealed beam, 250-watt, fixed headlight mounted above the nose compartment door.

about 7 feet 10 inches above the top of the rail. The other headlight has rotating red and white lights, and it is located about 10 feet 10 inches above the top of the rail. The carrier's operating rules² require that the fixed headlight must be displayed to the front of trains by day and night; the white oscillating light must be displayed at night and during the day when weather conditions seriously impair visibility, and the red oscillating light must be displayed both day and night when a train is disabled or stopped suddenly by an emergency application of brakes, or when the engineer or conductor finds it necessary to stop trains under conditions whereby adjacent tracks may be fouled.
