**RAILROAD SPECIAL INVESTIGATION
REPORT**

**DERAILMENT OF AMTRAK TRAIN NO. 12 AND
SIDESWIPE OF AMTRAK TRAIN NO. 79 ON PORTAL
BRIDGE NEAR SECAUCUS, NEW JERSEY,
NOVEMBER 23, 1996**

**Adopted: December 18, 1997
Notation 6813B**

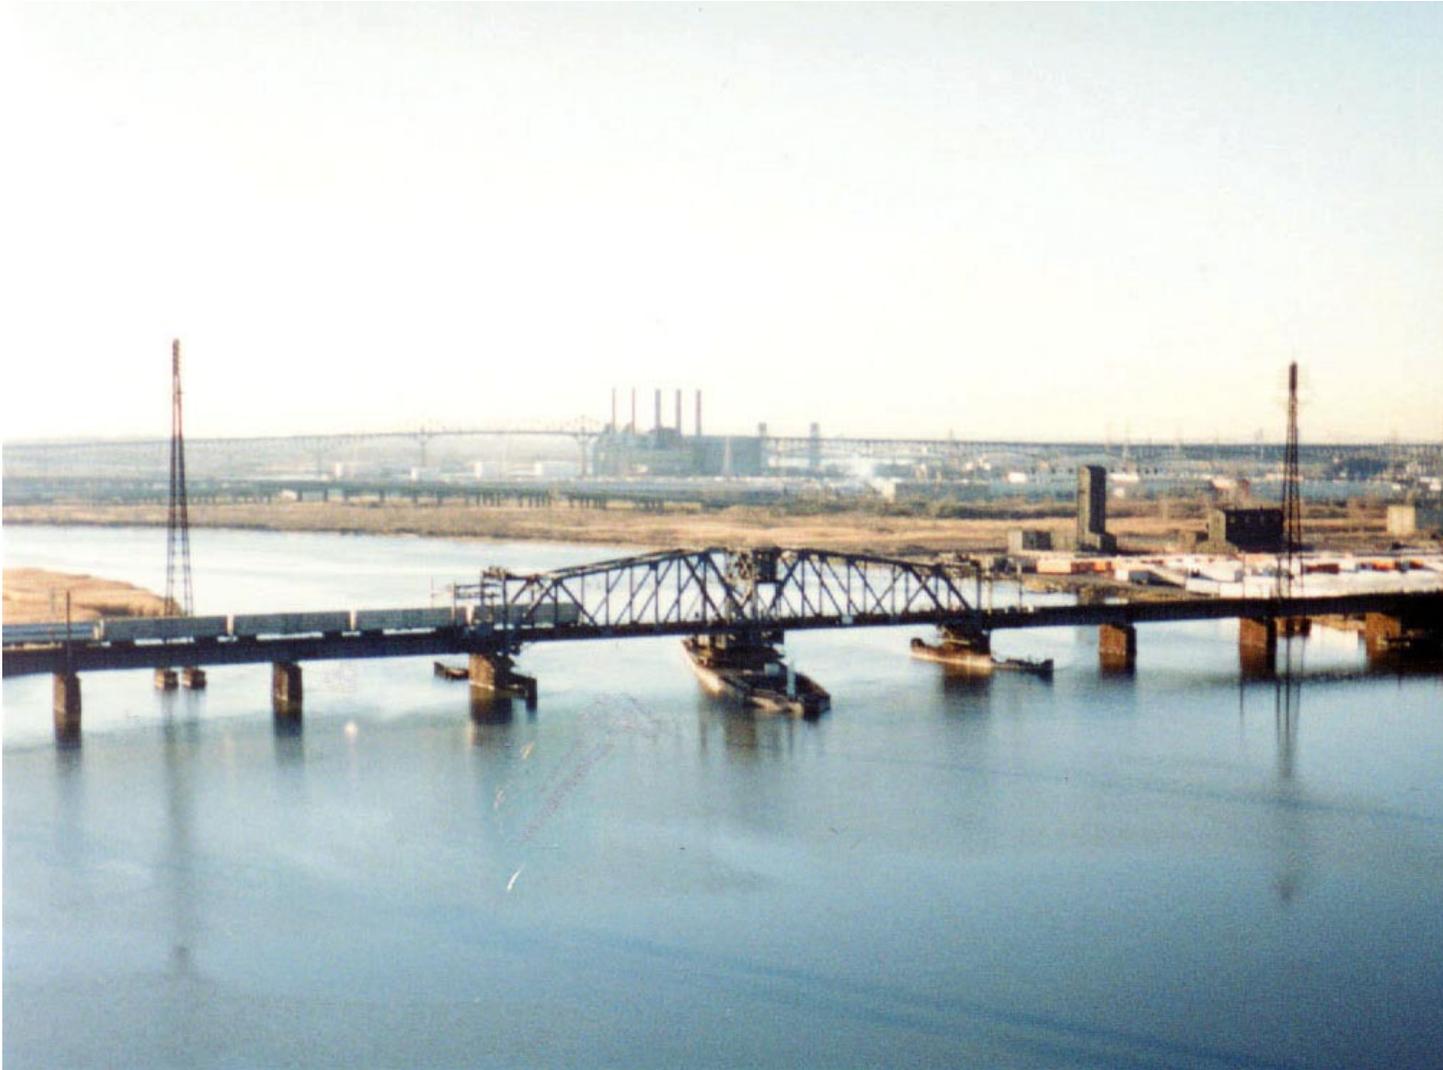
Figure 1- Looking south over Amtrak's Portal Bridge spanning the Hackensack River near Secaucus, New Jersey

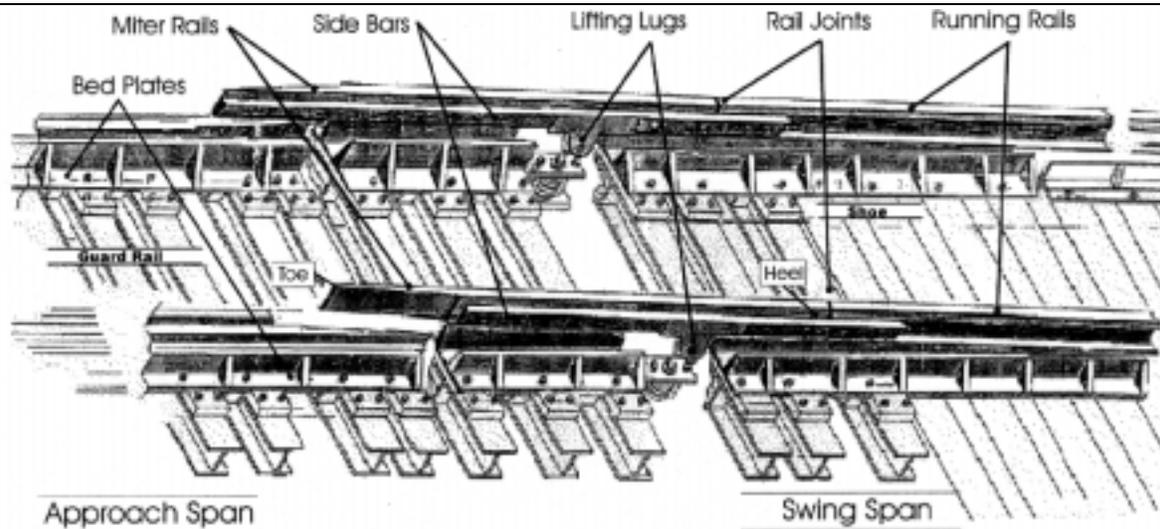
A major component of the special trackwork is the movable miter rail assembly that actually makes and breaks the rail connections at the edge of the rotating bridge span. At the time of the accident, a single miter rail assembly⁹ on the Portal Bridge movable span consisted of one 10 1/2-foot miter rail with a 31-inch tapered, or mitered, point known as the "toe"; one 11 1/2-foot side bar; one 8-foot 11-inch side bar; a section of running rail to which the miter rail was joined with the two side bars; and a base (bed) plate resting on an attaching base referred to as a "shoe." (See figure 4 – next page.) The miter rail was made of manganese steel, a much stronger steel than that used for the running rails.

Figure 4 — Components of the miter rail assembly in place on Portal Bridge at the time of the accident

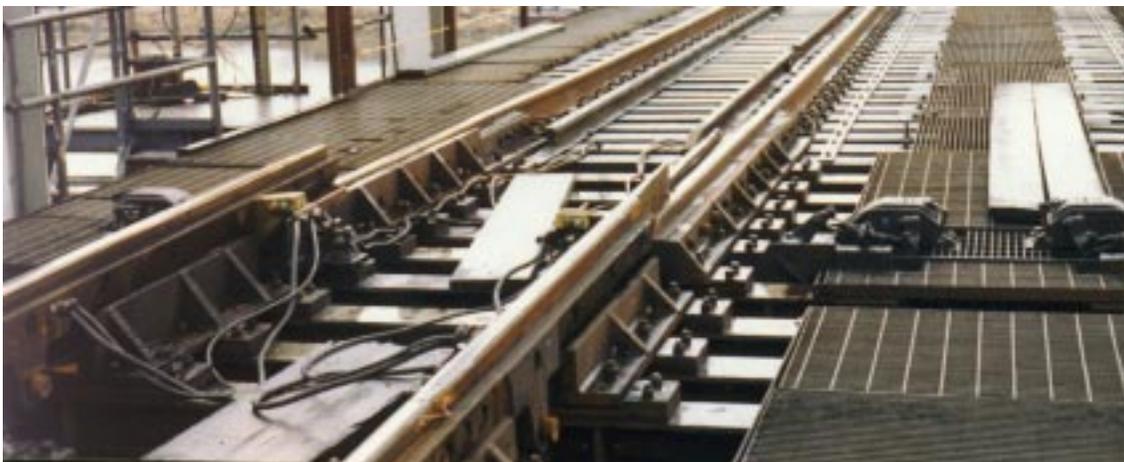
The toe (tapered end) of the movable miter rail mated with a section of fixed miter rail on the stationary spans of the bridge.¹⁰ The other end (the square end, or “heel”) of the miter rail butted against a 39-foot section of running rail. The rail sections were tied together by two side bars fastened (with 12 bolts, each 1 inch in diameter) on either side of the two rail sections across the joint. (See figure 5 – below.)

Figure 5 — Looking west along track 1 with miter rails in the lifted position
