RAILWAY ACCIDENT REPORT

HEAD-ON COLLISION OF SOUTHERN PACIFIC
TRANSPORTATION COMPANY FREIGHT TRAINS
YUMA, ARIZONA

JUNE 15, 1987

NTSB/RAR-88/02

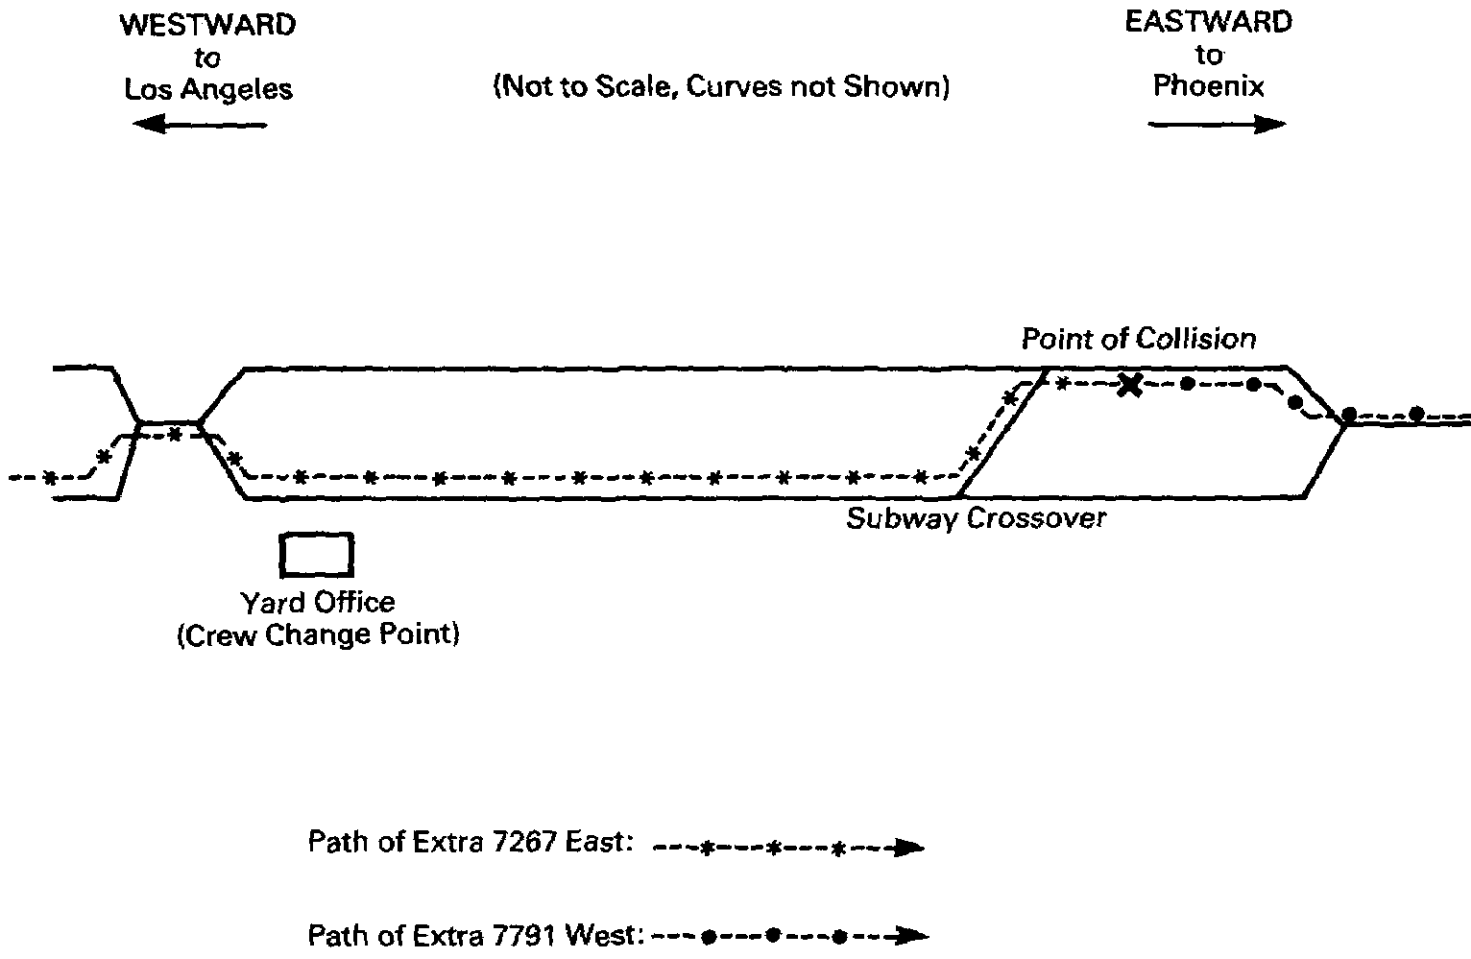
Figure 1 –Train routes to point of collision.

Extra 7791 West was about 6 miles from Yuma when the Yuma yardmaster informed the traincrew by radio that they would be routed on the westbound main track (see figure 1). The train was then to proceed to the "subway" ^{2/} (see figure 2), stop, and wait for an eastbound train to pass. Extra 7791 West was to then line through the crossovers to the eastbound main track and travel against the current of traffic to the yard office. Extra 7791 West had to cross over to the eastbound main track because another train was tied down on the westbound main track west of the subway.

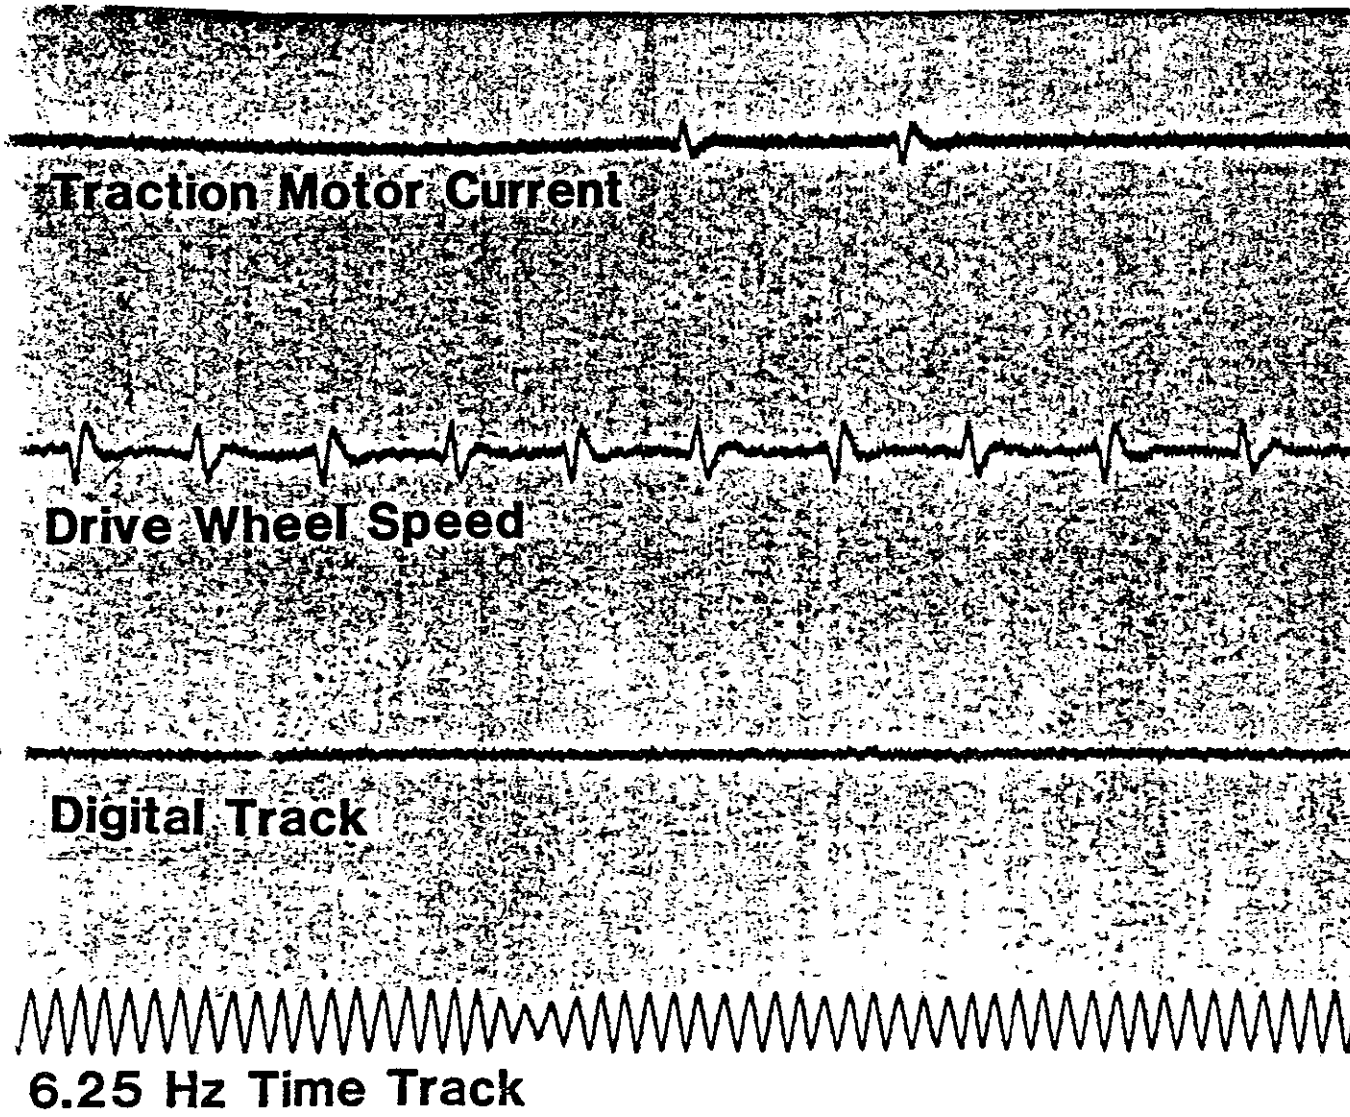
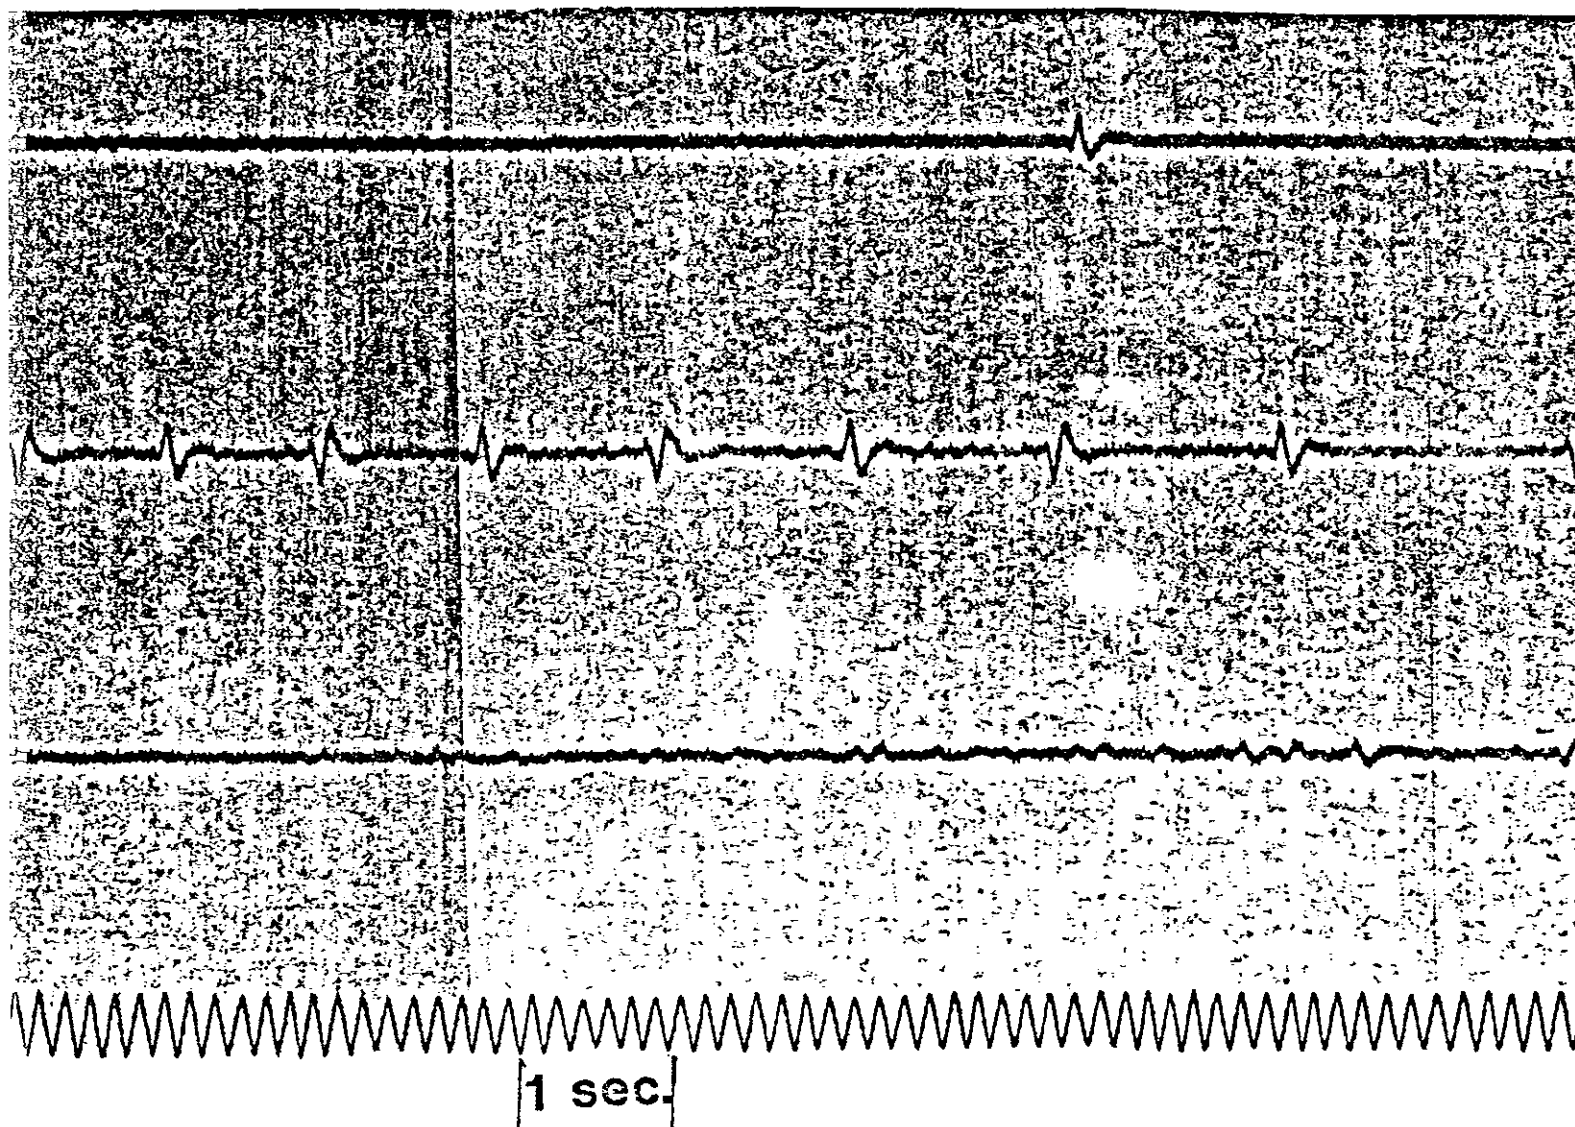
APPENDIX C
ORDER STRIP CHART

LOCOMOTIVE 7267
