INTERSTATE COMMERCE COMMISSION

REPORT OF THE DIRECTOR OF THE BUREAU OF SAFETY CONCERNING
AN ACCIDENT ON THE CHICAGO, MILWAUKEE, ST. PAUL &
PACIFIC RAILROAD NEAR SPECHTS FERRY, IA., ON MARCH
6, 1934.

May 11, 1934.

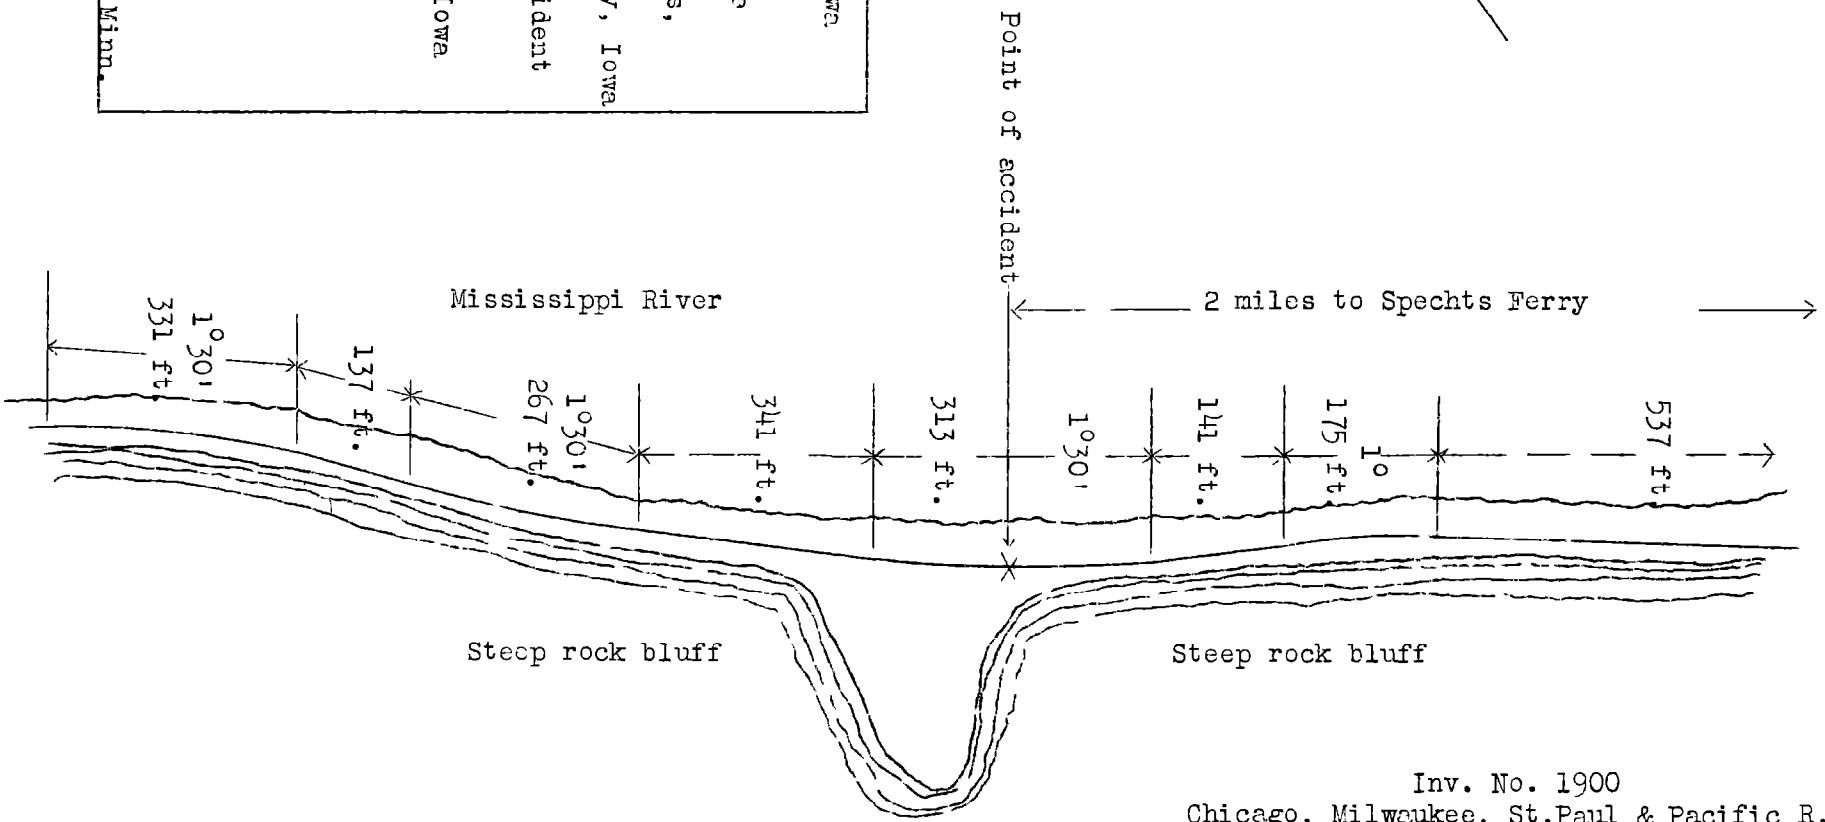
Inv. No. 1900
Chicago, Milwaukee, St. Paul & Pacific R.R.
Spechts Ferry, Iowa
March 6, 1934

•	Bellevue, Iowa	24.8 mi.
•	Dubuque, Iowa	1.2 mi.
•	Dubuque Shops,	11.1 mi.
•	Spechts Ferry, Iowa	2.0
✕	Point of accident	
•	Guttenberg, Iowa	20.4 mi.
•	Ia. Crescent, Minn.	82.2 mi.

This accident occurred on that part of the Second District of the Dubuque & Illinois Division which extends between La Crescent, Minn., and Dubuque Shops, Ia., a distance of 115.7 miles; in the vicinity of the point of accident this is a single-track line over which trains are operated by time table, train orders, and a manual block-signal system. The accident occurred at a point about 2 miles west of Spechts Ferry; approaching this point from either direction there was a series of short curves and tangents, the accident occurring near the center of a 1°30' curve to the right for west-bound trains which is 313 feet in length. The grade is level at the point of accident. The view was considerably restricted by a steep bluff covered with shrubbery on the engineman's side of an east-bound train.
