REPORT OF THE DIRECTOR

BUREAU OF SAFETY

ACCIDENT ON THE LINE OF THE
CHICAGO RAPID TRANSIT COMPANY

INVESTIGATION NO. 2121

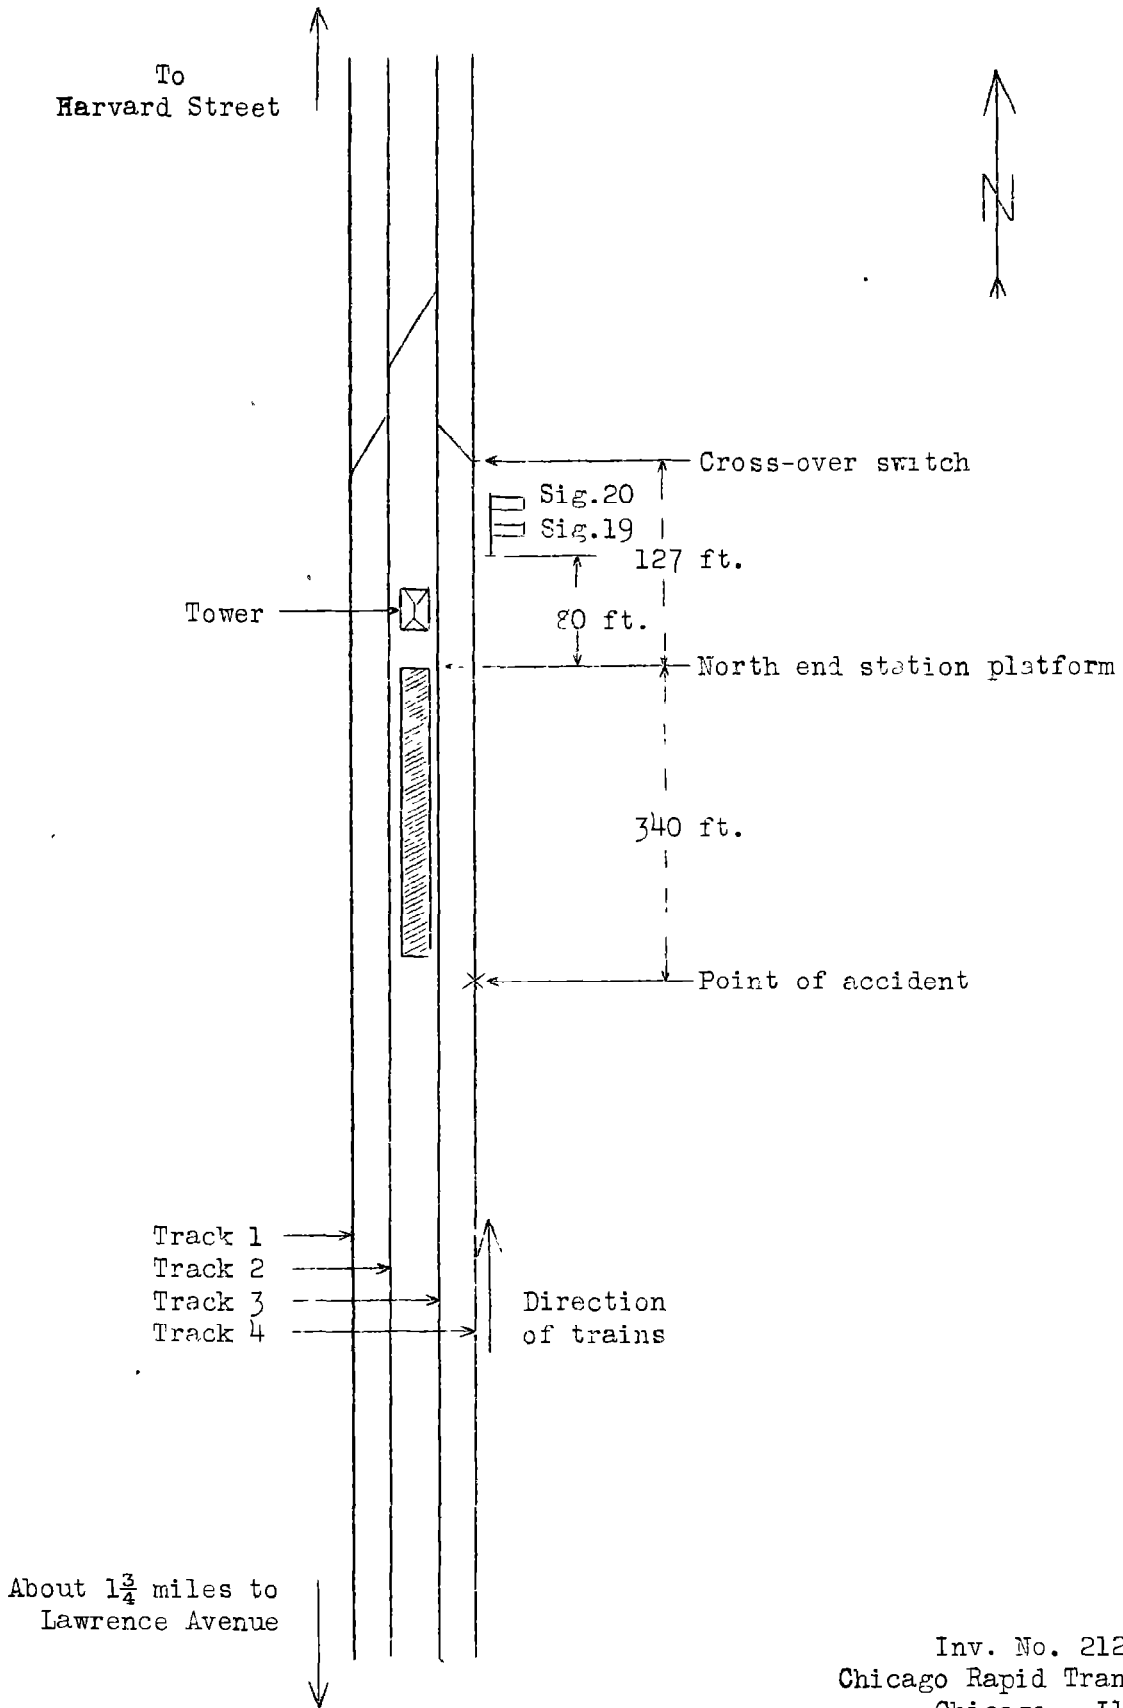
Inv. No. 2121
Chicago Rapid Transit Co.
Chicago, Ill.
Nov. 24, 1936

The tracks are numbered consecutively from west to east, tracks 1 and 2 being for south-bound trains, and tracks 3 and 4 for north-bound trains. North-bound L express trains use track 4 to Granville Avenue and then track 3 to Howard Street, while North Shore trains use track 4 through to Howard Street. The movement from track 4 to track 3 is made by means of a cross-over, the facing-point switch on track 4 being located 127 feet north of the north end of the station platform, which is between tracks 2 and 3. The interlocking signal governing movements over this switch is located 80 feet north of the station platform and is a 2-arm, 2-position home signal of the lower-quadrant semaphore type; the top arm, signal 20, governs through movements on track 4 and the lower arm, signal 19, governs cross-over movements to track 3. There is no distant signal to indicate to motormen of approaching trains the position of the home signal. These signals and the cross-over switches, as well as the other signals and cross-overs in the vicinity, are operated from a tower which is located 31 feet north of the station platform.

This accident occurred on track 4, at a point 420 feet south of the home signal. Approaching this point from the south the track is tangent from Lawrence Avenue, a distance of about $1\frac{3}{4}$ miles, while the grade is practically level. The view from Lawrence Avenue northward to the point of accident is unobstructed.
