REPORT OF THE DIRECTOR  
BUREAU OF SAFETY

ACCIDENT ON THE  
PENNSYLVANIA RAILROAD

PHILADELPHIA, PA.

INVESTIGATION NO. 2189

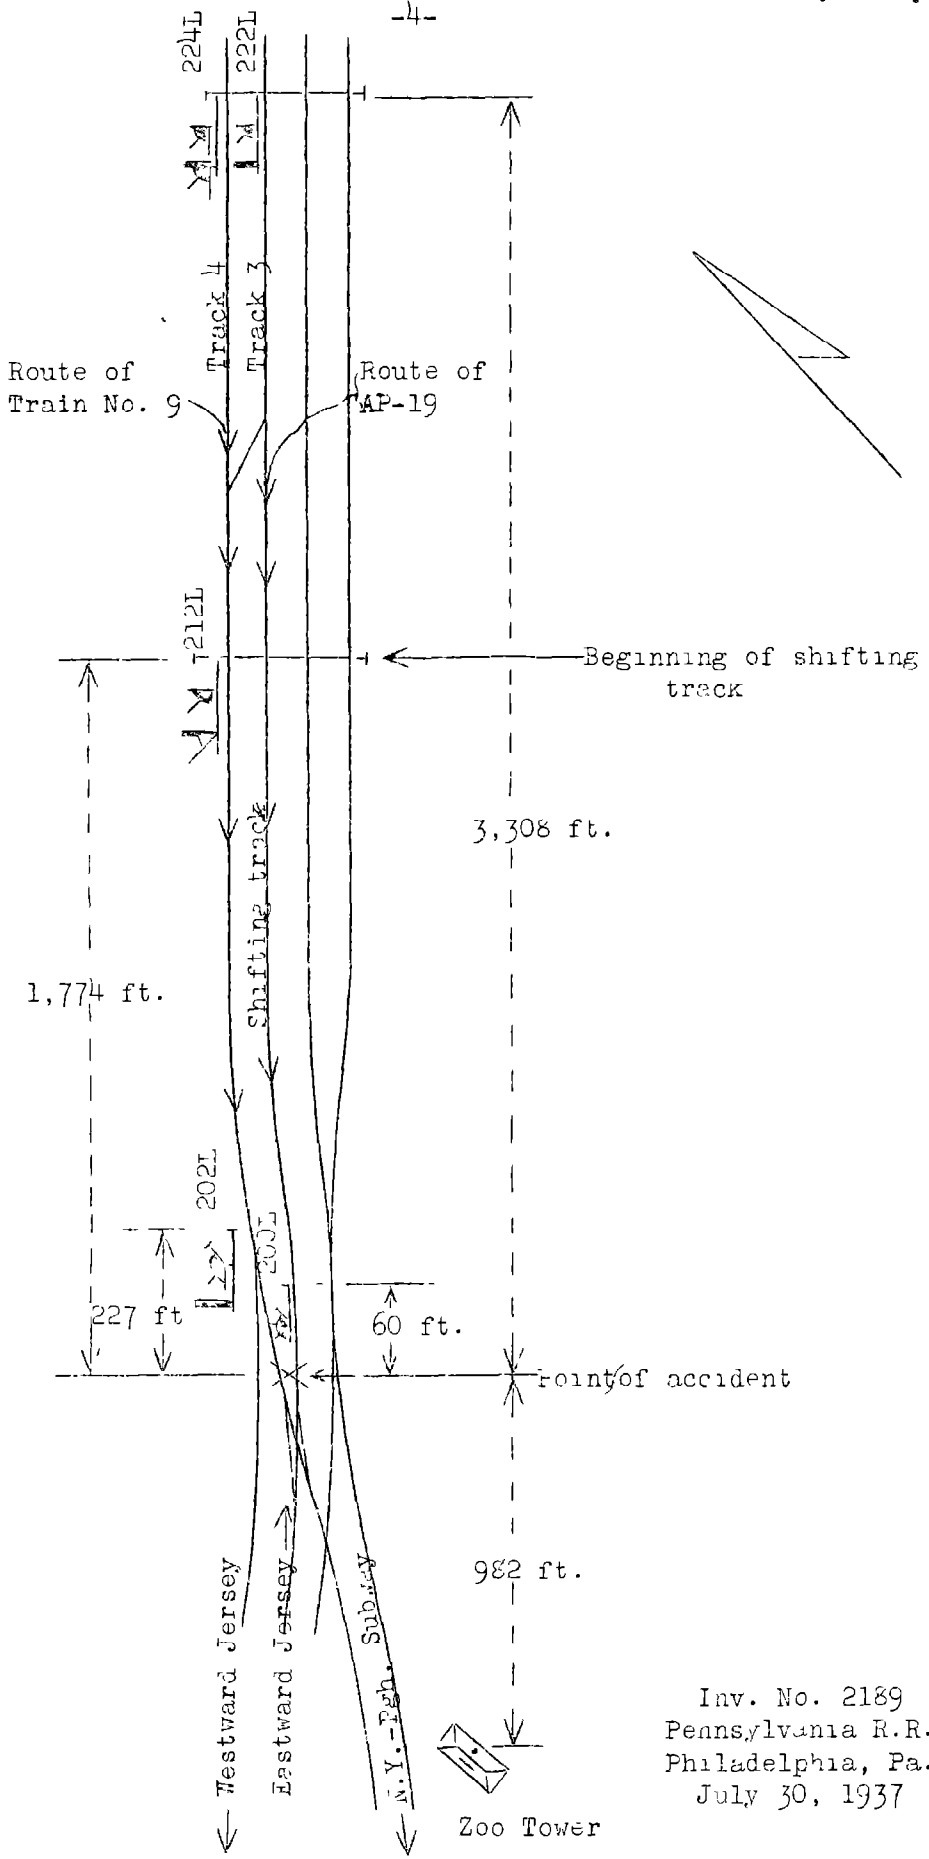
Inv. No. 2189  
 Pennsylvania R.R.  
 Philadelphia, Pa.  
 July 30, 1937

o	Frankford Jct., Pa.
	3.2 mi.
o	North Philadelphia
	2.9 mi.
X	Point of accident
o	Zoo interlocking
	2.4 mi.
o	Broad St. Station Philadelphia, Pa.

signals, but the shifting track is not so equipped for west-bound movements. The signals involved governing west-bound movements on track 4 are home signal 224L, and interlocking signals 212L and 202L, located 3,308 feet, 1,774 feet, and 227 feet, respectively, east of the point of accident. Signals 224L and 212L are located on signal bridges, while signal 202L is on a mast; these signals are 2-unit, position-light signals. For a movement through the plant from track 4 to the New York-Pittsburgh subway, home signal 224L displays a clear-restricting indication - "train proceed at not exceeding one-half its maximum authorized speed at point involved but not exceeding 30 miles per hour", - while signal 212L displays an approach-restricting indication - "train approach next signal at not exceeding one-half its maximum authorized speed at point involved but not exceeding 30 miles per hour", - and signal 202L displays a clear-restricting indication. The signals involved governing west-bound movements on track 3 and the shifting track, also of the position-light type, are home signal 222L, located on the same bridge as signal 224L, and dwarf signal 200L, located 60 feet east of the point of accident. With the route on track 4 lined, as described above, the most favorable indication signal 222L can display is a slow-speed indication - "train proceed at not exceeding 15 miles per hour prepared to stop at next signal"-, and dwarf signal 200L displays a stop indication.
