REPORT OF THE DIRECTOR

ACCIDENT ON THE

MINNEAPOLIS, ST. PAUL & SAULI STE. MARIE RY

INVESTIGATION NO. 2246

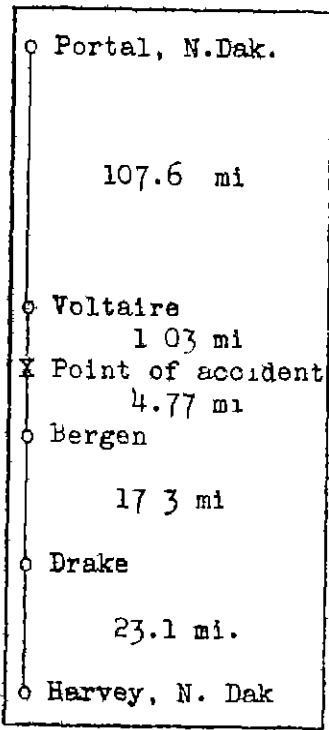
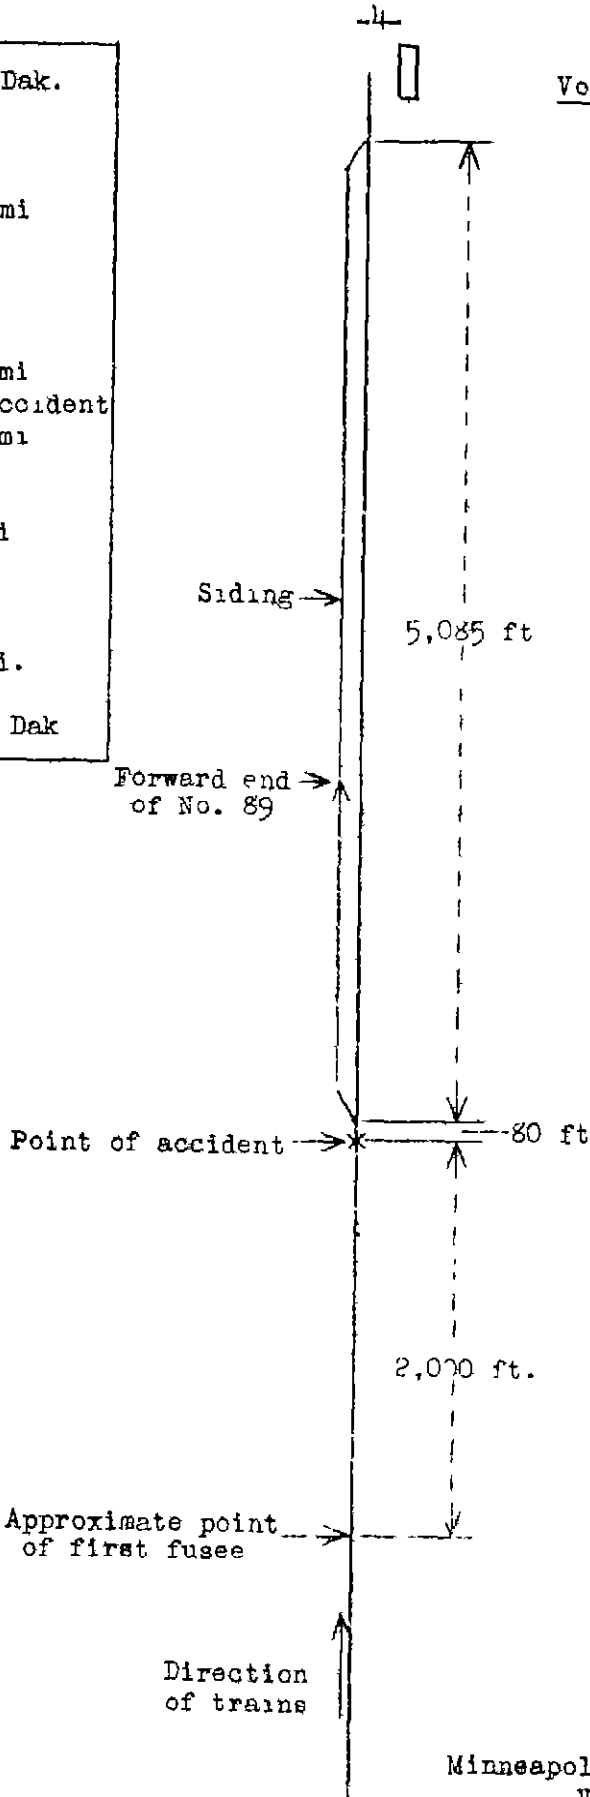
Inv. No. 2246
Minneapolis, St. Paul & Sault Ste. Marie
Voltaire, North Dakota
Jan. 20, 1938

Voltaire station

This accident occurred on the Fourth Subdivision of the Minnesota Division which extends between Harvey and Portal, N.Dak., a distance of 153.8 miles. This is a single-track line over which trains are operated by timetable, train orders, and a manual block-signal system. The accident occurred 1.035 miles east of the station at Voltaire; approaching this point from the east the track is tangent and practically level for a distance of more than five miles. A siding about 5,085 feet in length parallels the main track on the south, the west switch of which is located approximately 300 feet east of the depot; the accident occurred at a point about 80 feet east of the east switch of the siding.
