INTERSTATE COMMERCE COMMISSION

REPORT OF THE DIRECTOR

CHICAGO, ROCK ISLAND & PACIFIC RAILWAY

BRANDT, S. DAK.

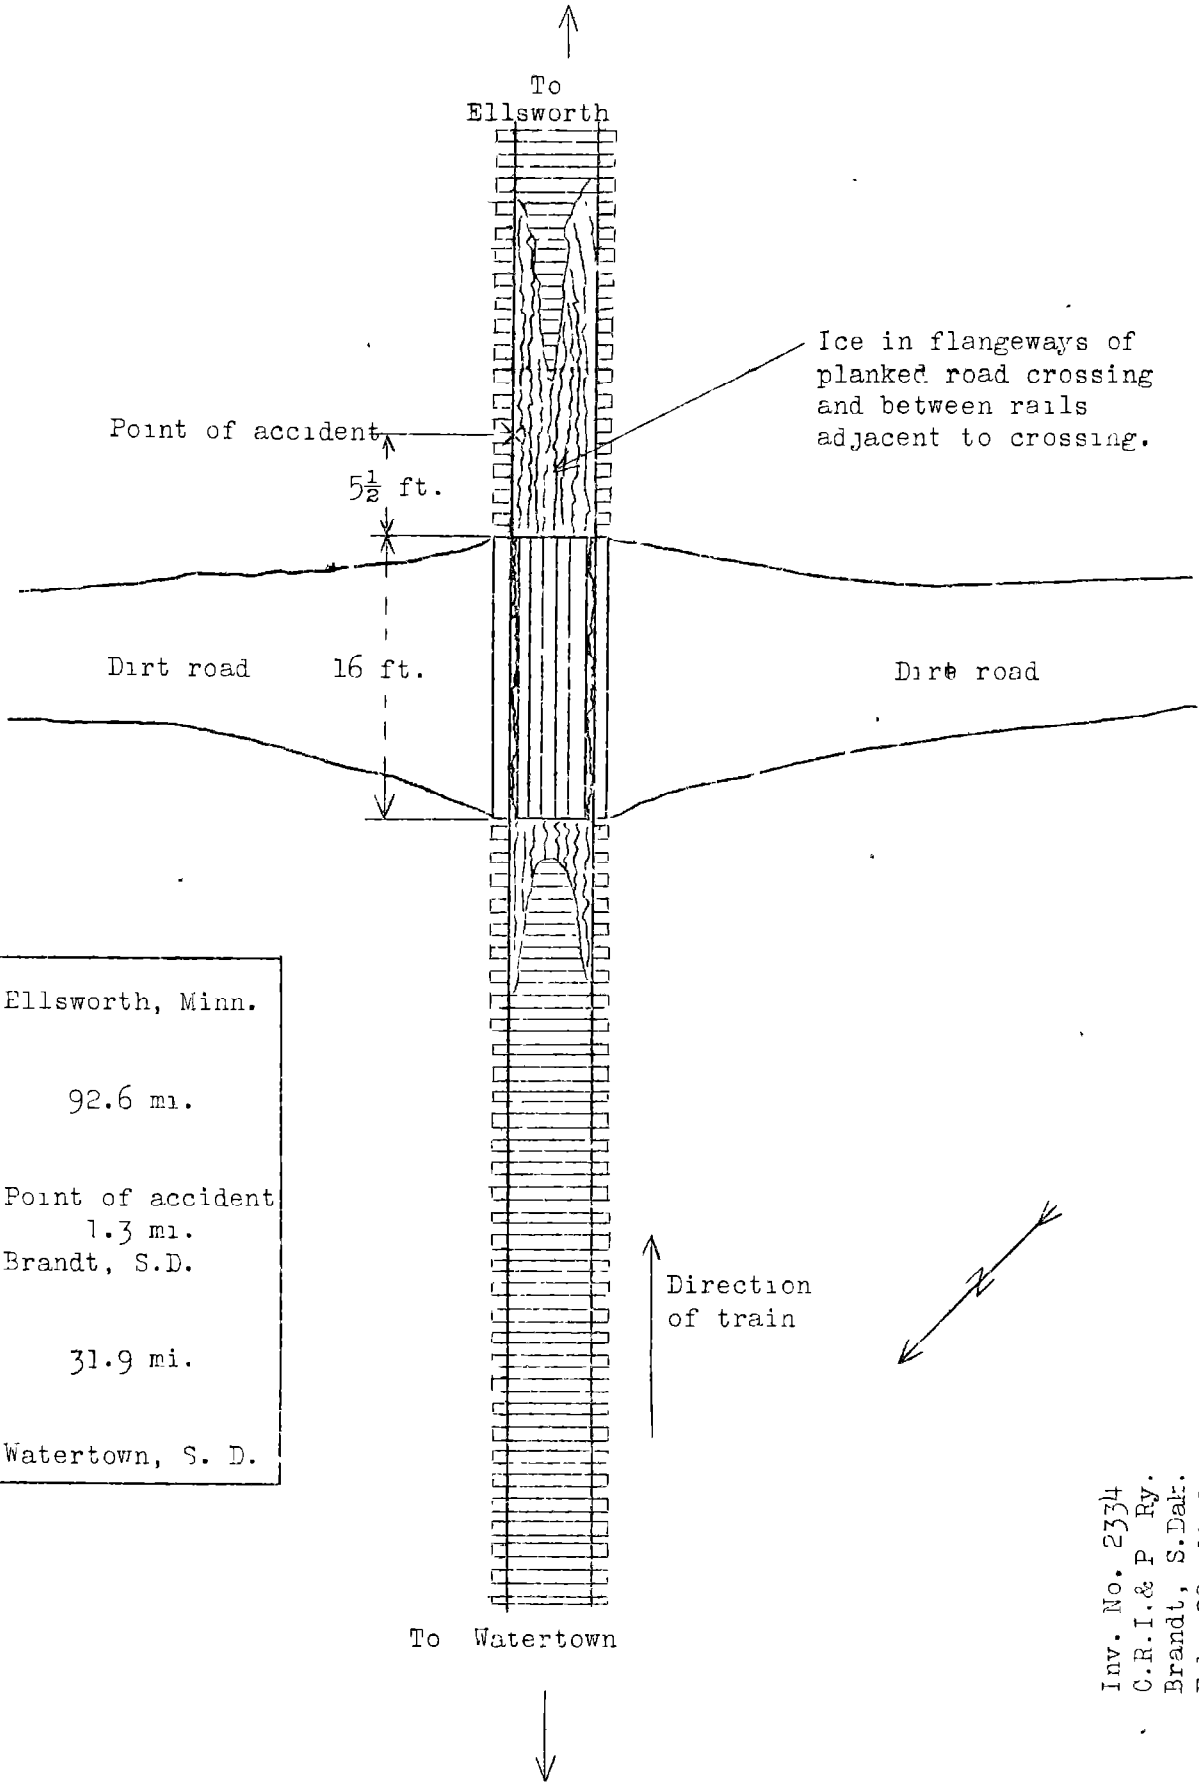
Inv. No. 2334  
 C.R.I. & P. Ry.  
 Brandt, S. Dak.  
 Feb. 20, 1939

o	Ellsworth, Minn.
	92.6 mi.
x	Point of accident
	1.3 mi.
o	Brandt, S.D.
	31.9 mi.
o	Watertown, S. D.
