REPORT OF THE DIRECTOR

ACCIDENT OF THE
PENNSYLVANIA RAILROAD

SEPTEMBER 27, 1930

INVESTIGATION NO. 2384

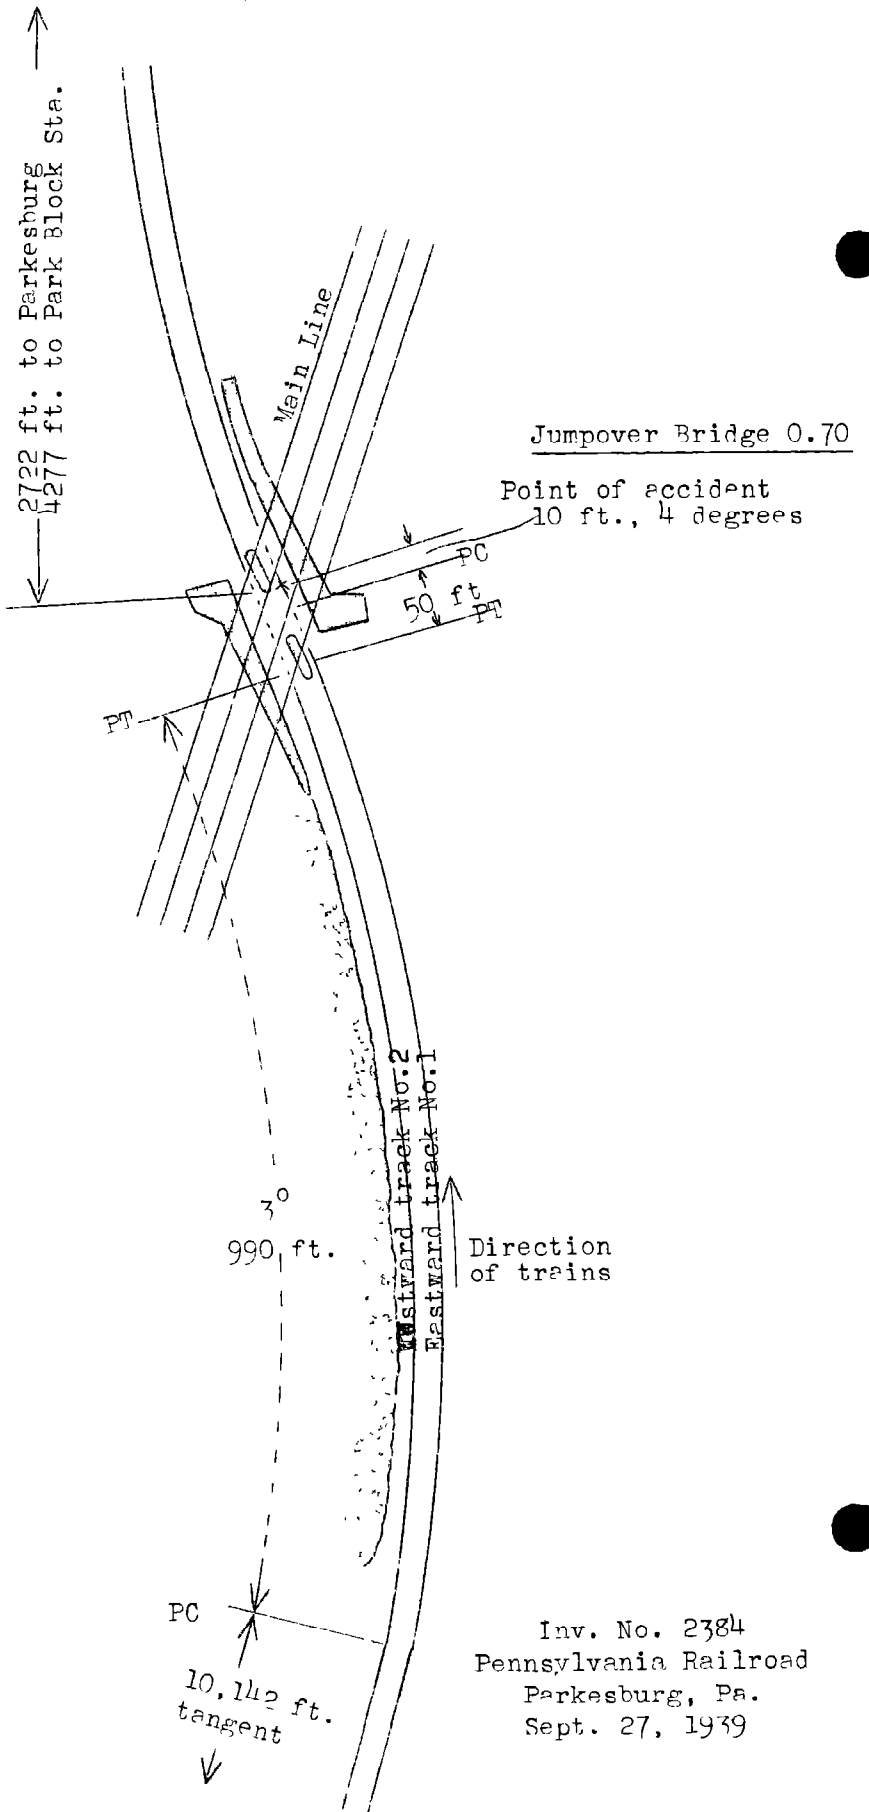
Inv. No. 2384
 Pennsylvania Railroad
 Parkesburg, Pa.
 Sept. 27, 1939

o	Park, Pa.
	0.2 mi.
o	Parkesburg
x	Point of accident
	22.2 mi.
o	Smith
	23.2 mi.
o	Shocks
	9.4 mi.
o	Cly
	15.9 mi.
o	Enola, Pa.
