INVESTIGATION NO. 2460

THE MINNEAPOLIS, ST. PAUL & SAULT STE. MARIE
RAILWAY COMPANY

REPORT IN RE ACCIDENT

AT WATKINS, MINN., ON

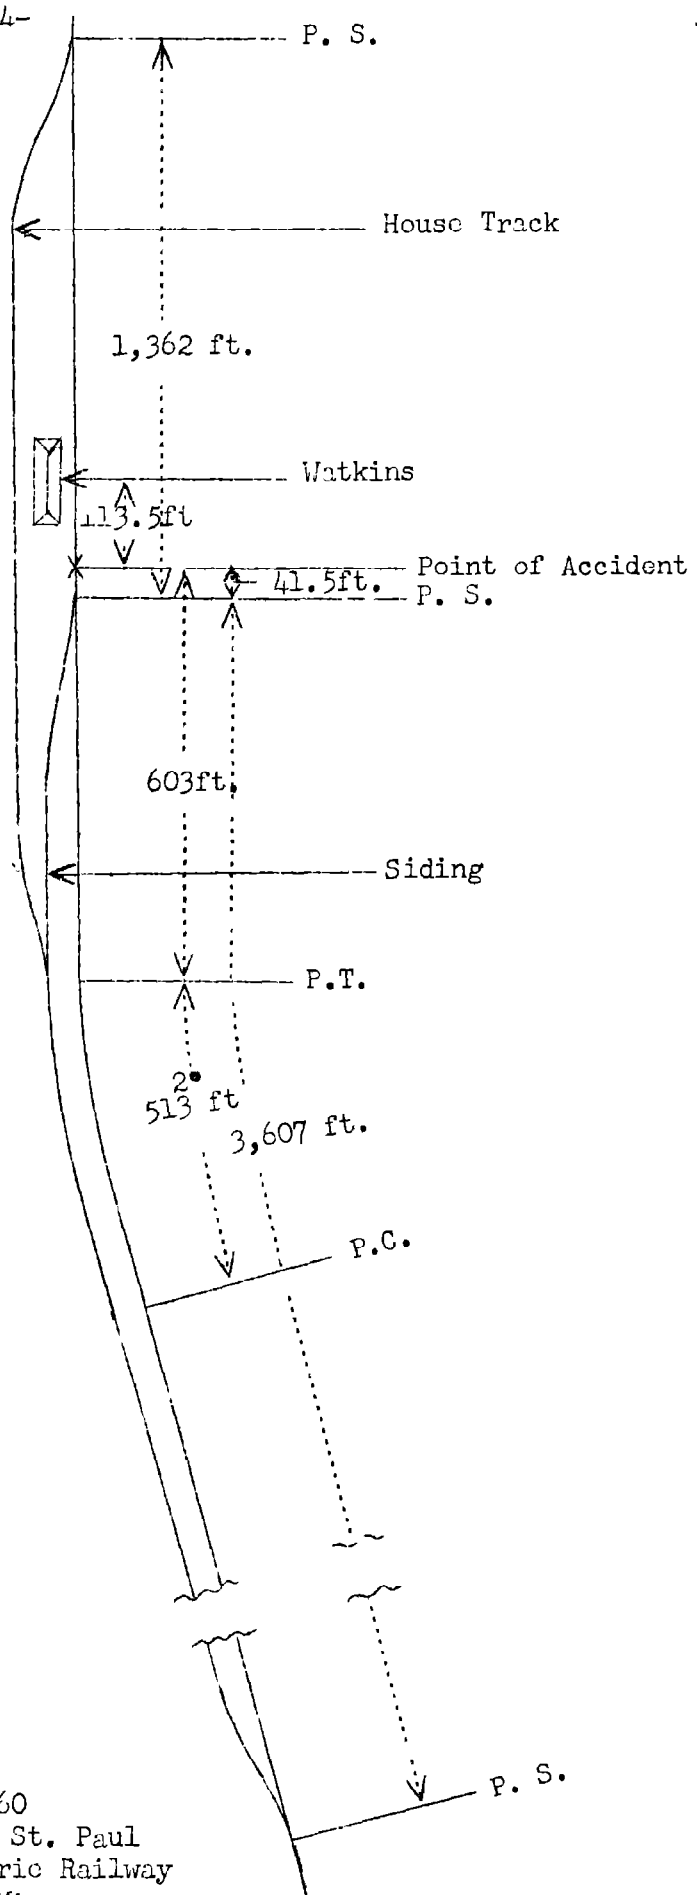
Inv-2460
 Minneapolis, St. Paul
 & Sault Ste. Marie Railway
 Watkins, Minn.
 November 11, 1940

○	Minneapolis, Minn.
○	15th Avenue North
	1.6 mi.
○	Camden Place
	18.2 mi.
○	Loretto
	34.3 mi.
○	South Haven
	5.2 mi.
○	Kimball
	5.4 mi.
⊗	Watkins
⊗	Point of Accident
	6.9 mi.
○	Eden Valley
	9.3 mi.
○	Paynesville
	37.8 mi.
○	Glenwood, Minn.
