INTERSTATE COMMERCE COMMISSION
WASHINGTON

INVESTIGATION NO. 2476
THE BALTIMORE & OHIO RAILROAD COMPANY
REPORT IN RE ACCIDENT
AT CUMBERLAND, MD., ON
JANUARY 1, 1941

Accident at Cumberland, Md., on January 1, 1941, caused
by failure properly to issue yard order to protect
movement against current of traffic.

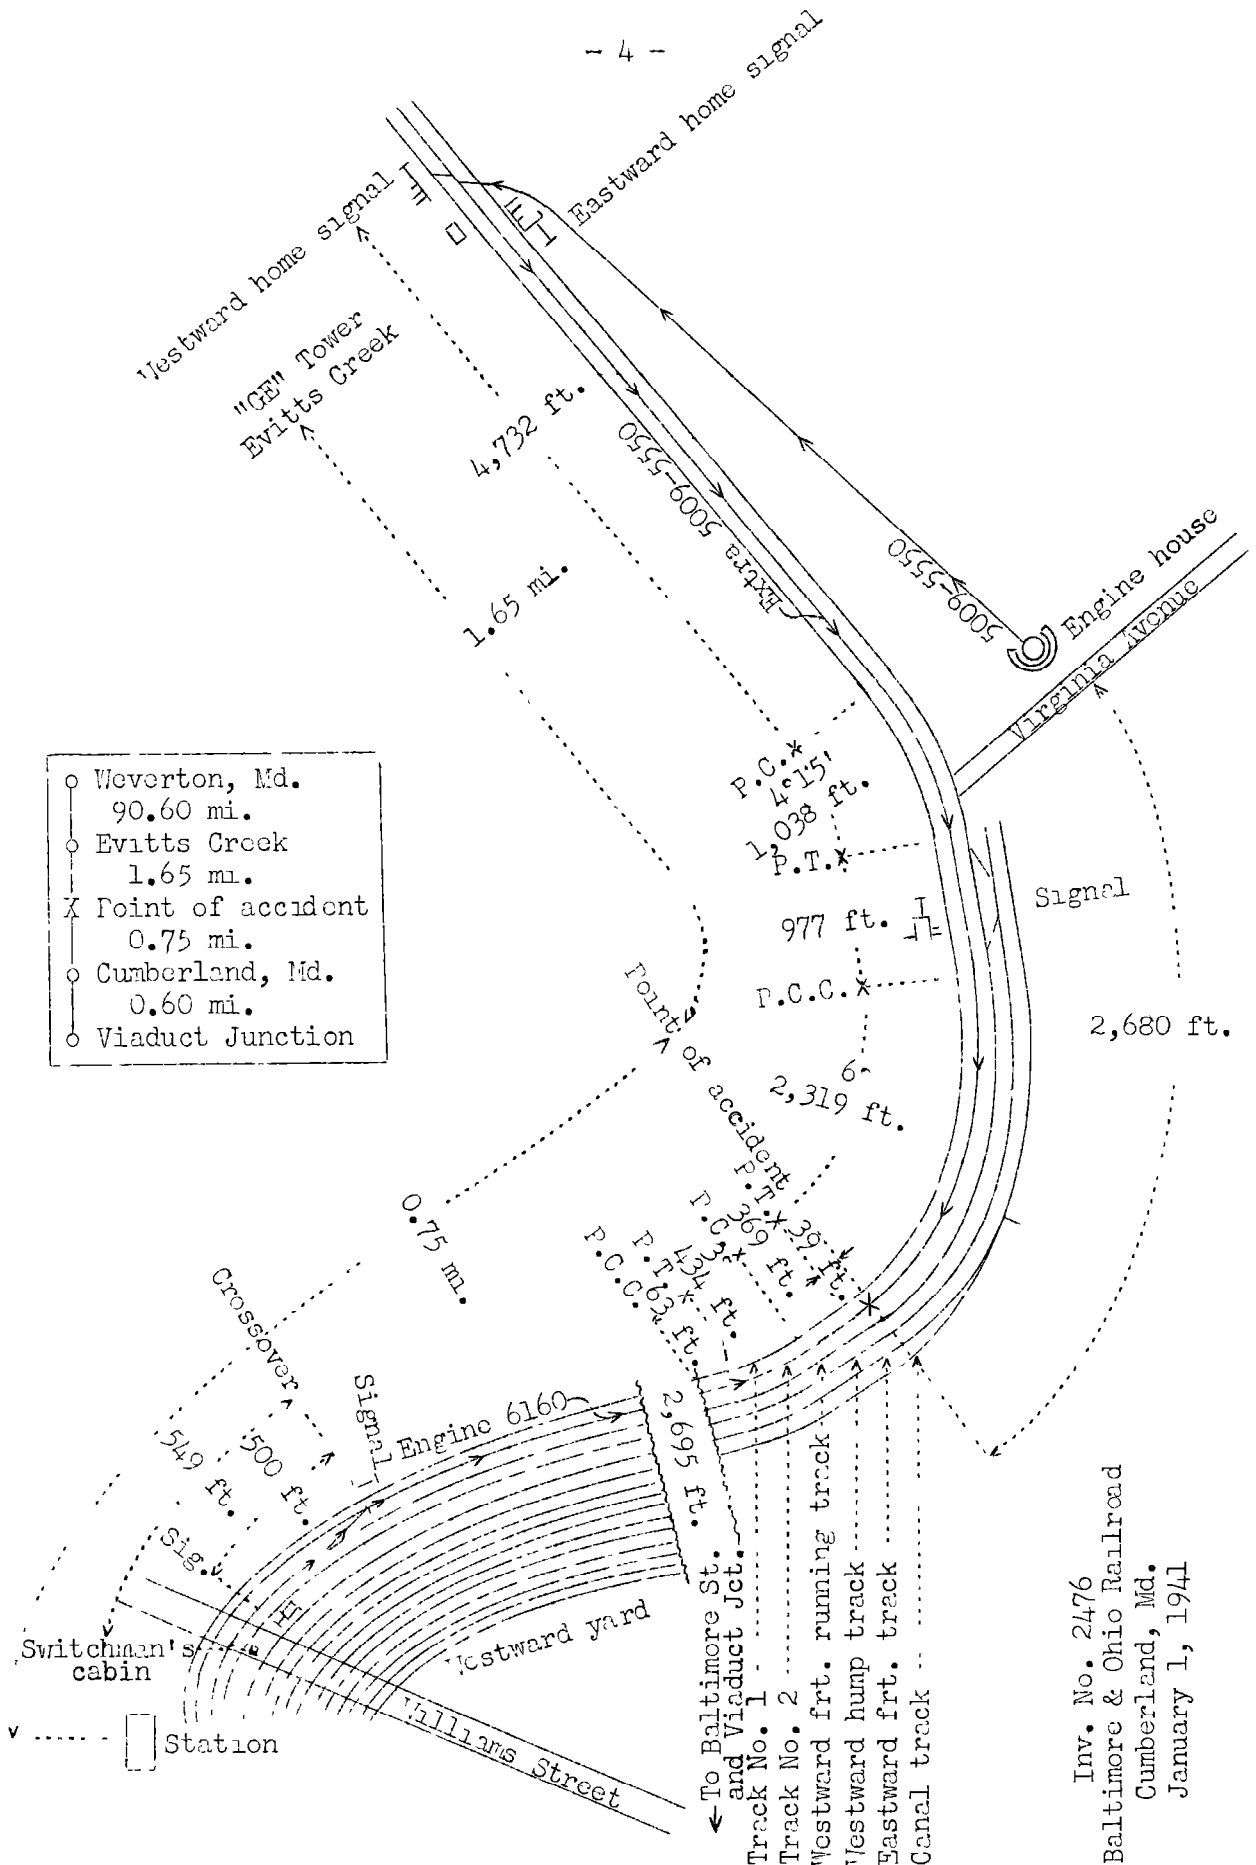
Inv. No. 2476
Baltimore & Ohio Railroad
Cumberland, Md.
January 1, 1941

- Weverton, Md.
90.60 mi.
- Evitts Creek
1.65 mi.
- X Point of accident
0.75 mi.
- Cumberland, Md.
0.60 mi.
- Viaduct Junction

Track: Double; 6° compound curve; 0.43 percent
descending grade westward

The Commission's inspectors observed that the switchman's cabin at Williams Street is a building 6 feet square; it provides shelter for the crossing watchman and the switchtender. A telephone, which is on a yard circuit of ten telephones, is provided. When movements are authorized against the current of traffic on track No. 2 between Evitts Creek and Williams Street the switchtender displays a red flag by day and a red light by night in a place provided at the eastward automatic signal at Williams Street. Numerous engines entered track No. 2 at the crossover and proceeded eastward at speeds considerably in excess of the slow-speed restriction required when the next signal in advance cannot be seen. Because of curvature, when track No. 1 is occupied by cars, as the point where the accident occurred is approached on track No. 2, the view is restricted to 211 feet.
