INVESTIGATION NO. 2486
THE ILLINOIS CENTRAL RAILROAD COMPANY
REPORT IN RE ACCIDENT
NEAR DELAWARE, IOWA, ON
MARCH 10, 1941

Accident near Delaware, Iowa, on March 10, 1941, caused by
failure to obey a meet order.

Inv-2486
 Illinois Central R.R.
 Delaware, Iowa
 March 10, 1941

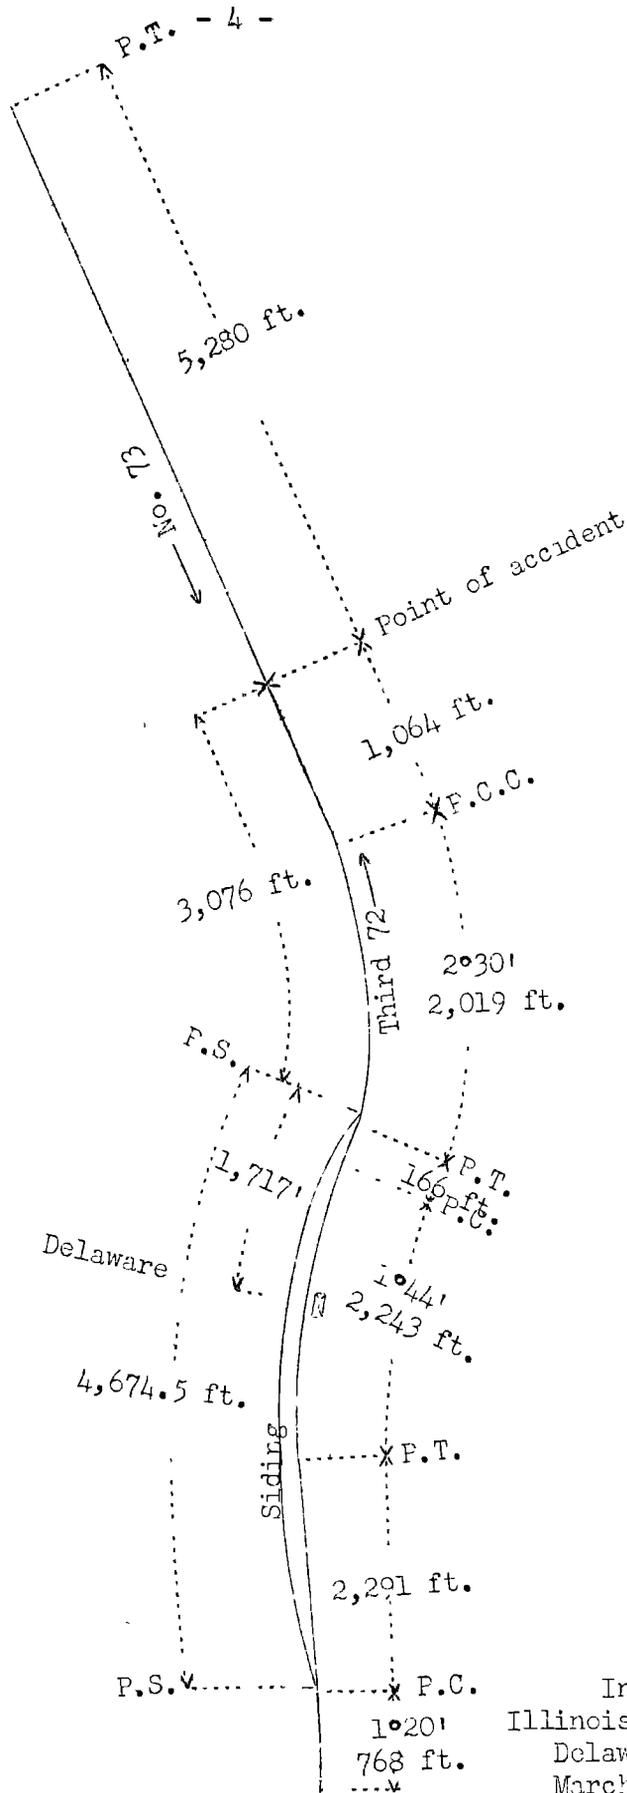
○	West Junction, Ill.	66.4 mi.
○	Dubuque, Iowa	9.6 mi.
○	Julien	4.9 mi.
○	Peosta	4.3 mi.
○	Epworth	3.9 mi.
○	Farley	6.5 mi.
○	Dyersville	7.7 mi.
○	Earlville	0.9 mi.
X	Point of accident	2.9 mi.
○	Delaware	6.0 mi.
○	Manchester	44.0 mi.
○	Rath	2.4 mi.
○	Waterloo, Iowa
