INTERSTATE COMMERCE COMMISSION  
WASHINGTON

INVESTIGATION NO. 2508  
THE ALTON RAILROAD COMPANY  
REPORT IN RE ACCIDENT  
AT WILMINGTON, ILL., ON  
JUNE 23, 1941

Kind of accident: Head-end collision

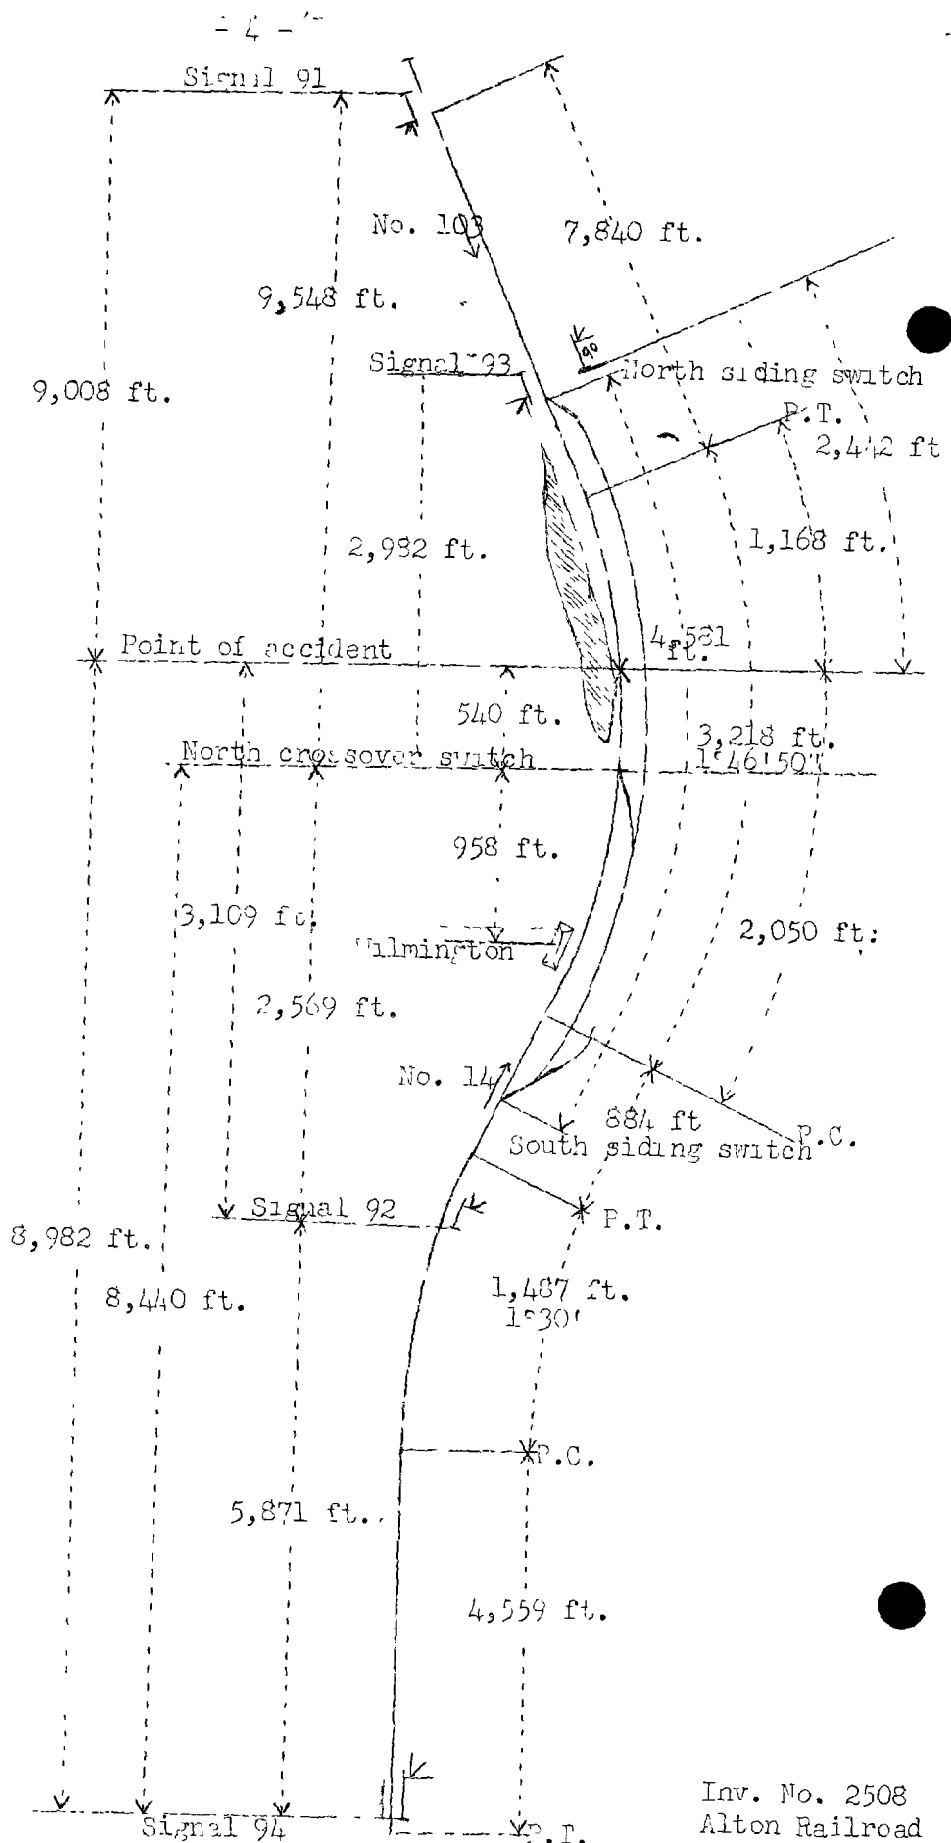
- o Chicago, Ill.
- 32.5 mi.
- o South Joliet
- 7.3 mi.
- o Elwood
- 6.7 mi.
- o Wilmington
- (Point of accident)
- 4.8 mi.
- o Braidwood
- 69.3 mi.
- o Bloomington, Ill.
