INVESTIGATION NO. 2661
THE PENNSYLVANIA RAILROAD COMPANY
REPORT IN RE ACCIDENT
NEAR COLUMBIA CITY, IND., ON
DECEMBER 12, 1942

Railroad: Pennsylvania
Date: December 12, 1942
Location: Columbia City, Ind.
Kind of accident: Rear-end collision
Trains involved: Freight : Passenger
Train numbers: Extra 8323 West : 23
Engine numbers: 2303 : 5471-5357
Consist: 82 cars, caboose : 15 cars
Estimated speed: 2-5 m. p. h. : 25-50 m. p. h.
Operation: Automatic block-signal system
Track: Double; tangent; 0.38 percent ascending grade westward
Weather: Hazy
Time: About 11:05 a. m.
Casualties: 1 killed; 2 injured
Cause: Accident caused by failure to provide adequate flag protection for preceding train, and by failure to operate following train in accordance with signal indications

Inv-2661
 Pennsylvania Railroad
 Columbia City, Ind.
 December 12, 1942

Location of Accident and Method of Operation

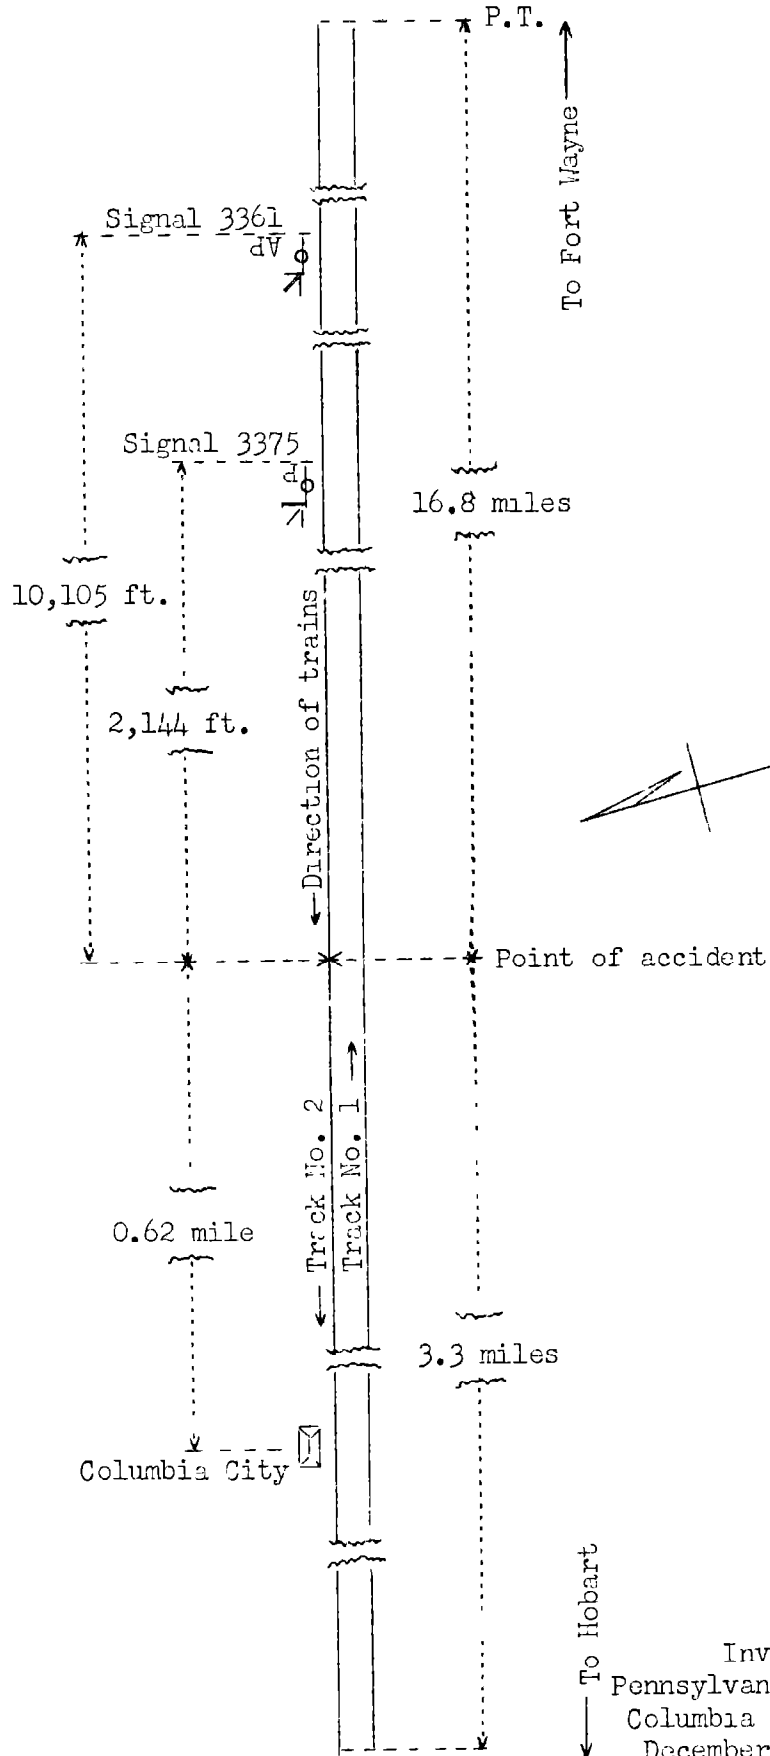
- Fort Wayne, Ind. 1.40 mi.
- Junction 16.88 mi.
- X Point of accident 0.62 mi.
- Columbia City 95.80 mi.
- Hobart, Ind.

This accident occurred on that part of the Fort Wayne Division extending between Fort Wayne and Hobart, Ind., a distance of 114.7 miles. In the vicinity of the point of accident this is a double-track line over which trains moving with the current of traffic are operated by an automatic block-signal system, the indications of which supersede timetable superiority. The main tracks from south to north are No. 1, eastward main, and No. 2, westward main. The accident occurred on track No. 2 at a point 0.62 mile east of the station at Columbia City. Approaching from the east the track is tangent 16.8 miles to the point of accident and 3.3 miles beyond. The grade for west-bound trains is 0.38 percent ascending.
