INTERSTATE COMMERCE COMMISSION
WASHINGTON

INVESTIGATION NO. 2728

THE MINNEAPOLIS, ST. PAUL & SAULT STE. MARIE
RAILWAY COMPANY

REPORT IN RE ACCIDENT
AT VALLEY SIDING, WIS., ON
SEPTEMBER 18, 1943

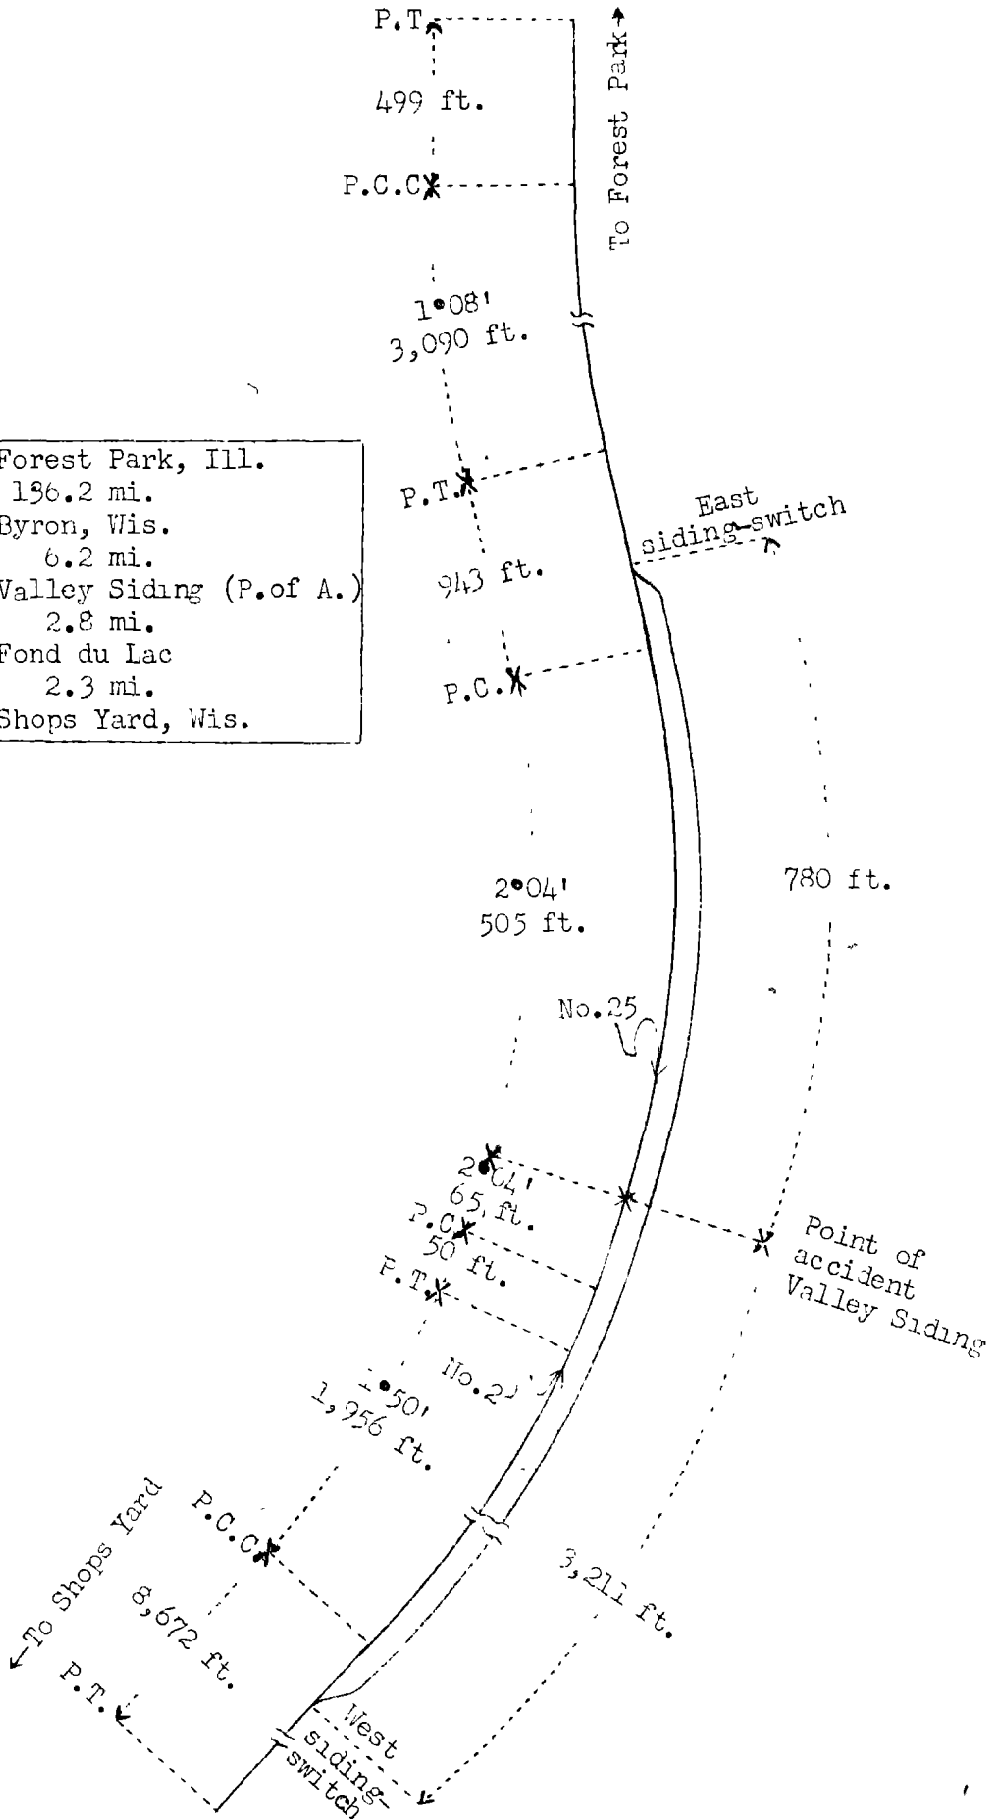
Inv. No. 2728
 Minneapolis, St. Paul & Sault Ste. Marie Railway
 Valley Siding, Wis.
 September 13, 1943

Location of Accident and Method of Operation
