INVESTIGATION NO. 2745  
THE BALTIMORE AND OHIO RAILROAD COMPANY  
REPORT IN RE ACCIDENT  
AT NEWTON FALLS, OHIO, ON  
NOVEMBER 24, 1943

Location: Newton Falls, Ohio

Kind of accident: Rear-end collision and wreckage struck  
by train moving on adjacent track

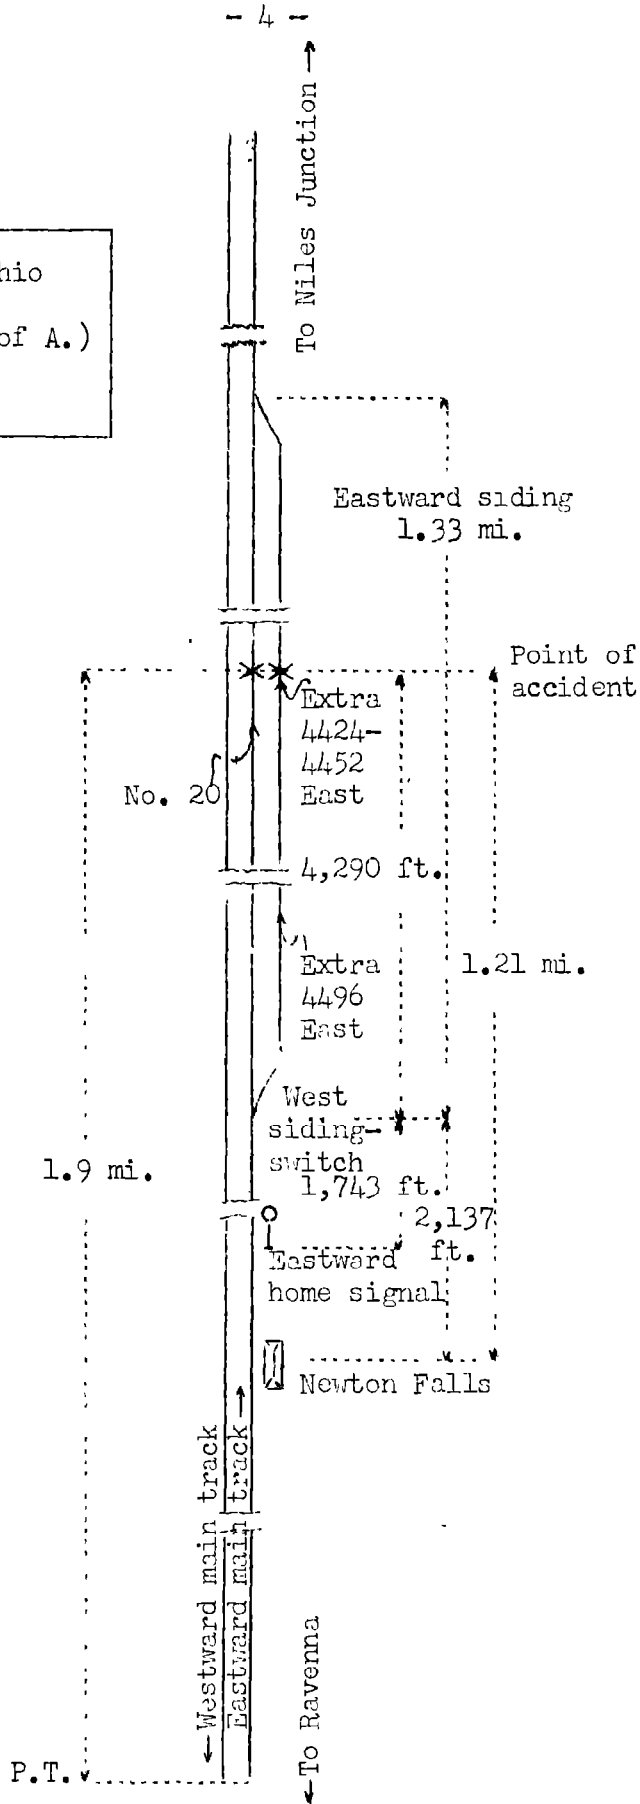
Inv. No. 2745  
 Baltimore and Ohio Railroad  
 Newton Falls, Ohio  
 November 24, 1943

o Niles Junction, Ohio  
    8.2 mi.  
 X Newton Falls (P. of A.)  
    14.5 mi.  
 o Ravenna, Ohio

Location of Accident and Method of Operation
