INVESTIGATION NO. 2756  
THE CHICAGO & EASTERN ILLINOIS RAILROAD COMPANY  
REPORT IN RE ACCIDENT  
NEAR GOREVILLE, ILL., ON  
JANUARY 1, 1944

Accident near Goreville, Ill., on January 1, 1944, caused  
by failure to deliver a meet order.

Inv. No. 2756  
 Chicago & Eastern Illinois Railroad  
 Goreville, Ill.  
 January 1, 1944

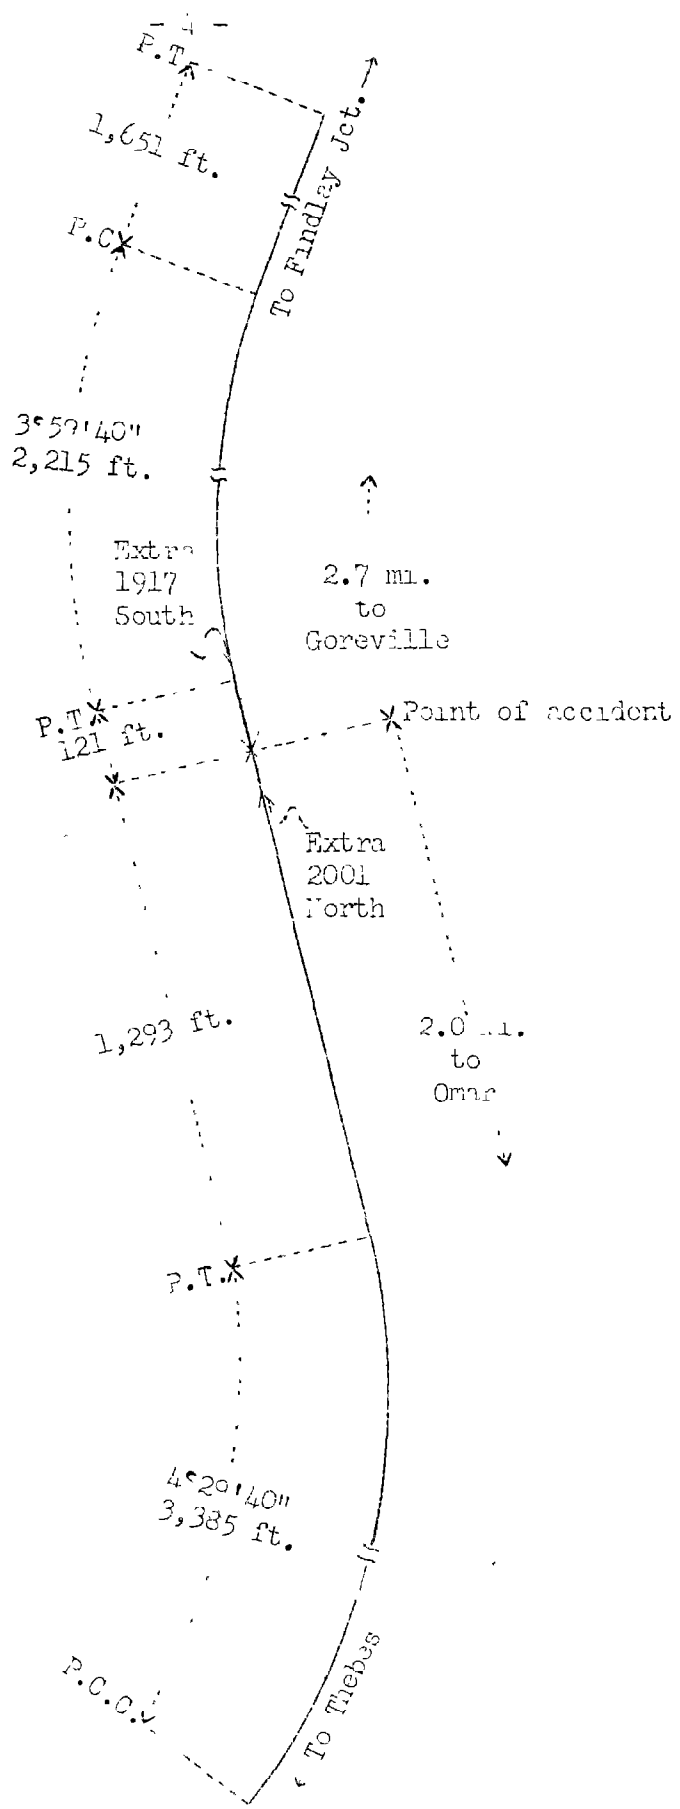
- o Findlay Jct., Ill. 66.6 mi.
- o Salem Yard 52.9 mi.
- o West Frankfort 11.6 mi.
- o Marion 12.7 mi.
- o Goreville 2.7 mi.
- x Point of accident 2.0 mi.
- o Omar 11.3 mi.
- o Cypress 32.7 mi.
- o Thebes, Ill.
