INVESTIGATION NO. 2870

THE CHICAGO, ST. PAUL, MINNEAPOLIS & OMAHA
RAILWAY COMPANY

THE MINNEAPOLIS, ST. PAUL & SAULT STE. MARIE
RAILROAD COMPANY

REPORT IN RE ACCIDENT

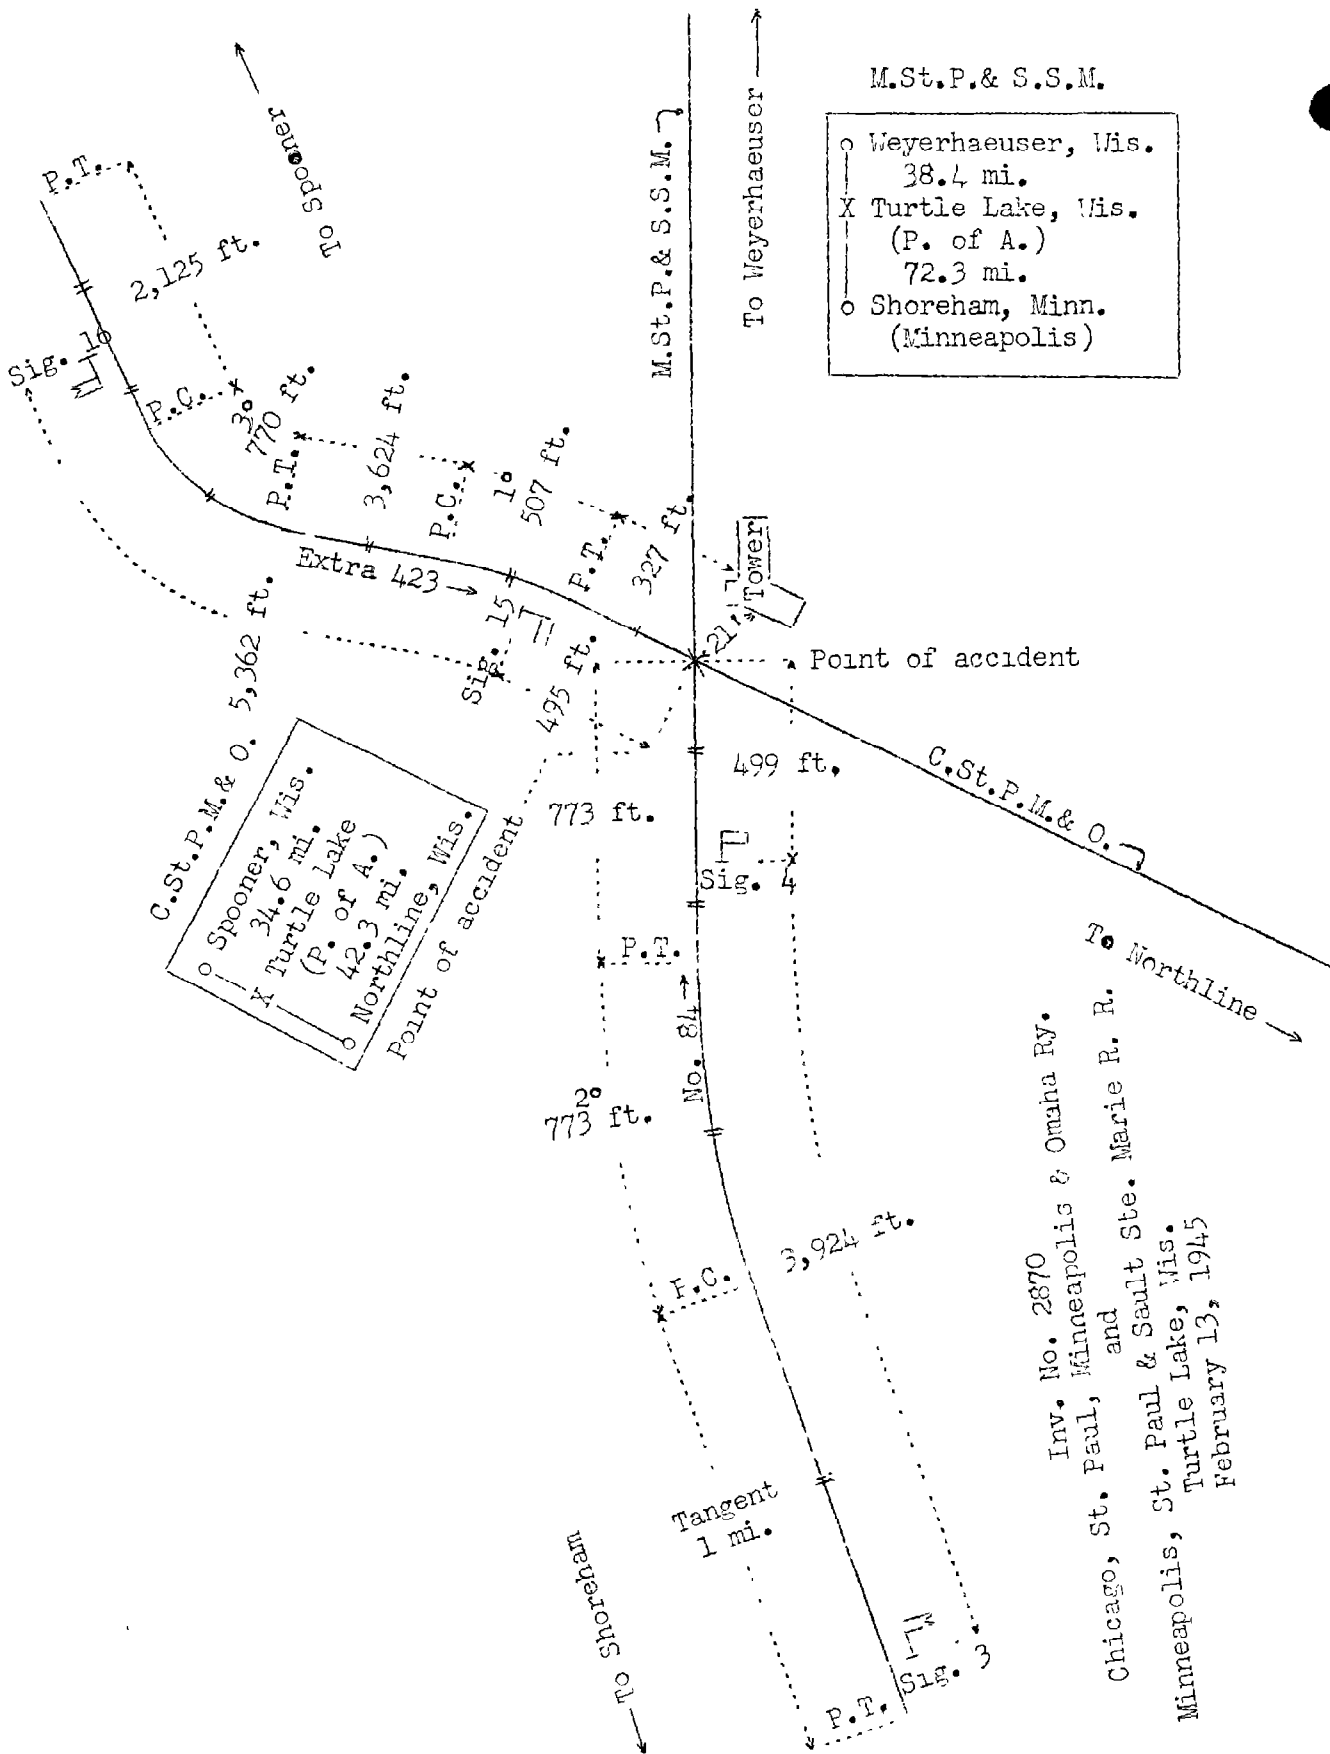
M. St. P. & S. S. M.

- o Weyerhaeuser, Wis. 38.4 mi.
- X Turtle Lake, Wis. (P. of A.) 72.3 mi.
- o Shoreham, Minn. (Minneapolis)
