INVESTIGATION NO. 2955

THE BALTIMORE AND OHIO CHICAGO TERMINAL
RAILROAD COMPANY

REPORT IN RE ACCIDENT

AT 36TH STREET, CHICAGO, ILL., ON

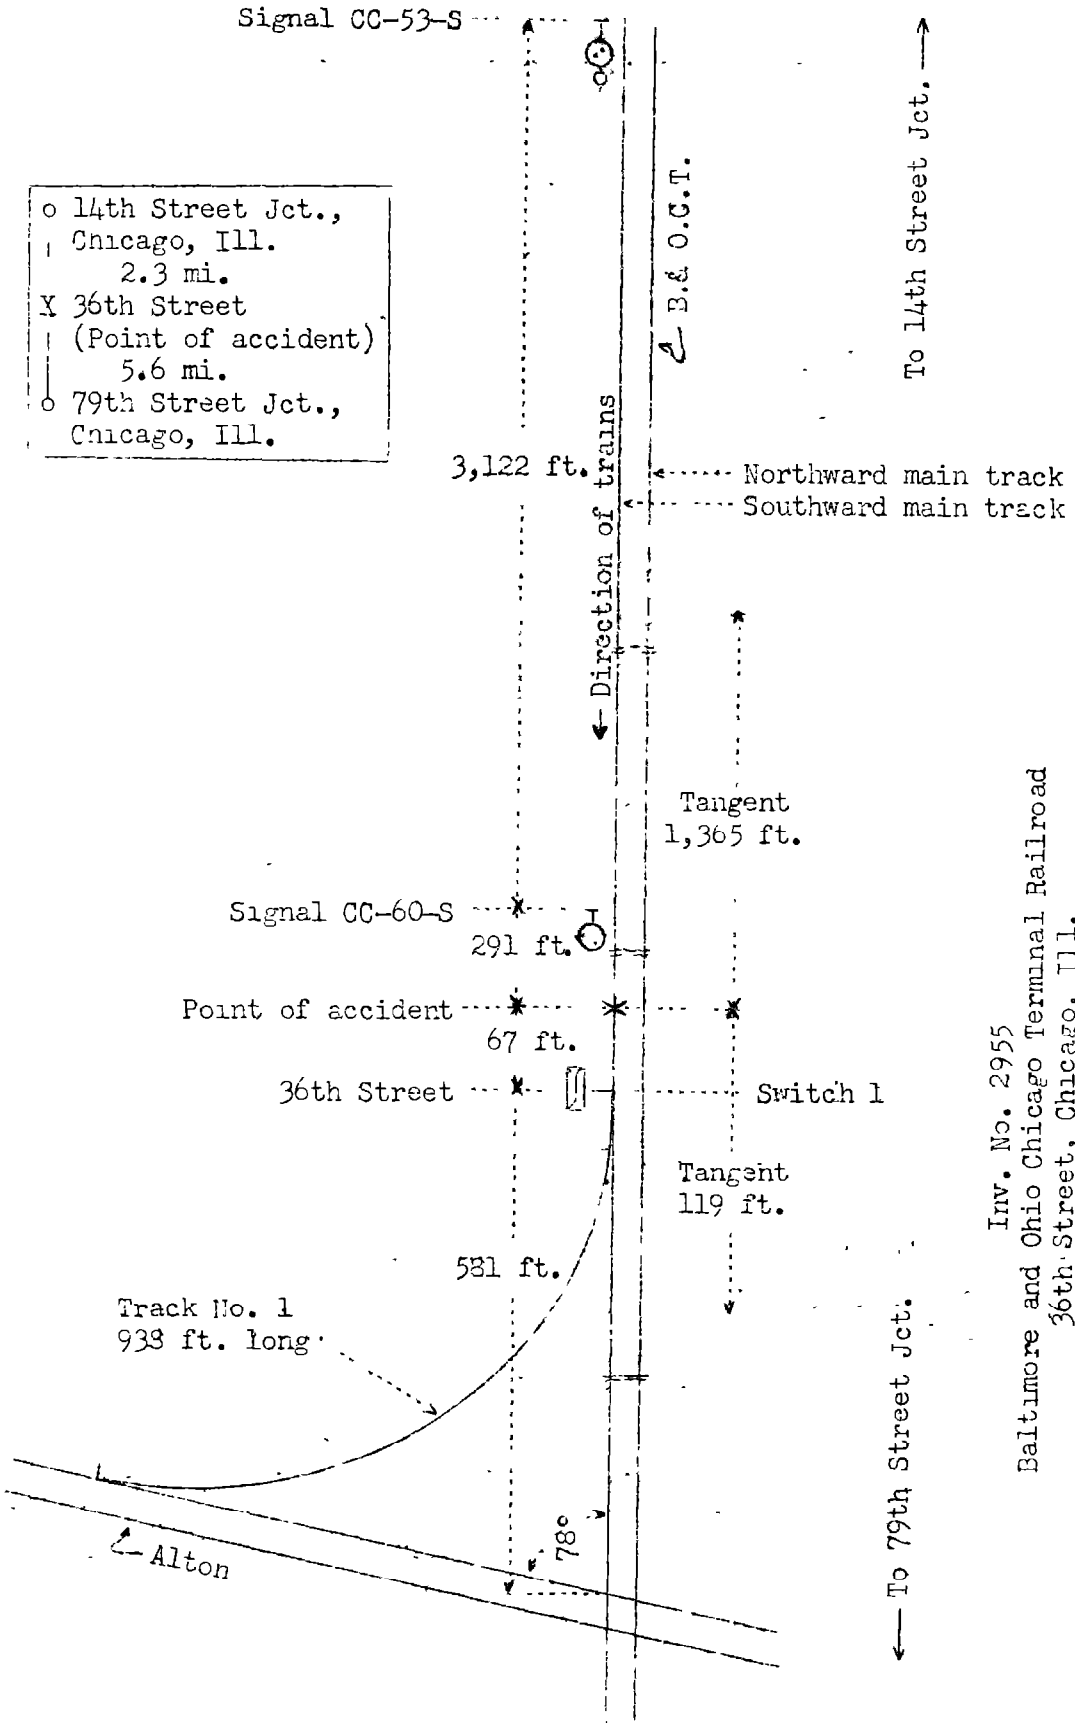
Inv. No. 2955
 Baltimore and Ohio Chicago Terminal Railroad
 36th Street, Chicago, Ill.
 December 12, 1945

- o 14th Street Jct.,
Chicago, Ill.
2.3 mi.
- X 36th Street
(Point of accident)
5.6 mi.
- o 79th Street Jct.,
Chicago, Ill.

This accident occurred on that part of the Baltimore and Ohio Chicago Terminal Railroad extending between 14th Street Jct. and 79th Street Jct., Chicago, Ill., 7.9 miles, a double-track line in the vicinity of the point of accident, over which trains moving with the current of traffic are operated by signal indications. Trains of the Alton Railroad and the Pere Marquette Railway are operated over this line. At 36th Street, 2.3 miles south of 14th Street Jct., a double-track line of the Alton Railroad intersects the line of the Baltimore and Ohio Chicago Terminal Railroad at an angle of 78° at a point 581 feet south of the station. The north leg of a wye, 938 feet long and hereinafter referred to as track No. 1, connects the B. & O.C.T. southward main track and the Alton westward main track. The switch of track No. 1 on the B. & O.C.T., hereinafter referred to as switch 1, is opposite the station at 36th Street. Switch 1 is hand-operated and is in the charge of the operator at 36th Street. The accident occurred on the B. & O.C.T. southward main track at a point 67 feet north of switch 1. The southward main track is tangent throughout a distance of 1,365 feet north of the point of accident and 119 feet southward. The grade for south-bound trains is 0.06 percent ascending 1,325 feet, then it is 1.00 percent descending 42 feet to the point of accident and 687 feet southward.
