INVESTIGATION NO. 2989  
GULF, MOBILE AND OHIO RAILROAD COMPANY  
REPORT IN RE ACCIDENT  
AT WINFORD JUNCTION, KY., ON  
MAY 1, 1946

Accident at Winford Junction, Ky., on May 1, 1946, caused  
by an interlocking home signal displaying a false  
proceed indication for the Illinois Central train.

Inv. No. 2989  
 Gulf, Mobile and Ohio Railroad  
 Winford Junction, Ky.  
 May 1, 1946

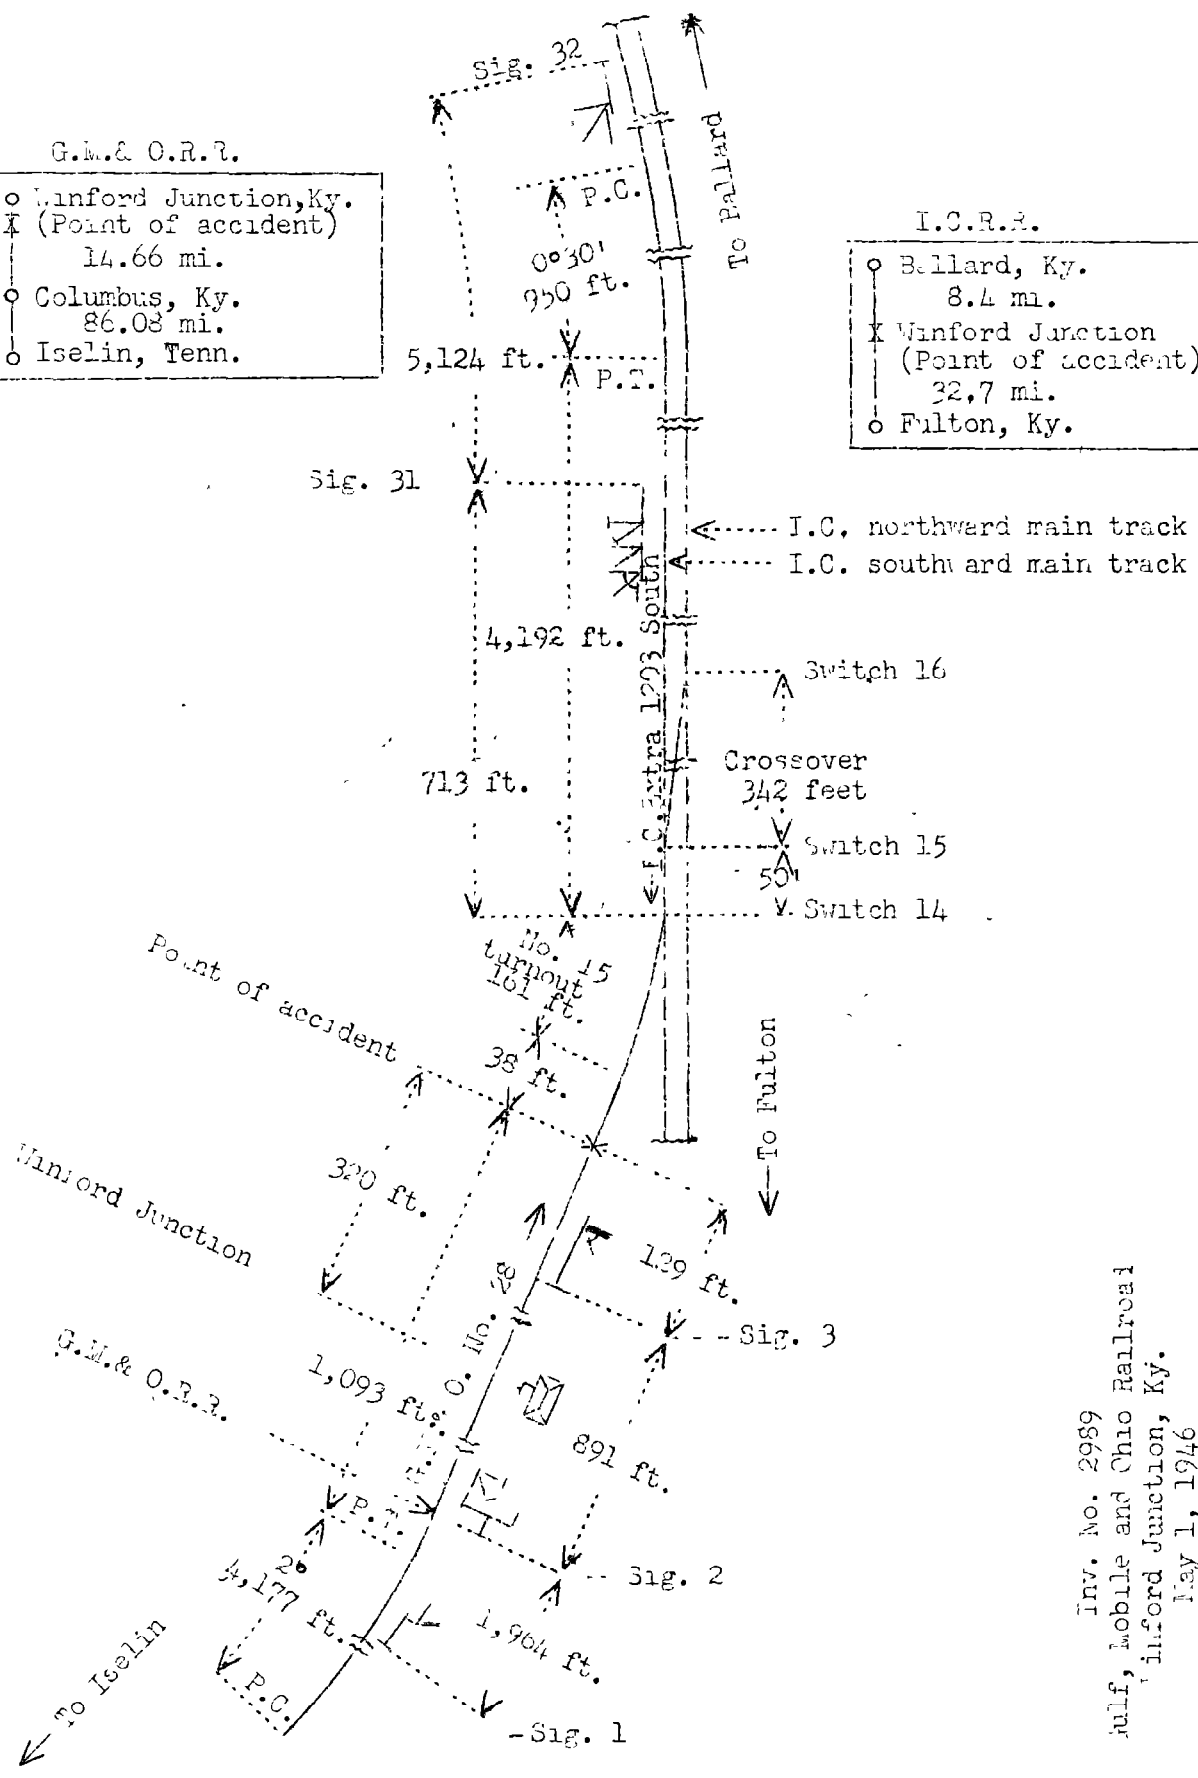
- o Winford Junction, Ky.
- X (Point of accident)
- 14.66 mi.
- o Columbus, Ky.
- 86.03 mi.
- o Iselin, Tenn.

- o Ballard, Ky.
- 8.4 mi.
- X Winford Junction
- (Point of accident)
- 32.7 mi.
- o Fulton, Ky.

Location of Accident and Method of Operation

The investigation disclosed that about 5:29 a. m., immediately after No. 28 stopped at signal 2, which displayed stop, the operator-leverman lined the route for this train to proceed from the G.M. & O. main track through switch 14 to the I.C. southward main track and thence through the crossover to the I.C. northward main track. The lever in control of signal 31 was in position for this signal to display stop for south-bound movements on the I.C. southward main track. The enginemen of No. 28, and the front brakeman, who was on the engine, observed the proceed indications displayed by signals 2 and 3 when the route was lined, and they called the indications to each other. However, because the enginemen were attempting to stop a steam leak from the right cylinder, an interval of several minutes elapsed before No. 28 proceeded. In the meantime, Extra 1203 South entered the annunciator circuit, which extended about 2.5 miles north of the tower, but the operator-leverman said he made no attempt to change the route to permit Extra 1203 South to proceed through the interlocking. However, Extra 1203 South passed signal 31, entered the G.M. & O. main track at switch 14 and collided with No. 28 at a point 199 feet south of the switch.
