INVESTIGATION NO. 3078  
THE PENNSYLVANIA RAILROAD COMPANY  
REPORT IN RE ACCIDENT  
NEAR GALLITZIN, PA., ON  
FEBRUARY 18, 1947

Railroad: Pennsylvania  
Date: February 18, 1947  
Location: Gallitzin, Pa.  
Kind of accident: Derailment  
Train involved: Passenger  
Train number: 68  
Engine numbers: 422-3771  
Consist: 14 cars  
Speed: In excess of 65 m. p. h.  
Operation: Signal indications  
Tracks: Four; 8°30' curve; 1.73 percent descending grade eastward  
Weather: Hazy  
Time: 3:21 a. m.  
Casualties: 24 killed; 138 injured  
Cause: Excessive speed on curve

Accident near Gallitzin, Pa., on February 18, 1947, caused  
by excessive speed on a curve.

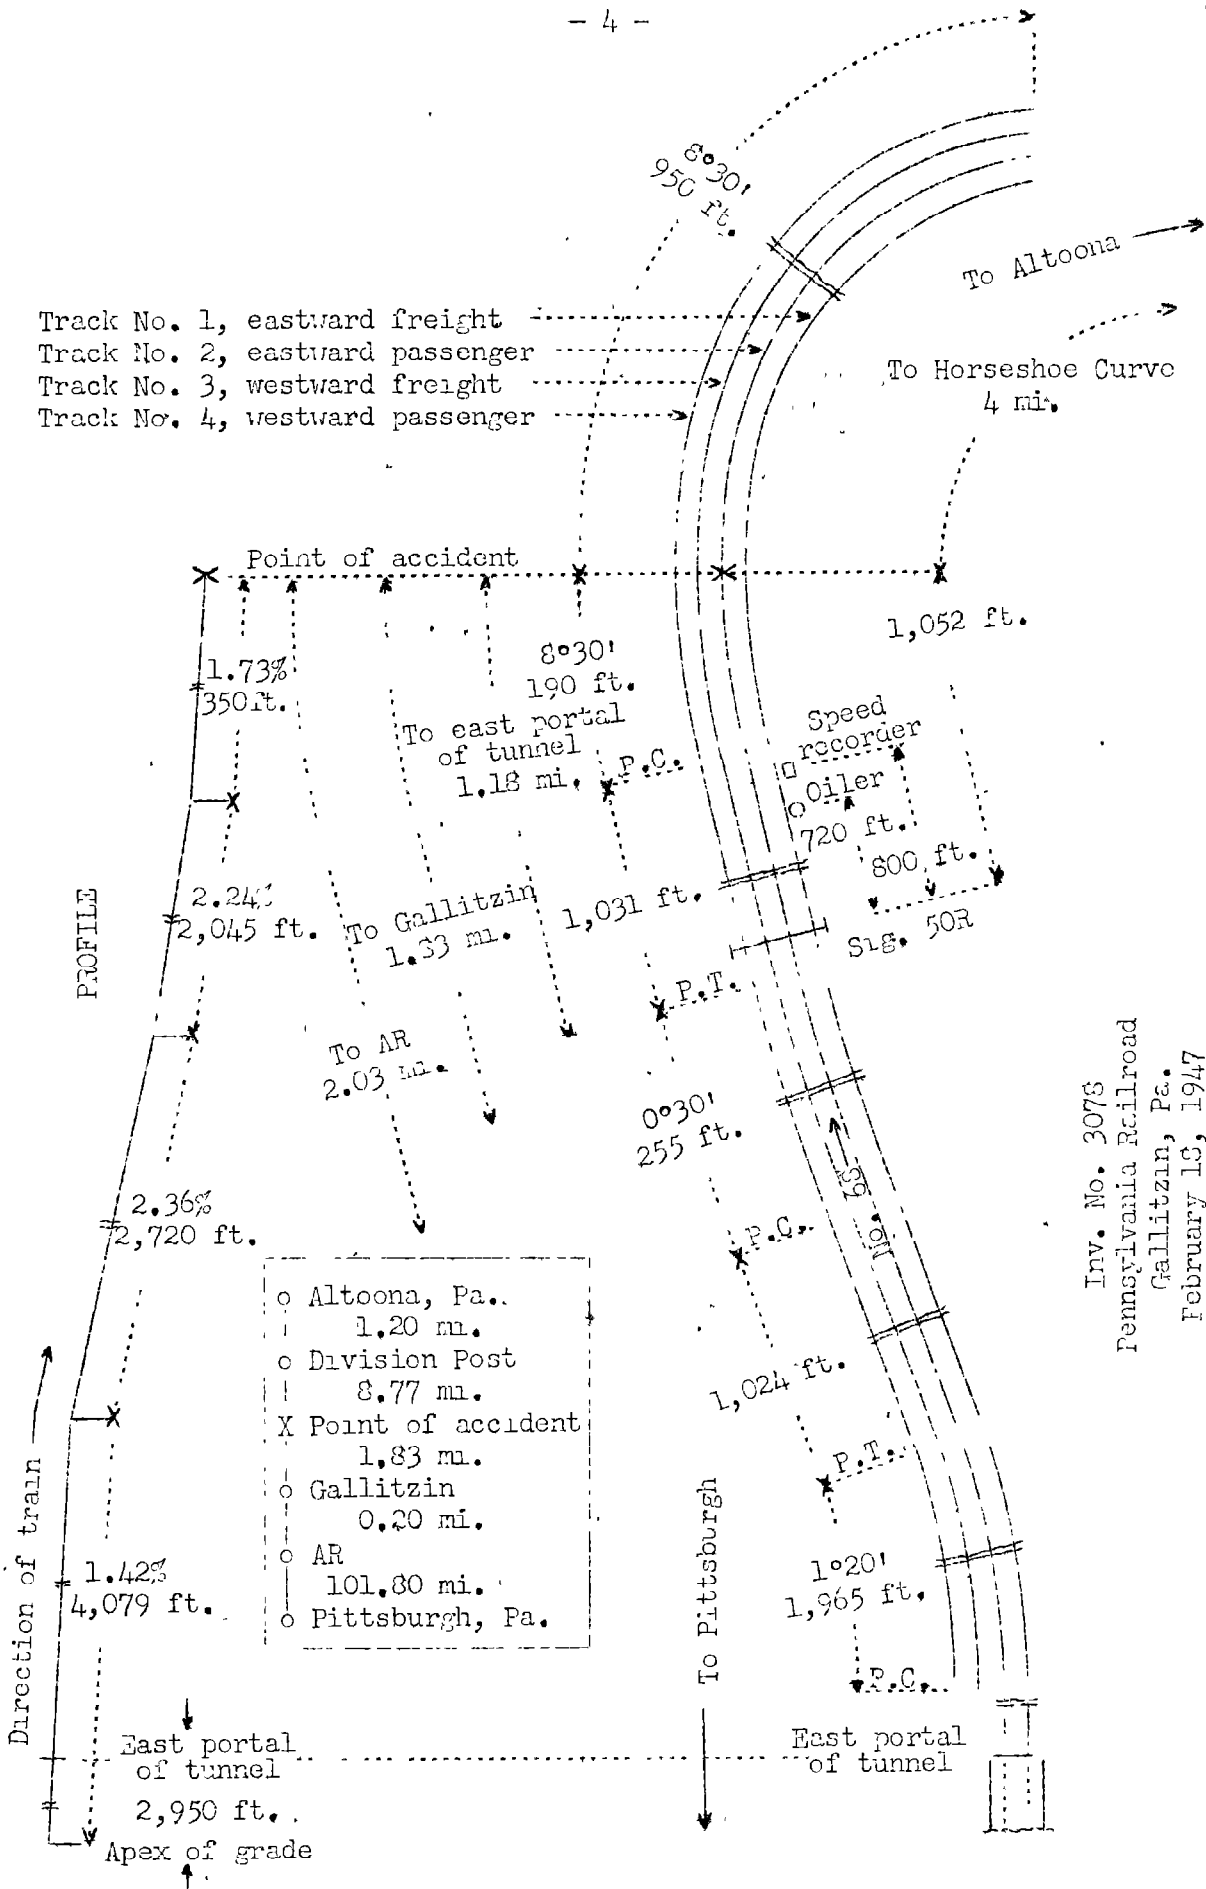
Inv. No. 3078  
 Pennsylvania Railroad  
 Gallitzin, Pa.  
 February 13, 1947

- Track No. 1, eastward freight
- Track No. 2, eastward passenger
- Track No. 3, westward freight
- Track No. 4, westward passenger

o	Altoona, Pa.	1.20 mi.
o	Division Post	8.77 mi.
X	Point of accident	1.83 mi.
o	Gallitzin	0.20 mi.
o	AR	101.80 mi.
o	Pittsburgh, Pa.

Location of Accident and Method of Operation

The first engine overturned to the left and stopped on its left side, down the embankment and at right angles to the tracks, with the front end 405 feet east of the point of derailment and 104 feet north of the centerline of track No. 2. The cab was demolished, steam pipes within the cab were broken and the left side of the engine was badly damaged. The tender of the first engine stopped upside down, off its trucks, at a point 80 feet north and 27 feet east of the engine and at right angles to it. The tender was badly damaged. The second engine overturned to the left, stopped on its left side and against the first engine, with the front end 401 feet east of the point of derailment and 82 feet north of the centerline of track No. 2. The front-end frames and the cradle casting and tail piece were broken, the cab was demolished, steam pipes within the cab were broken and this engine was otherwise badly damaged. The tender of the second engine stopped upside down, off its trucks and at a point 76 feet north and 68 feet east of its engine. This tender was badly damaged. The engine trucks of both engines were torn loose, and stopped near their respective engines. The safety chains of the engine-truck assemblies of both engines were broken as a result of the derailment. The first car stopped on its left side and down the embankment, with the front end 425 feet east of the point of derailment and 96 feet north of track No. 2. This car was practically demolished. The second car stopped on its left side, across tracks Nos. 3 and 4 and at

an angle of 15 degrees to them, at a point 481 feet east of the point of derailment. This car was badly damaged. The third car stopped with the front end on top of the first car and the rear end on track No. 4. The top of this car was crushed inward to the belt rail, and the car was otherwise badly damaged. The fourth car stopped on its left side and on top of the tender of the first engine. This car was practically demolished. The fifth car stopped upright, about 8 feet west of the second engine and in line with it. This car was badly damaged. The sixth car stopped on its left side, down the embankment and at an angle of about 45 degrees to the track, with the front end 397 feet east of the point of derailment and 200 feet north of track No. 2. This car was badly damaged. The seventh car stopped upright, on the roadbed and at an angle of about 50 degrees to the tracks, with the front end 304 feet east of the point of derailment and 89 feet north of track No. 2. This car was considerably damaged. The eighth, ninth and tenth cars remained coupled and stopped upright, across tracks Nos. 2, 3 and 4 and at an angle of about 10 degrees to them, with the front of the eighth car 23 feet north of track No. 2 and the rear of the tenth car between tracks Nos. 2 and 3. These cars were more or less damaged.
