INVESTIGATION NO. 3079
THE NEW YORK CENTRAL RAILROAD COMPANY
REPORT IN RE ACCIDENT
AT CHARLOTTE, N. Y., ON
FEBRUARY 22, 1947

Railroad: New York Central
Date: February 22, 1947
Location: Charlotte, N. Y.
Kind of accident: Derailment
Equipment involved: Engine with cars
Engine number: 1599
Consist: 38 cars
Estimated speed: 3 m. p. h.
Operation: Timetable, train orders and
manual-block system; yard
limits
Track: Single; tangent; 0.58 percent
ascending grade westward
Weather: Snowing
Time: 4:23 a. m.
Casualties: 1 killed; 1 injured
Cause: Failure properly to control the
movement of an engine with cars
approaching a drawbridge within
yard limits

Accident at Charlotte, N. Y., on February 22, 1947, caused
by failure properly to control the movement of an
engine with cars approaching a drawbridge within
yard limits.

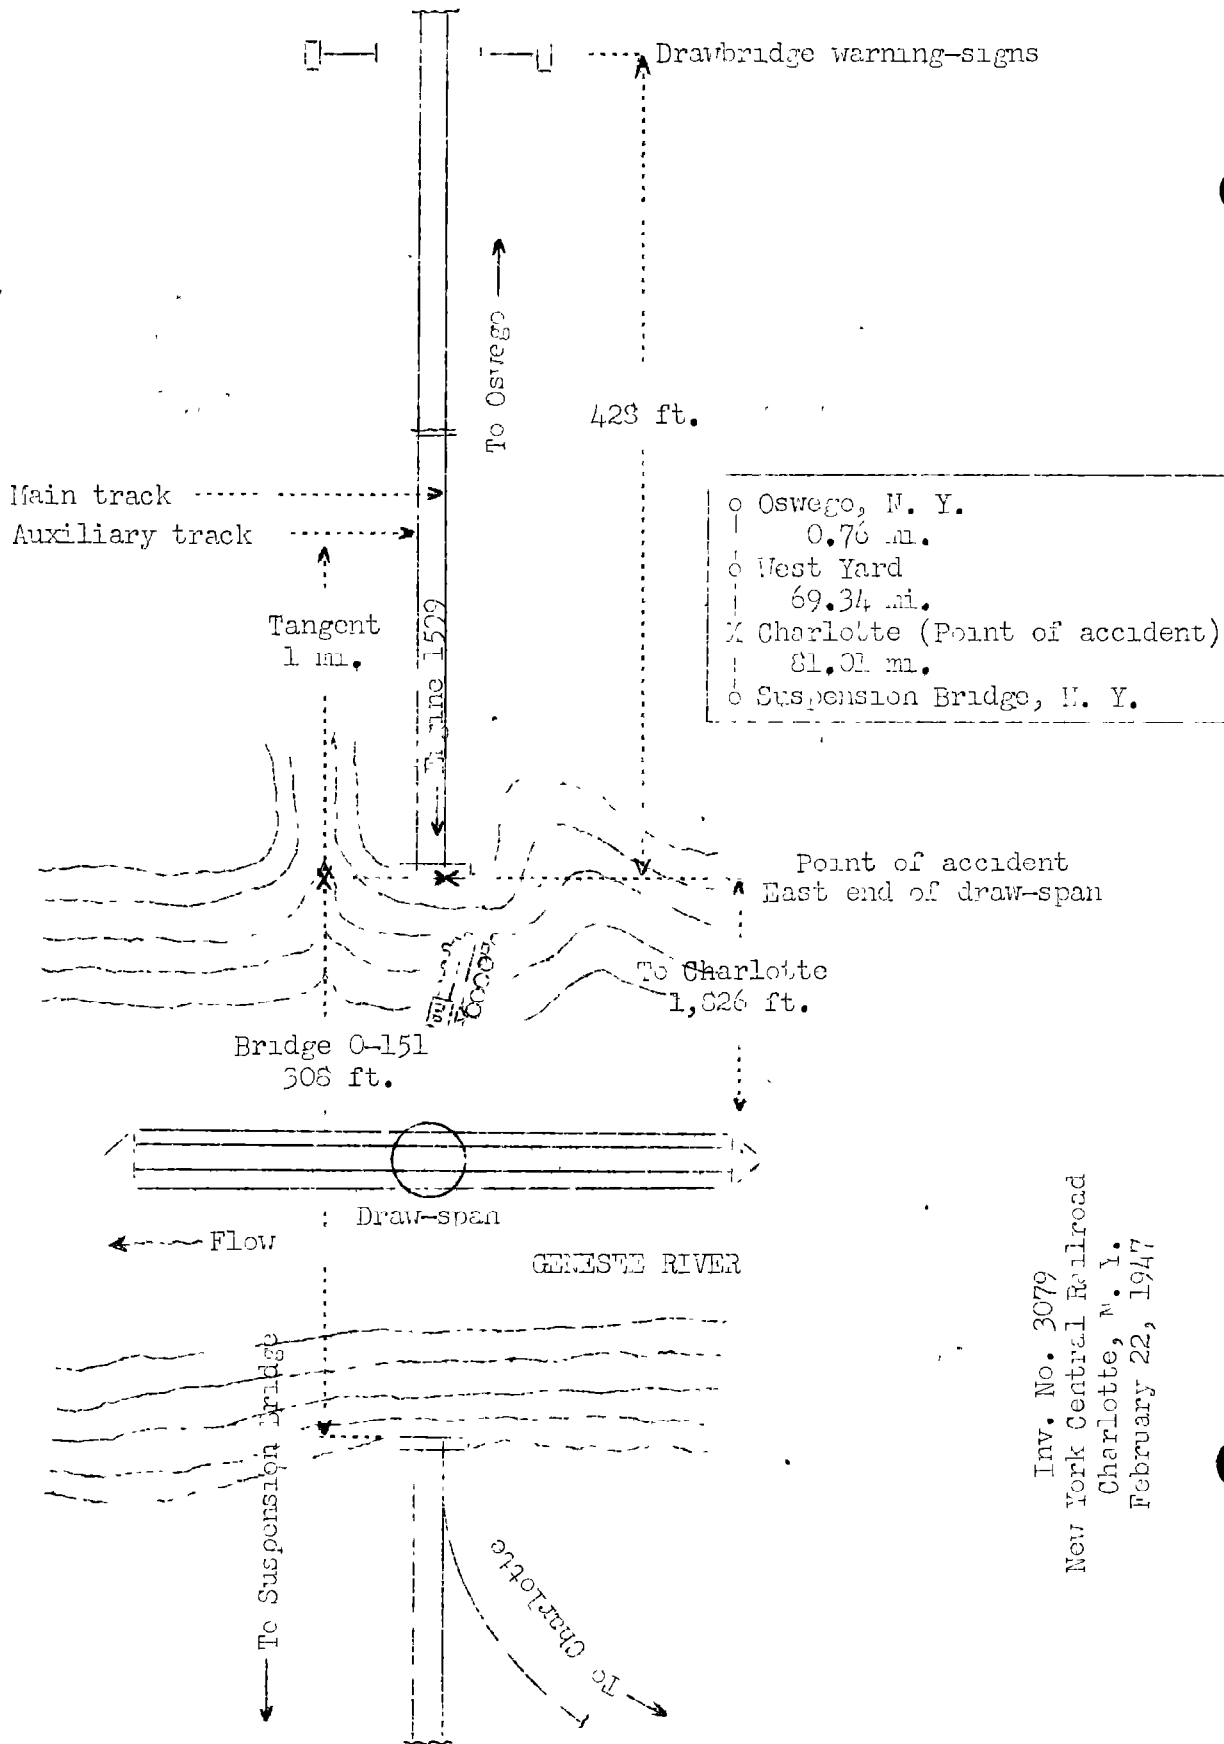
Inv. No. 3079
 New York Central Railroad
 Charlotte, N. Y.
 February 22, 1947

Location of Accident and Method of Operation
