INVESTIGATION NO. 5167  
THE PENNSYLVANIA RAILROAD COMPANY  
REPORT IN RE ACCIDENT  
NEAR TEMPLETON, PA., ON  
FEBRUARY 19, 1948

Accident near Templeton, Pa., on February 19, 1948, caused  
by admitting a following freight train to an occupied  
manual block under a clear-block indication.

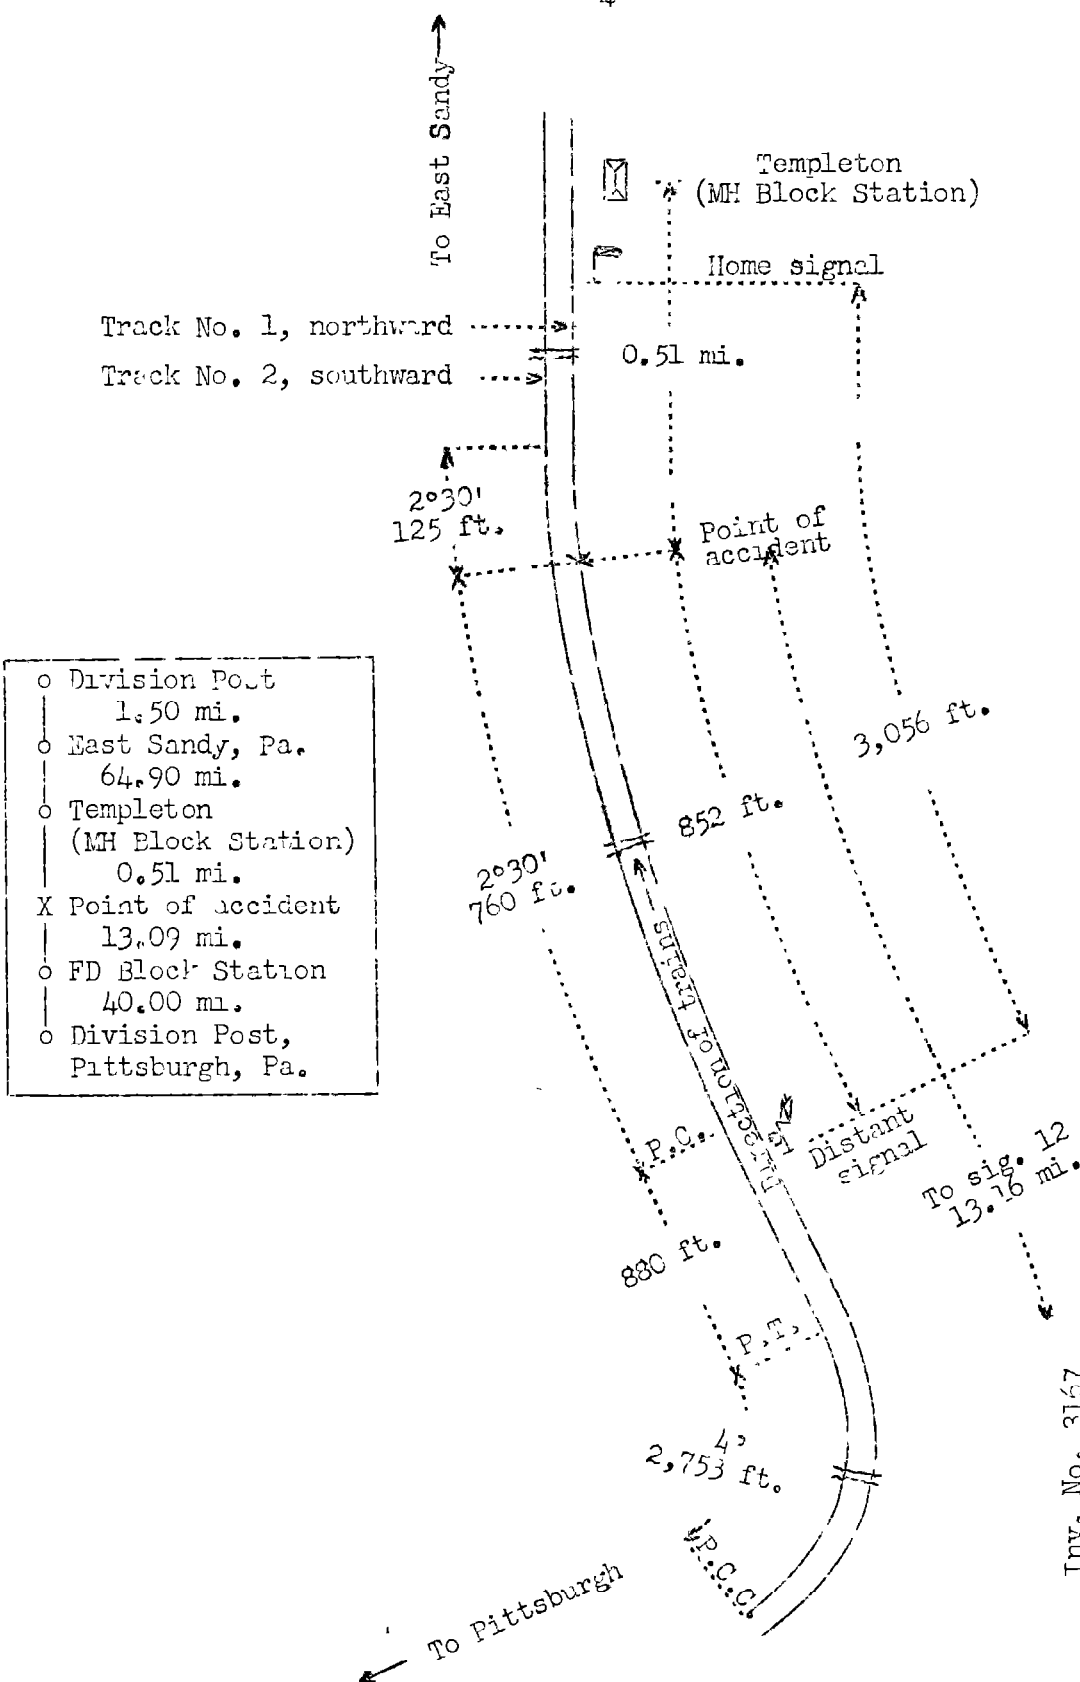
Inv. No. 3167  
 Pennsylvania Railroad  
 February 19, 1948

- o Division Post  
1.50 mi.
- o East Sandy, Pa.  
64.90 mi.
- o Templeton  
(MH Block Station)  
0.51 mi.
- X Point of accident  
13.09 mi.
- o FD Block Station  
40.00 mi.
- o Division Post,  
Pittsburgh, Pa.

Location of Accident and Method of Operation
