REPORT NO. 3271
THE PEORIA AND EASTERN RAILWAY COMPANY
IN RE ACCIDENT
AT MACKINAW, ILL., ON
AUGUST 18, 1949

Accident at Mackinaw, Ill., on August 18, 1949, caused by
an open switch.

Report No. 3271
Peoria and Eastern Railway
Mackinaw, Ill.
August 18, 1949

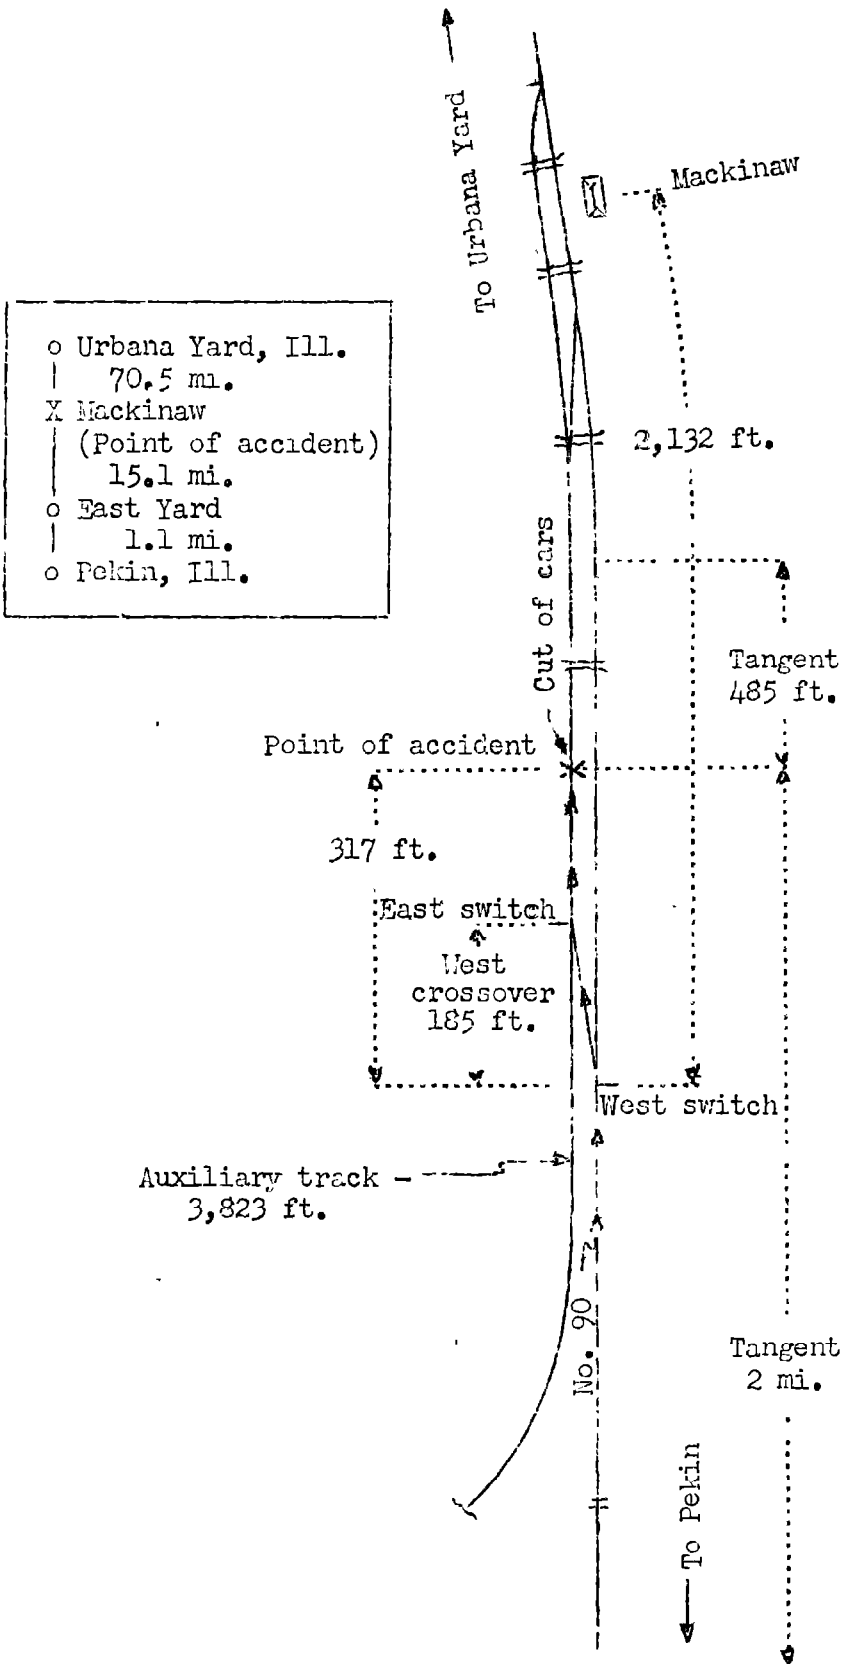
Location of Accident and Method of Operation

The west crossover is provided with a No. 10 turnout at the west end and a No. 8 turnout at the east end. The switch stand at the west switch is of the hand-throw, intermediate-stand type, and is located 9 feet 6-1/2 inches south of the center-line of the main track. It is equipped with an oil-burning lamp, which displays a green aspect when the switch is lined in normal position, and displays a red aspect when the switch is lined for entry to the crossover. The centers of the lenses of the lamp are 9 feet 7 inches above the level of the tops of the rails. When the switch is in normal position a green banner 12 inches wide and 35 inches long with a 1-inch white border is displayed at right angles to the track. This banner is pointed at each end and is attached to the spindle in a diagonal position, 8 feet 2-13/16 inches above the tops of the ties. When the switch is lined for the crossover a red banner, 16 inches wide and 36 inches long, is displayed at right angles to the track. This banner is rounded at each end and is attached to the spindle at the same level as the green banner. The operating lever is of the horizontal-throw type, and is provided with a hole for the insertion of a keeper pin to secure the lever in the desired position. The keeper pin is provided with a hole at its lower end for the insertion of a switch lock.

The switch is provided with a switch-point lock, which is manually operated by means of a treadle located near the base of the switch stand. The switch stand at the east switch of the crossover is of the ground-throw, low-stand type, and is located 7 feet 1 inch north of the center-line of the auxiliary track. It is equipped with an oil-burning lamp, which displays a lunar white aspect when the switch is lined for movement on the auxiliary track, and displays a yellow aspect when the switch is lined for entry to the crossover. It also is equipped with a white banner, which is displayed at right angles to the track when the switch is in normal position, and a yellow banner is displayed at right angles to the track when the switch is lined for entry to the crossover. The lenses of the lamp are 24 inches above the level of the tops of the rails, and the banners are mounted immediately below the lamp.

The engine and tender, the first to the twelfth cars, inclusive, the front truck of the thirteenth car, and the front truck of the fourteenth car of No. 90 were derailed. The engine stopped on its left side and at an angle of 45 degrees to the track, with the front end 50 feet east of the point of accident. It was badly damaged. The tender was detached from the engine, and the trucks and the cistern of the tender were torn from the frame. The first to the twelfth cars, inclusive, were overturned to the north and stopped in various positions on or near the track. The first, second, third, and the fifth to ninth cars, inclusive, were destroyed. The fourth, tenth, eleventh and twelfth cars were badly damaged. The thirteenth and fourteenth cars stopped upright and were slightly damaged. The five most westerly cars of the cut of cars on the auxiliary track were derailed. The first to the fourth cars, inclusive, were overturned to the north and were destroyed. The fifth car stopped upright and was badly damaged.
