REPORT NO. 3344

MINNEAPOLIS, ST. PAUL & SAULT STE. MARIE  
RAILROAD COMPANY

IN RE ACCIDENT

AT PAYNESVILLE, MINN., ON

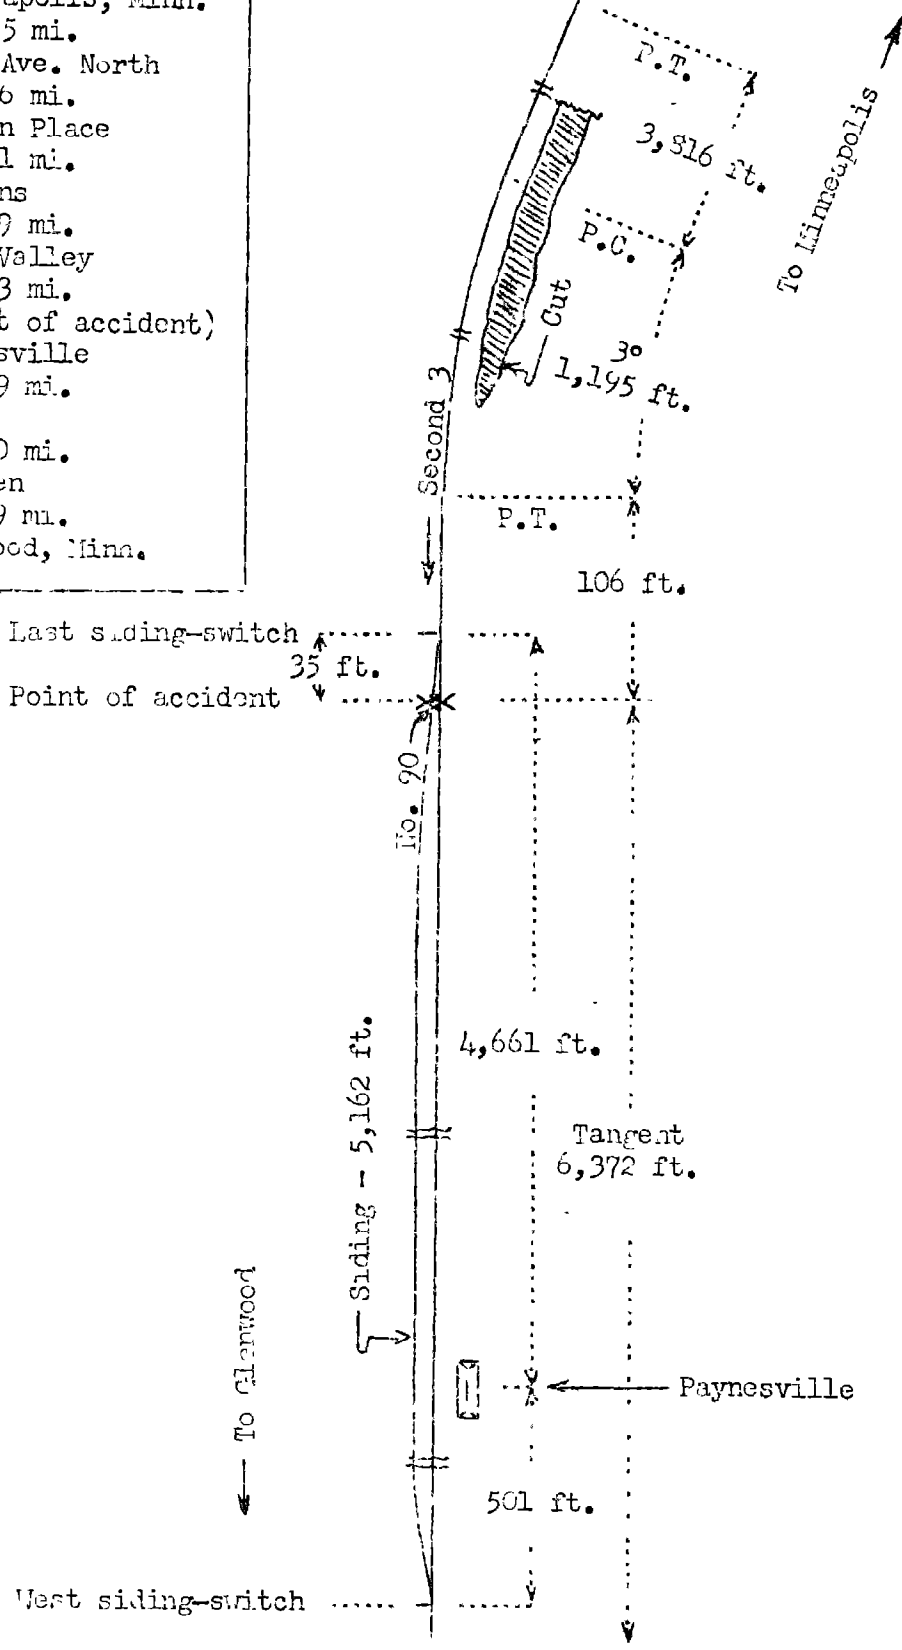
Report No. 3344  
 Minneapolis, St. Paul & Sault Ste. Marie Railroad  
 Paynesville, Minn.  
 July 13, 1950

- o Minneapolis, Minn.
- | 1.5 mi.
- o 14th Ave. North
- | 1.6 mi.
- o Camden Place
- | 63.1 mi.
- o Watkins
- | 6.9 mi.
- o Eden Valley
- | 9.3 mi.
- X (Point of accident)
- | Paynesville
- | 6.9 mi.
- o Regal
- | 15.0 mi.
- o Erooten
- | 15.9 mi.
- o Glenwood, Minn.

Location of Accident and Method of Operation
