REPORT NO. 3354  
THE PENNSYLVANIA RAILROAD COMPANY  
IN RE ACCIDENT  
NEAR BOYNE FALLS, MICH., ON  
AUGUST 26, 1950

Accident near Boyne Falls, Mich., on August 26, 1950,  
caused by an inferior train occupying the main  
track on the time of an opposing superior train  
without protection.

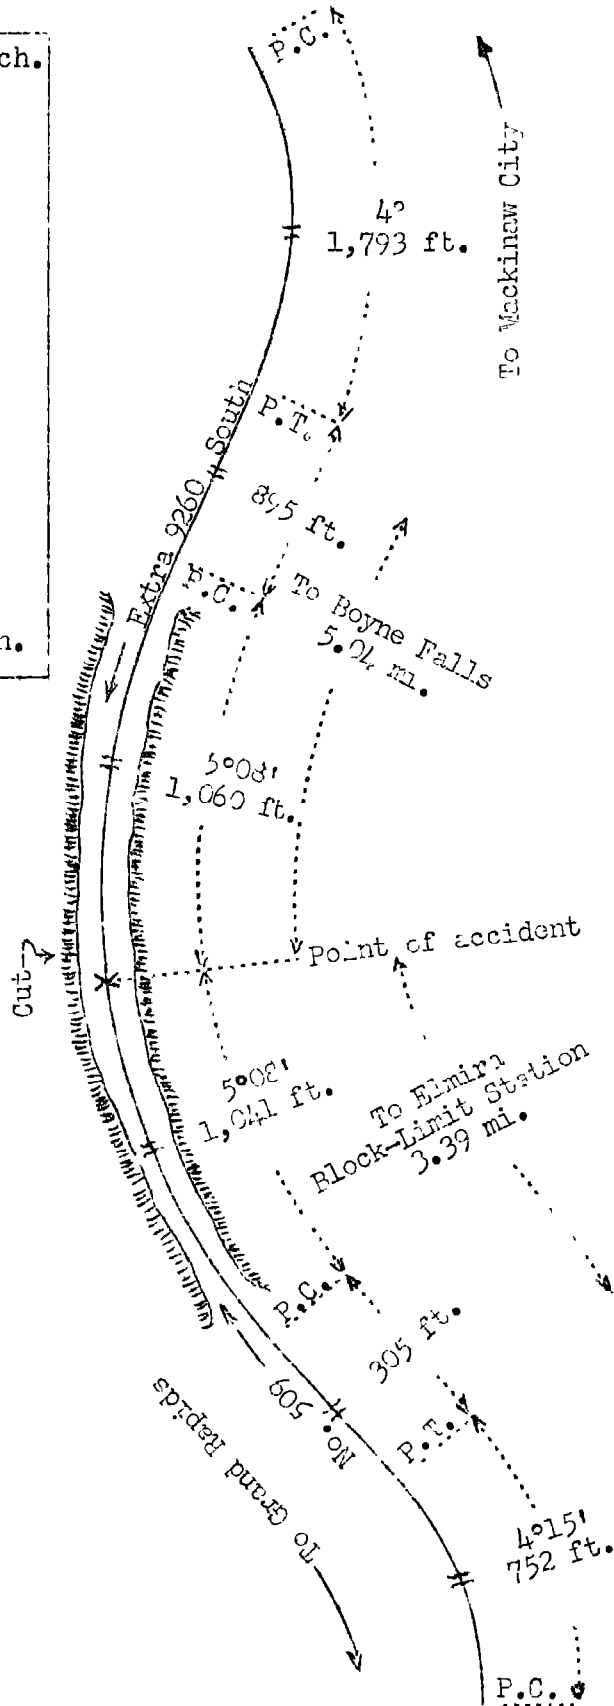
Report No. 3354  
 Pennsylvania Railroad  
 Boyne Falls, Mich.  
 August 26, 1950

o	Mackinaw City, Mich.	34.90 mi.
o	Petoskey	1.80 mi.
o	Formans	14.00 mi.
o	Boyne Falls	5.04 mi.
X	Point of accident	3.86 mi.
o	Elmira	15.20 mi.
o	Mancelona	21.50 mi.
o	South Boardman	31.60 mi.
o	Cadillac	97.80 mi.
o	Grand Rapids, Mich.

Location of Accident and Method of Operation
