REPORT NO. 3357
CHICAGO AND NORTH WESTERN RAILWAY COMPANY
IN RE ACCIDENT
AT BARRINGTON, ILL., ON
AUGUST 27, 1950

Accident at Barrington, Ill., on August 27, 1950, caused by
a train occupying the main track immediately in front
of a following train.

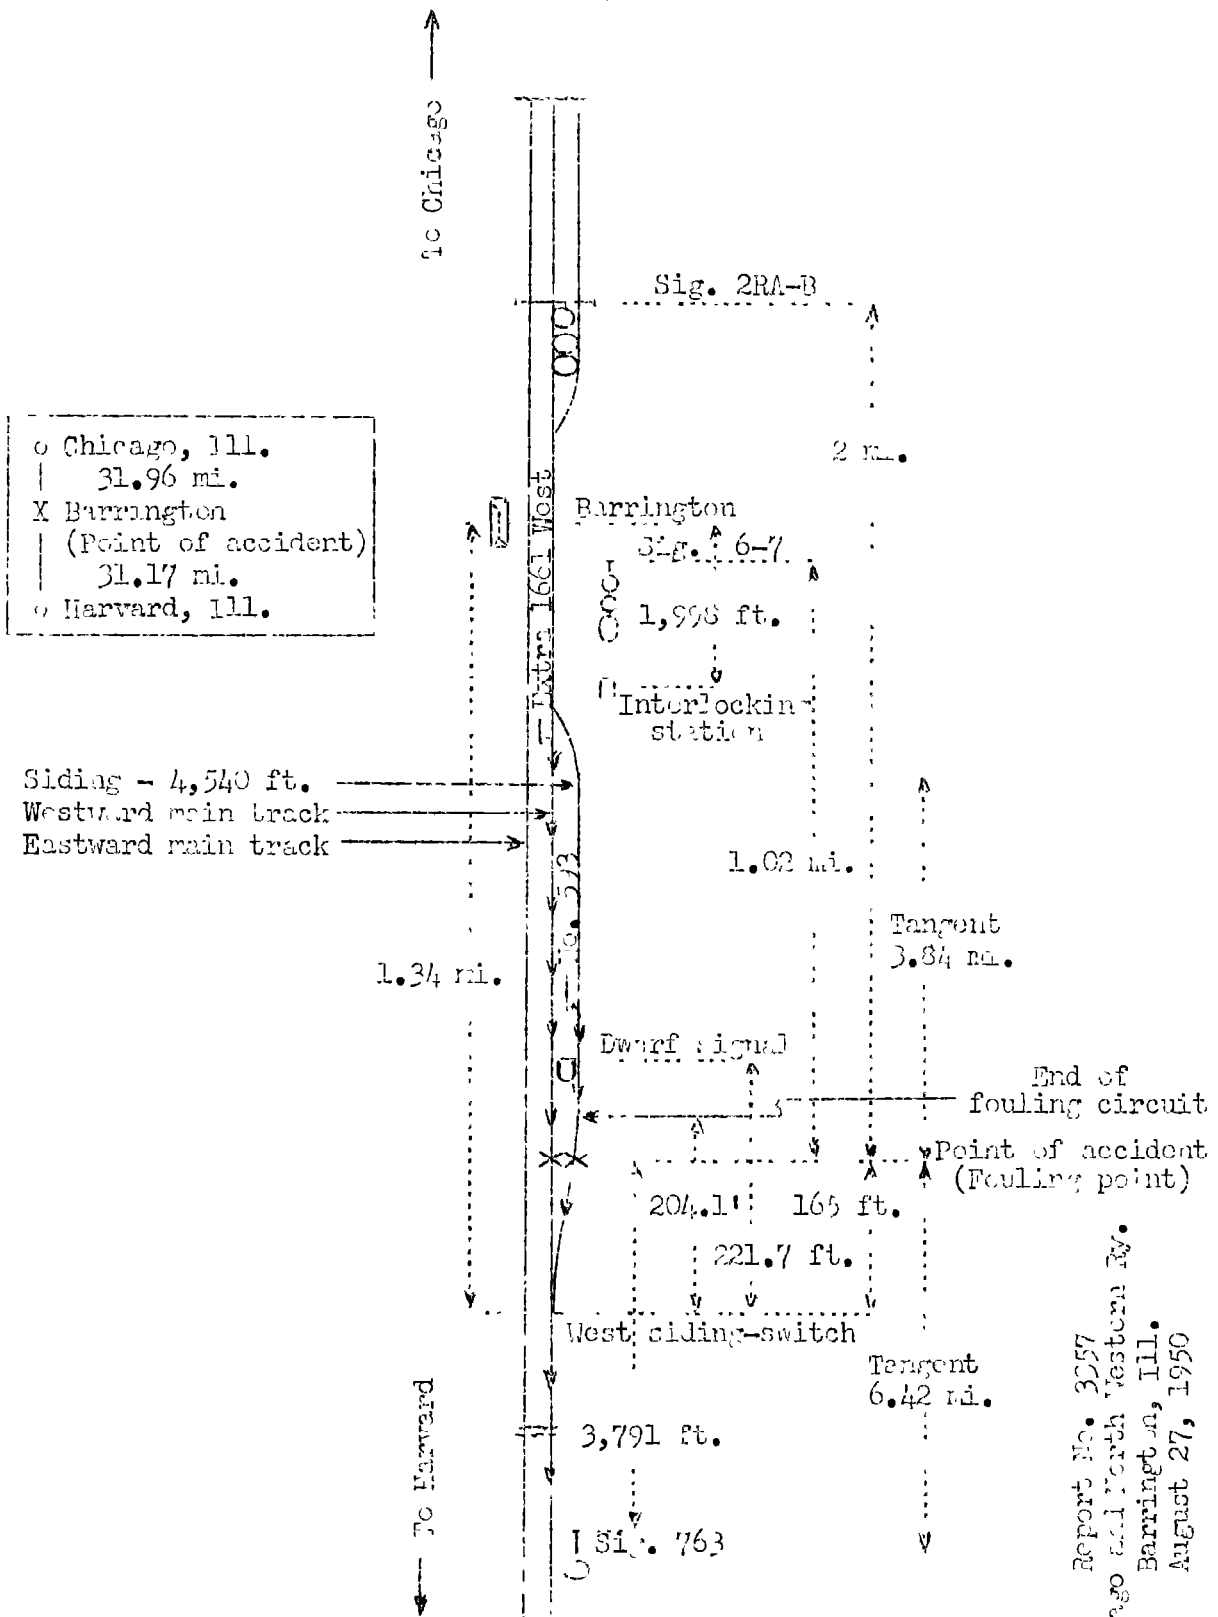
o Chicago, Ill.
 | 31.96 mi.
 X Barrington
 | (Point of accident)
 | 31.17 mi.
 o Harvard, Ill.

Siding - 4,540 ft.
 Westward main track
 Eastward main track

west end of the siding was occupied by No. 593 before Extra 1661 West passed signal 6-7, the block indicator in the interlocking station would display a red aspect and the indication of signal 6-7 would change from Proceed to Stop. The fireman of Extra 1661 West said that signal 2RA-B indicated Proceed when he first observed it. This indicates that signal 6-7 was displaying an aspect to proceed at that time. Extra 1661 West then moved a distance of over 2 miles at an estimated speed of 35 miles per hour before the collision occurred, and the dwarf signal at the west siding-switch should have displayed a red aspect during that time. After No. 593 entered the fouling circuit, it moved a distance of about 250 feet at an estimated speed of 4 to 7 miles per hour before the collision occurred.
