RAILROAD ACCIDENT INVESTIGATION

Report No 3775

THE NEW YORK CENTRAL RAILROAD COMPANY

WHITE PIGEON, MICH

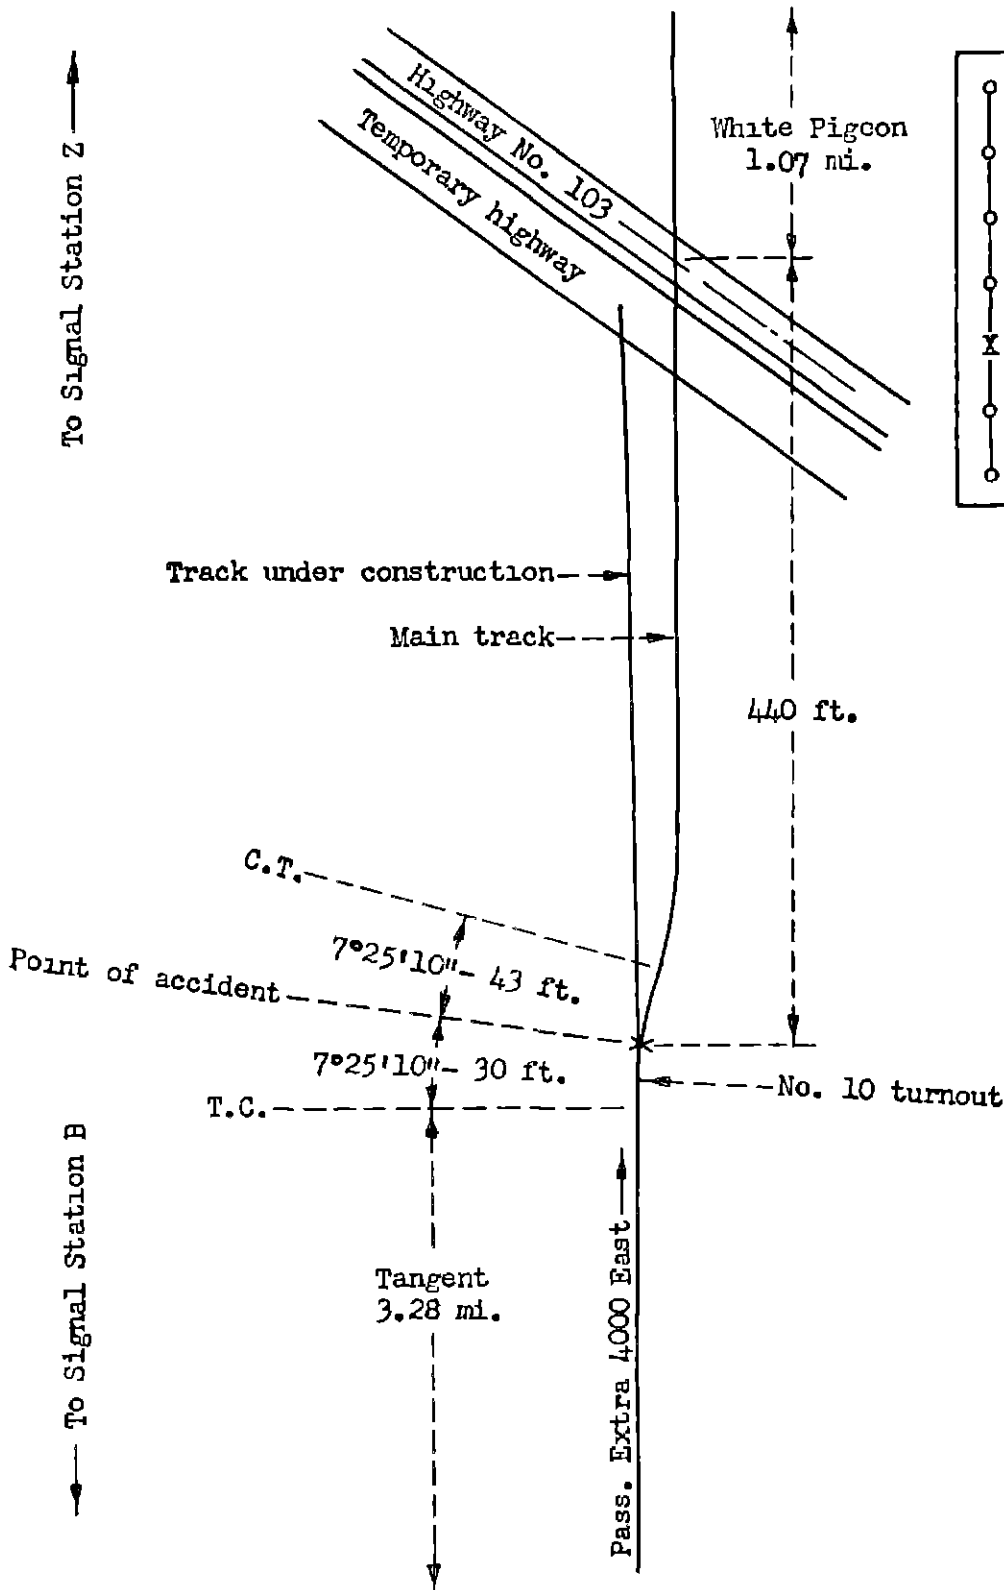
The New York Central Railroad
 White Pigeon, Mich.
 November 16, 1957

- Toledo, Ohio 2.00 mi.
- Signal Station Z 63.68 mi.
- Hillsdale, Mich. 57.96 mi.
- White Pigeon, Mich. 1.15 mi.
- X Point of accident 17.48 mi.
- Signal Station B 0.15 mi.
- Elkhart, Ind.

This accident occurred on that part of the Toledo Division extending between Signal Station B, Elkhart, Ind., and Signal Station Z, Toledo, Ohio, 140.27 miles, designated as the Old Road. In the vicinity of the point of accident this is a single-track line over which trains are operated by timetable, train orders, and a manual block-signal system. At White Pigeon, Mich., 18.63 miles east of Signal Station B, Michigan State Highway No. 103 crosses the main track at grade. The centerline of the highway is 1.07 miles west of the station. Prior to the time the accident occurred the main track in the vicinity of the highway was relocated approximately 14 feet south of its original location and a track was being laid parallel to and approximately 15 feet north of the main track. The main track and the west end of the track under construction were connected by a No. 10 turnout at a point 1.15 miles west of the station at White Pigeon and 440 feet west of the centerline of the highway. Planking was laid immediately west of the highway at the intersection and was being used as a temporary crossing while work was being performed on the highway. At the time the accident occurred the switch of the turnout was lined for movements on the main track and was spiked in that position. The accident occurred at the turnout. From the west there are, in succession, a tangent 3.28 miles in length, a $7^{\circ}25'10''$ curve to the right 30 feet to the point of accident and 43 feet eastward. The grade for eastbound trains is 0.20 percent ascending at the point of accident.
