RAILROAD ACCIDENT INVESTIGATION

Report No 3840

THE NEW YORK CENTRAL RAILROAD COMPANY

ROSAMOND, ILL.

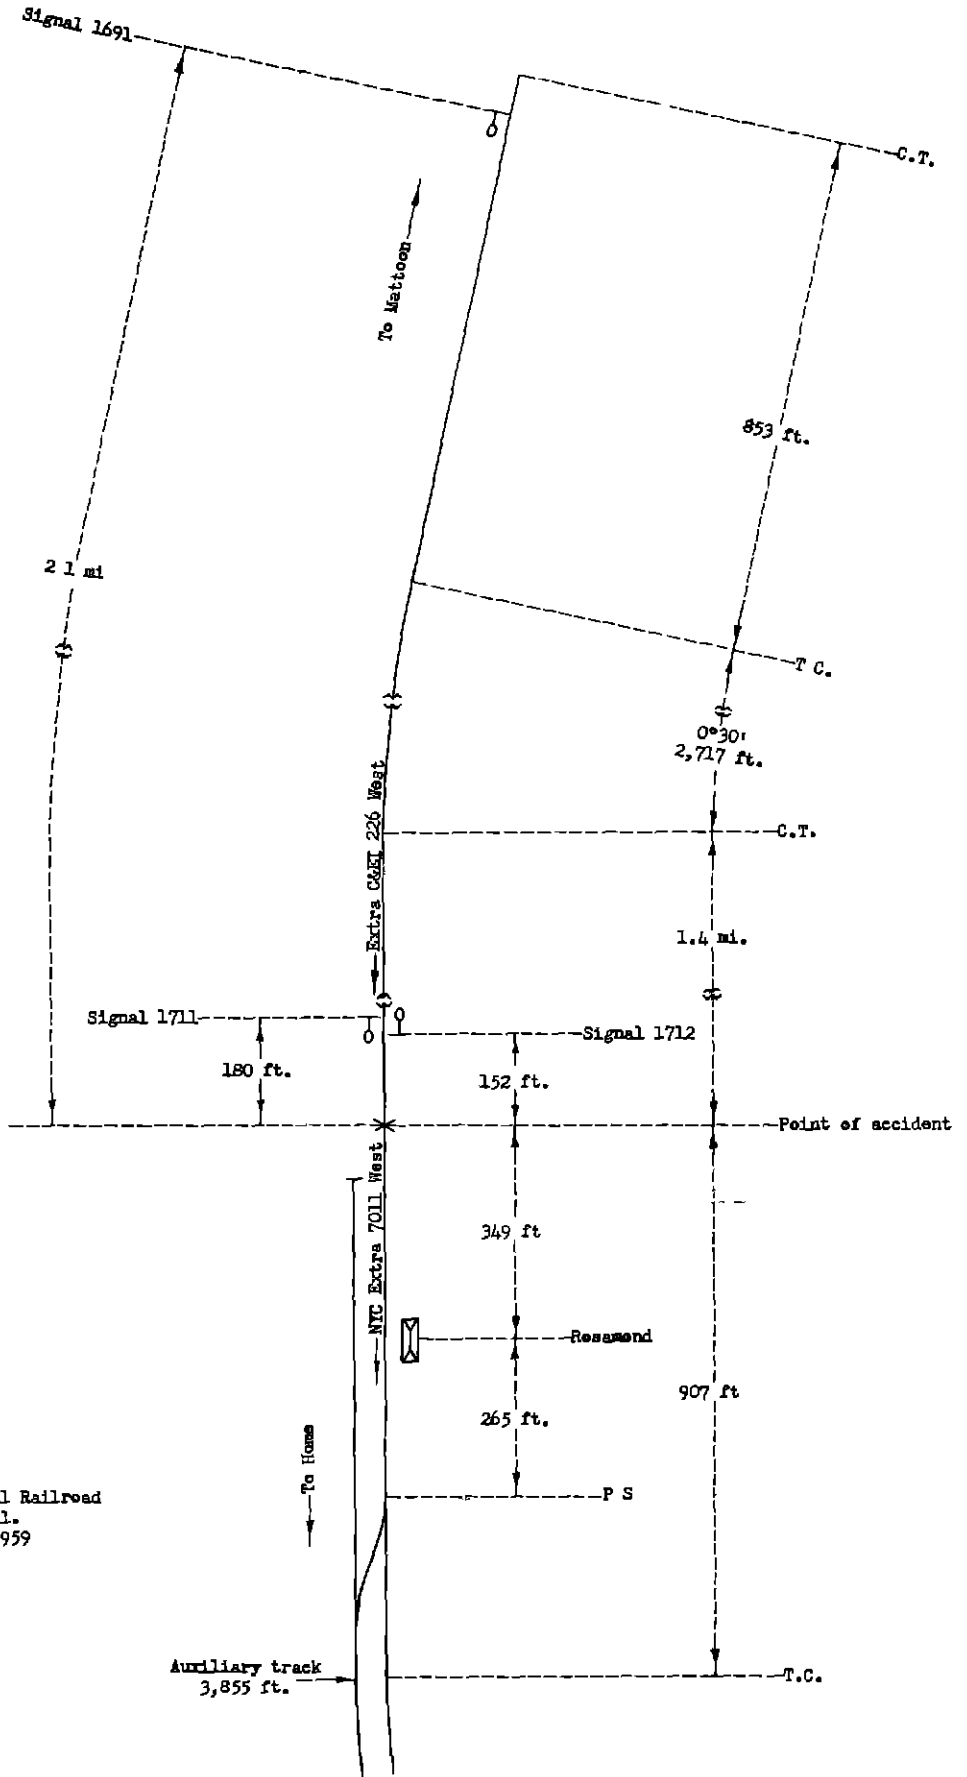
The New York Central Railroad
 Rosamond, Ill.
 February 9, 1959

- Mattoon, Ill.
38.9 mi.
- Pana
4.3 mi.
- X Rosamond
(Point of accident)
64.3 mi.
- Home, Ill.

This accident occurred on that part of the Illinois Division of the New York Central Railroad (NYC) extending between Mattoon and Home, Ill., 107.5 miles. In the vicinity of the point of accident this is a single-track line over which trains are operated by signal indications supplemented by an intermittent inductive-type automatic train-stop system. Trains of the Chicago and Eastern Illinois Railroad (C&EI) regularly operate over this line between Pana and Mitchell, 38.9 and 109 miles, respectively, west of Mattoon. In the vicinity of the point of accident a southbound C&EI train moves westward by NYC timetable directions, which are used in this report. At Rosamond, 43.2 miles west of Mattoon, an auxiliary track 3,855 feet in length parallels the main track on the north. The east switch of the auxiliary track is located 265 feet west of the station.
