# Maintenance on C. & N. W. Terminals Heavy Passenger Traffic Requires Efficient Organization on Nineteen Interlockings and Intervening Automatic Signals

# The Territory Covered, the Traffic and the Type of Plants

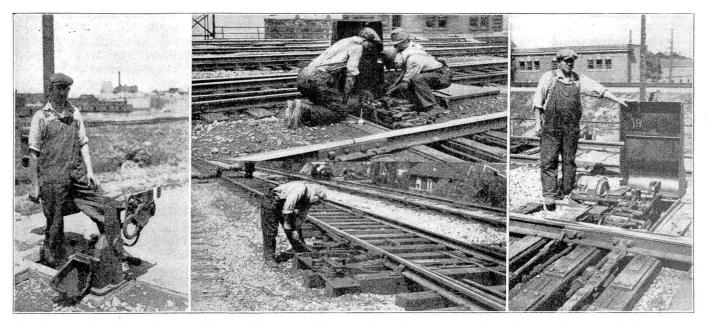
A. Johnson, Maintainer at Deering Inspecting a Dwarf Signal

Above—A Minor Maintenance Operation at Clinton St. Below—Adjusting a Mechanical S. & L. M. at Rosehill Plant

J. P. Winandy, Maintainer at Main St. Inspecting a Switch Machine

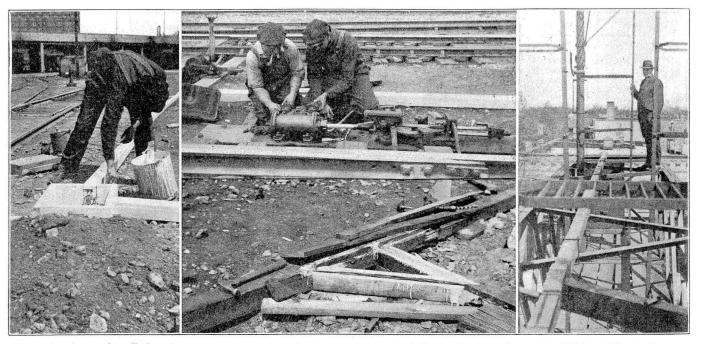
Trunking Runs Are PaintedAbove—Inspecting the Live End of an Electro-Pneumatic<br/>White to Make ThemF. L. Wells, Signal Super-<br/>visor on Bridge Showing<br/>Insulation All Trunking Junctions and<br/>For SafetyF. L. Wells, Signal Super-<br/>visor on Bridge Showing<br/>Trunking on Top of<br/>Upper Girder

on the deck of a signal bridge that cinders and dirt get into the trunking to cause trouble. Therefore, on renewals the trunking is suspended on hooks underneath the deck of the bridge, the deck being on the lower girder. Where bridges are too low to allow proper clearance the trunking is placed on top of the upper bridge girders as is shown in one of the photographs. One unique feature on all trunking work is that no right angle turn is made as the wires are run through the piece of trunking running across the corner, thus making a corner of 135 deg. instead of 90 deg.
