Dispatcher Signaling System Operates Through Sleet Storm

A HEAVY sleet storm in northwestern Ohio on March 29 and 30, broke down hundreds of telegraph poles along the railways in that area, including over 600 poles on the New York Central's 40-mile installation of the centralized dispatching system extending from Berwick to Stanley. In spite of the loss of these poles no delays to trains resulted on this line because of any shortcomings of the dispatching system, notwithstanding the fact that all other communication and facilities for directing train movements were out of commission. This storm subjected the dispatcher signaling system, installed

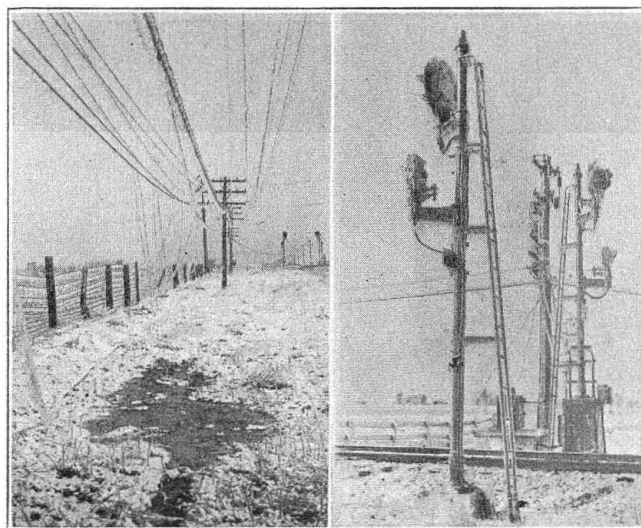
Ice-covered cables, line wires and signals

last summer by the General Railway Signal Company, to an operating test beyond anything anticipated at the time of its installation. All control wires are carried in Hazard steel-armored cable which did not break the circuit continuity at any point, despite the pole line failure.*

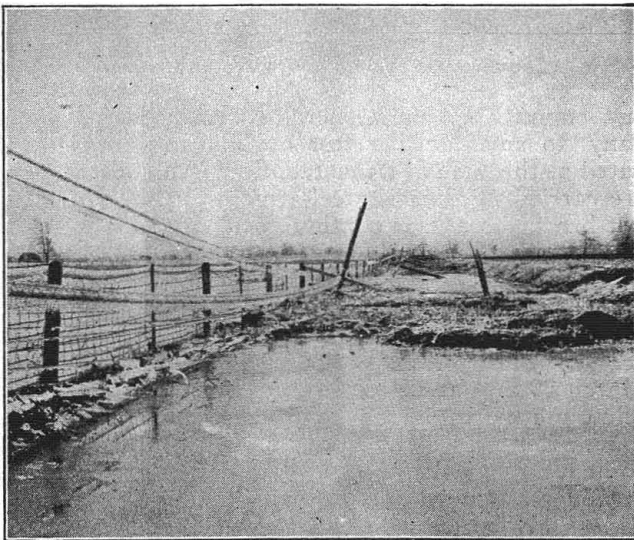
Five-inch icicles formed on the wires, causing over 600 poles to go down

intermediate stations is not required for through movements. Although over 600 poles went down under the ice load between Toledo and Berwick, the control wires of the dispatching system, which are in cable, were not broken. The cable was especially designed with steel-tape covering to make it bullet-proof and was installed with 7/16-in. messenger to withstand any sleet storm. Although this storm was more severe than anything anticipated, the strength of the messenger wire emphasized the merits of this type of construction. The alternating-current power supply is fed to this system at four points. Although

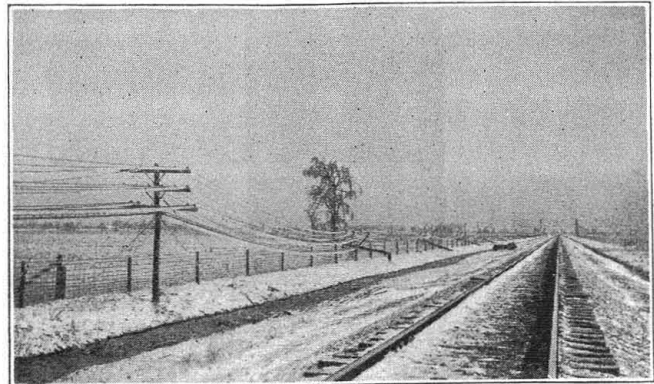
The pole in foreground was guyed four ways and held while all the others in the view went down
