Monon Revamps Signals to Co-Ordinate with Automatic Train Stop

Part I—Signal reconstruction program embraces 161-mile single-track line between Hammond, Ind., and Indianapolis*

By E. G. Stradling

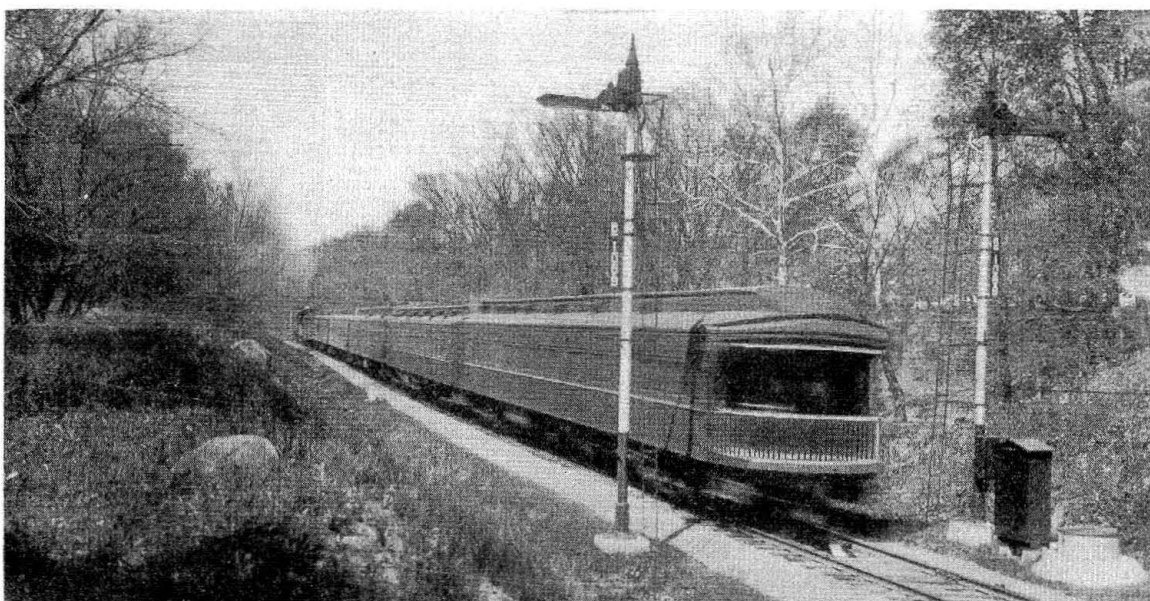
The route of the Hoosier is protected by automatic signals and train stop
