Hollow End Mill

By F. C. Larson

Relay Shopman, Great Northern, St. Paul, Minn.

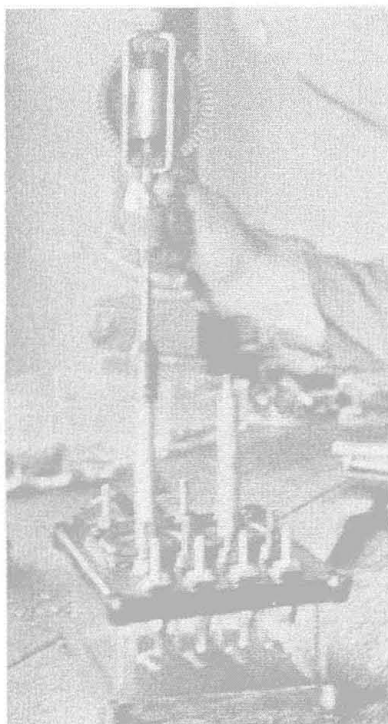
Close-up view of the hollow end mill, chucked in a breast drill, being used for cleaning and truing the shoulders of a magnet core When the corresponding back-yoke surfaces are being cleaned, the guide (see detail sketch) is locked in the mill with the machine screw.

on the back yoke, that make magnetic contact with the cores. With the use of this hollow end mill it is not necessary to remove the magnet cores from the relay to do a perfect job of cleaning rust and other substance from the magnetic contact points between the cores and back-yoke of relay.

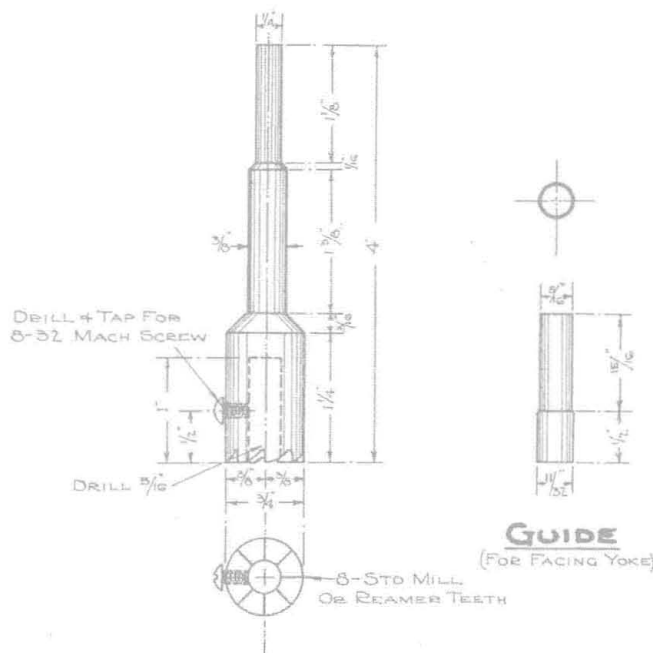
Detail sketch showing dimensions of special tool used for cleaning and truing shoulders of relay magnet cores and the back-yoke surfaces that make magnetic contact with the cores.

The tool has eight end-mill or reamer teeth, with a hole in the center, so that the tool fits exactly over the top, threaded, end of the core. The shank can be made either square or round to fit into an ordinary brace or breast-drill. A few revolutions with the tool will clean rust or any other foreign matter from the point of magnetic contact, leaving the core shoulder machined smooth and true. The back-yoke can be machined by inserting the pin or guide into the hole in the center of the tool and clamping same by tightening up on the small machine screw provided for that purpose. The back-yoke can be held in the vise for this operation, and, as with the cores, after a few revolutions with the tool, the surface that contacts with the cores are cleaned perfectly.

The tool should be made from a good grade of tool steel. This particular tool is especially made to fit the G. R. S. 9-A, 9-D, 9-E and 10-A relays.
