Crossing Protection

on the Monon

Installation at Bloomington, Ind., includes flashing-light signals with rotating stop signs and special cut-outs for switching operations

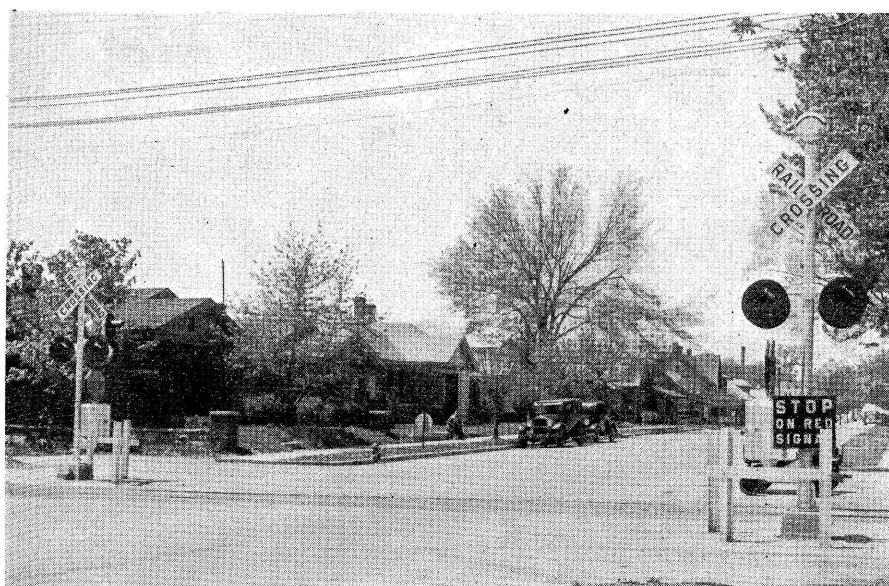
View looking west
showing the rotating
stop signs in the clear
position

The flashing-light signals are assembled complete, back-to-back mounting, with signs according to the A.A.R. Signal Section standard. In view of the fact that side streets, paralleling the track on the west side, enter the highway at the crossing, extra flasher units were mounted on the signal on the west side of the track. These lamps flash the same as the main signal units to give warning to drivers approaching on the side
