What's the **ANSWER?**

Unusual Signaling Trouble

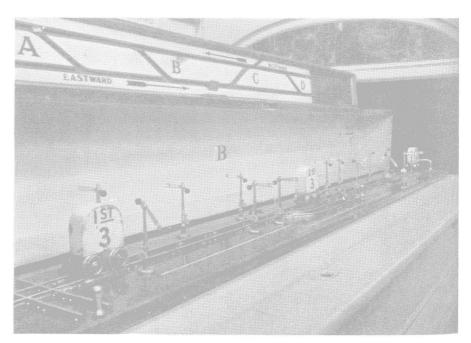
A working model of a block system is provided for the instruction of enginemen

railroad with sidings and a complete arrangement of automatic block signals. The signals are electrically controlled and as the instructor moves the miniature brass cars along the track circuits, the class can see the signals function just as they do in actual practice.

vide a classroom and living quarters for the instructor and his assistant. Part of the instruction is, of course, on block signal rules and, to facilitate these instructions and to assist in explaining the operation of the block system, a working model is used. It represents about six miles of been instructed. Class periods are of three hours duration. One period, which is attended by men in all branches of operating service, is devoted to a review of general rules, and interlocking and block signal operation. The other period covers air
