Union Pacific Installs ...

Protection For Motor Cars at Tunnels

Special signal controls hold trains out of tunnels for 15 min. allowing man or motor car to clear the tunnels before train can proceed. Flashing-red-aspect on home signal initiated by switch-key control

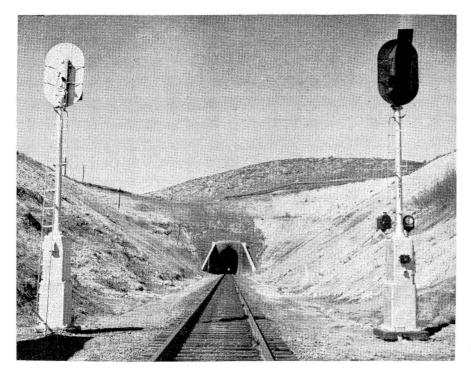
EAST END ALTAMONT TUNNEL looking west controller toward Ogden. Switch-key and indicator lamp are mounted on end of signal case, below motor car dicators. When controller operated by switch key, home signals at each end of tunnel will display flashing-red aspects. First signals in approach display yellow, second signals in ap-proach will display flashing-yellow and third signal in approach will be green

approaching within limits) he inserts restricted speed" signal, indicating his switch key in the controller case that a motor car is in the tunnel. For on a relay, or signal case at the end a second motor car movement of the tunnel, turns the key to the through the tunnel while the home right 90 deg., then back, and removes the key. If no train is approaching the tunnel, this action will cause the home signals at each end of the tunnel to display a steady red aspect for 5 sec. and then a flashing-red aspect for 15 min. As shown in Fig. 2, the first signal in approach will display a yellow aspect; the second signal in approach the flashing-yel-

lamp on the switch-key controller case burns steady for 5 sec. and then will flash 55 times per min., indicat- ated, a relay and its repeater are reing to the motor car operator that leased, which transfers the signal the protection system is in operation, lighting circuit to the red aspect and and that he has 15 min. to pass introduces flashing control, all of through and clear the tunnel. If a which are automatically cut out by

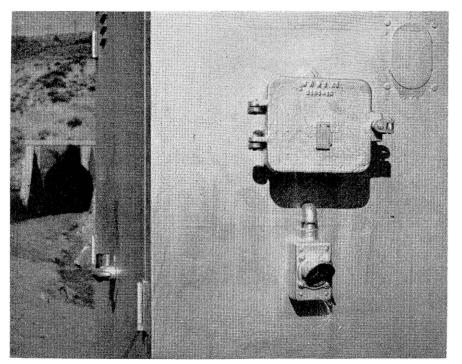
INDICATING LAMP burns steady, then flashes showing motor-car protection is "OK"
