Indication locking

Failure to maintain the Montgomery interlocking in a safe condition for train movements was the cause of an accident on the Chicago, Burlington & Quincy at Montgomery, Ill., on Sept. 27, 1964. So ruled Division 3 of the Interstate Commerce Commission. The accident involved a head-end collision between passenger trains of the CB&Q and the Chicago, Rock Island & Pacific, resulting in the death of 4 railroad employees, and in the injury of 37 railroad employees, 2 railway post office employees and 201 passengers. The following is an abstract of the report of the ICC following an investigation and hearing.

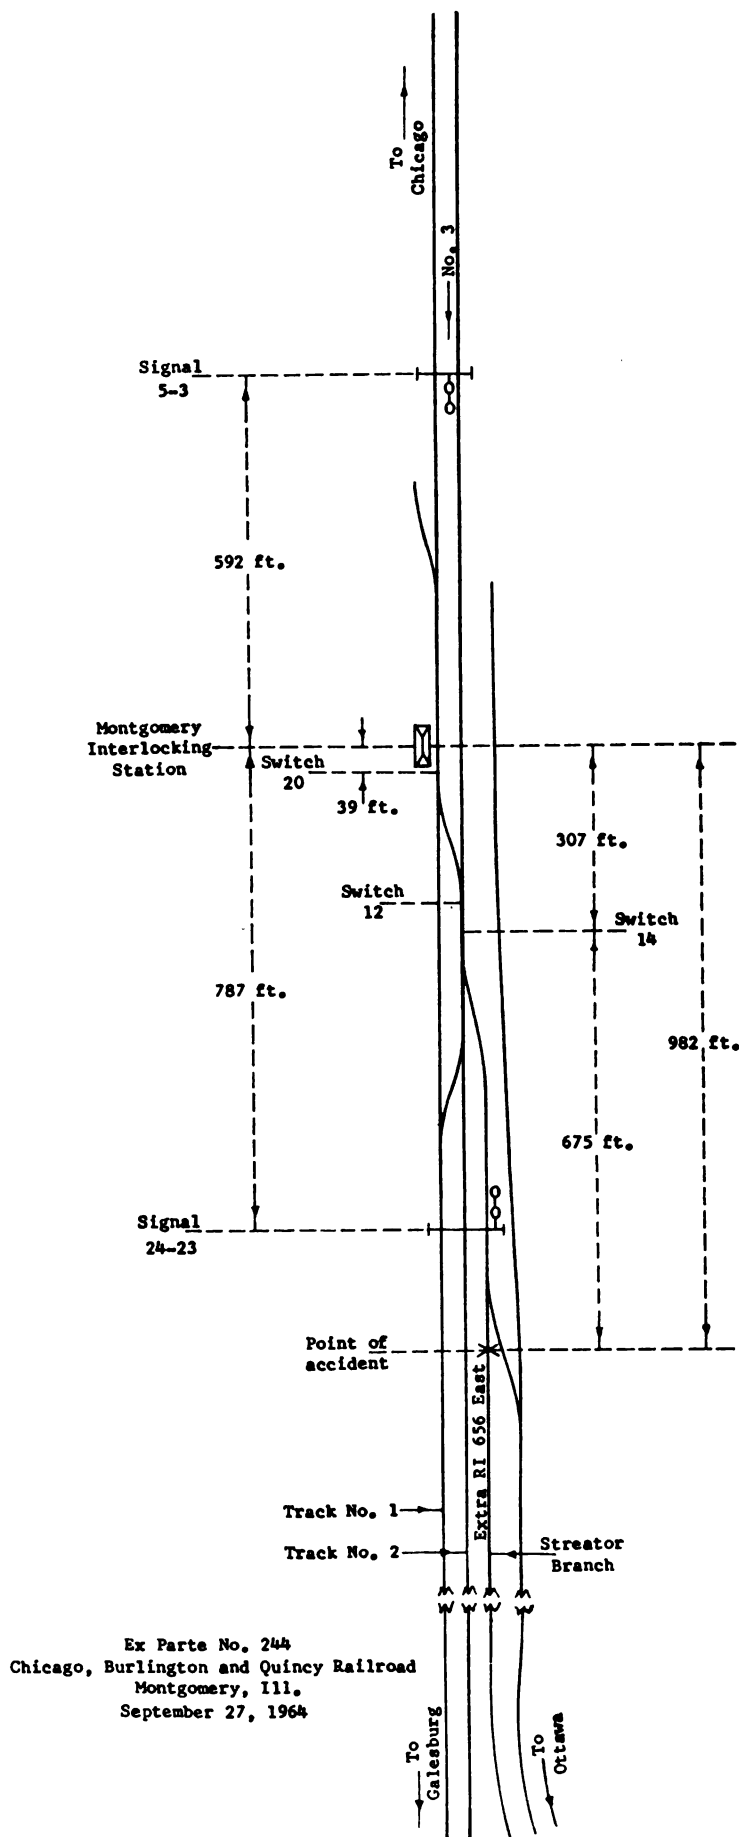
The accident occurred on that part of the CB&Q between Chicago and Galesburg, Ill. This is a double-track line in the accident area. Trains operate in both directions on either main track by signal indications of automatic block-signal and interlocking systems. From the north, the main tracks are designated as tracks No. 1 and No. 2.

Montgomery, a mechanical interlocking, is 40 miles west of Chicago and 2.2 miles west of the station at Aurora, Ill. Movements through the interlocking are controlled by the operator from an interlocking machine, which is in a station.

The Streator Branch, a single-track line, diverges southwestward from track No. 2 at switch 14 of the interlocking. This switch is facing point for westbound movements on track No. 2. A crossover connects tracks No. 1 and No. 2 within the interlocking. Its switches are designated as No. 12 and No. 20. The latter switch is facing point for westbound movements on track No. 1.

The accident occurred on the Streator Branch main track 982 ft west of Montgomery interlocking station and 675 ft west of switch 14.

A signal bridge spans tracks No. 1 and No. 2 at a point 592 east of the interlocking station. Semi-automatic signal 5-3, fixed to a mast on this signal bridge, governs westbound movements through the interlocking on track No. 2 and westbound movements from track No. 2 to the Streator Branch main track via switch 14.

A signal bridge spans the Streator Branch main track and tracks No. 1 and No. 2 at a point 787 ft west of the interlocking station. Semi-automatic signal 24-23 governing east-bound movements from the Streator Branch main track to tracks No. 1 and No. 2, is fixed to a mast on this signal bridge.

The Montgomery interlocking was of the mechanical pipe-operated type. Approach, route and indication locking were provided. The interlocking machine had 24 mechanical working levers in a 28-lever frame. Levers 3, 5, 23 and 24 were four of the signal levers and each controlled its corresponding numbered interlocking signal unit. Levers 14, 12 and 20 were three of the switch levers and each controlled its corresponding numbered interlocking switch. Lever 15, one of the locking levers, controlled the locking of switch 14. At the time of the accident, Montgomery interlocking was being converted to the electrical power-operated type for remotely controlled operation under a forthcoming traffic control system. Switches 14, 12 and 20 had been converted to power-operated switches and were controlled through circuit controllers operated by the corresponding numbered interlocking machine levers.
